A Restoration Plan for the

*M*ASONIC CEMETERY

HOPE ABBEY *M*AUSOLEUM
EUGENE, OREGON DECEMBER 1995

DONALD PETING AND RICH A WILSON Preservation Consultants

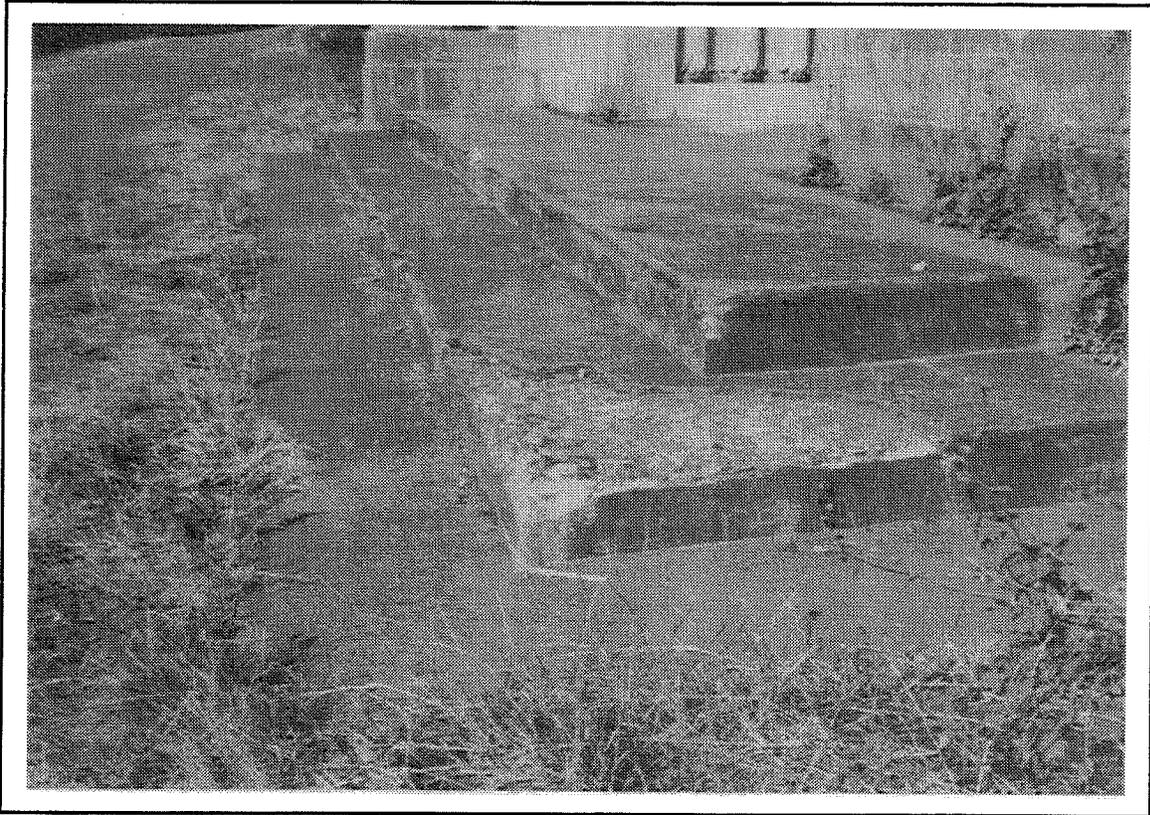
The mausoleum has only one entrance. It is accessed by concrete entrance steps, which suffer from severe spalling and invasive plant growth. The first of the three risers is nearly flush with the ground as movement of soil has resulted in a higher grade than when the building was first constructed.

View north of the entrance steps at the Hope Abbey Mausoleum

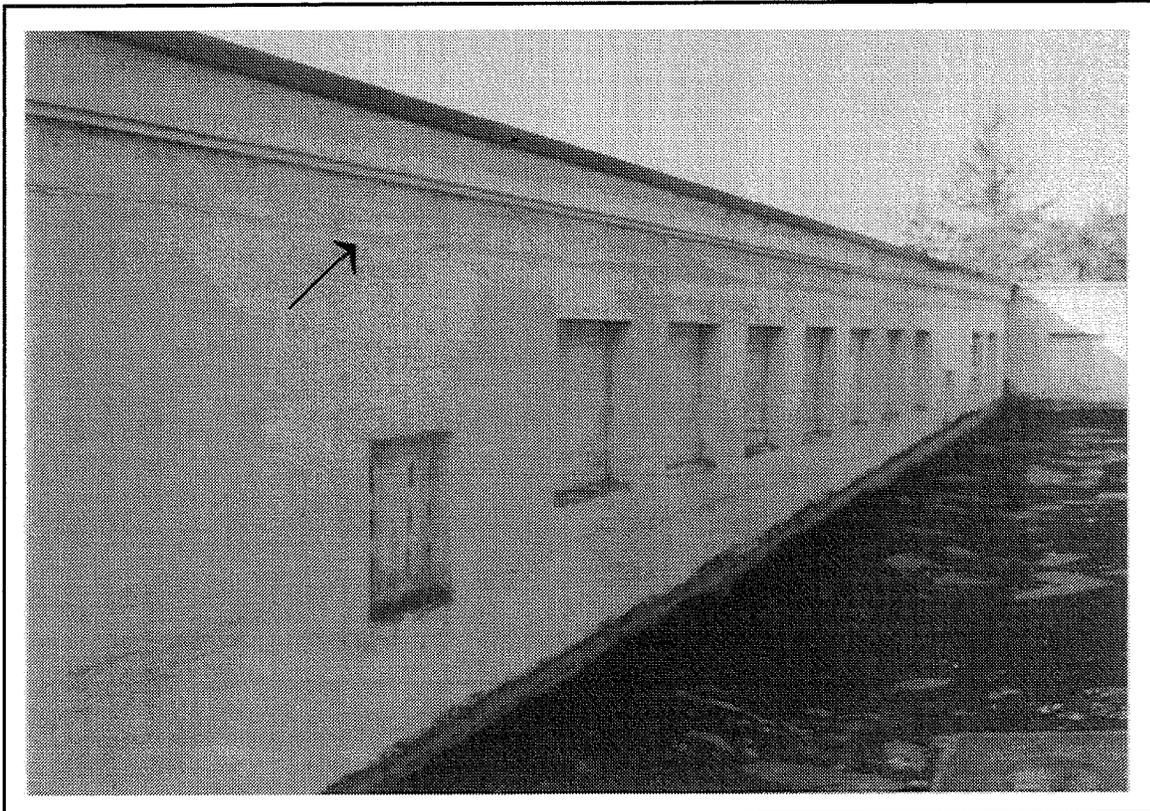
There are many non-progressive cracks that can be attributed to modest settling or changes in cold joints formed during construction. Some larger, vertical cracks have formed as a result of what appears to be water penetration. In previous maintenance efforts, some parging has been applied over these cracks in an attempt to control this problem. The most significant cracking is at the roof-to-wall juncture where a horizontal crack extends around the three sides of the attic's southern bay.¹⁰ It has been filled with sealant.

Illustration of horizontal cracking where roof connects to clerstory

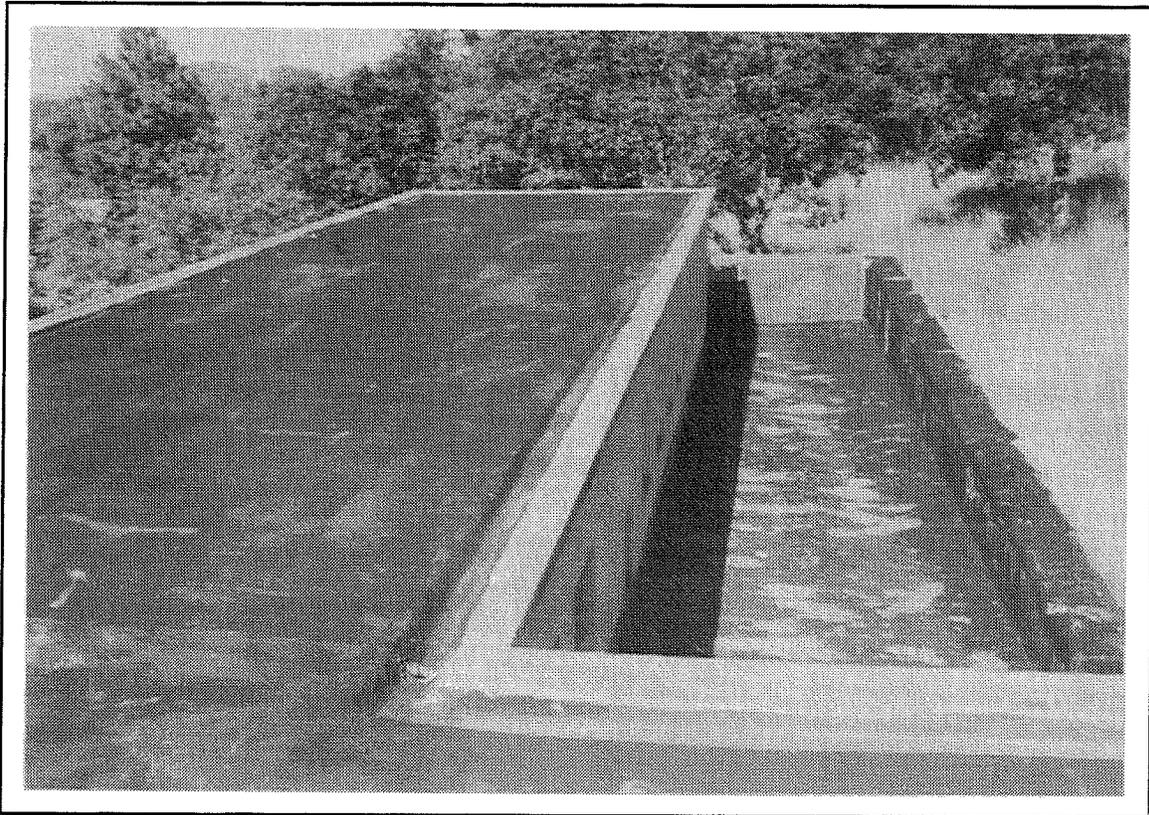
Clerestory roof with drainage gutters and mineral surface membrane roofing

Currently, the top roofing layer is standard mineral surface membrane roofing applied on underlying roll roofing. A lack of maintenance, coupled with exceeding the normal life of the roofing without replacement, has led to its failure. It is unclear, given the amount of moisture inside from wall seepage, how much leakage can be attributed to the roofing, but the membrane failure in the form of alligatoring and buckling is pronounced.

The most serious problem is the inability of the original drainage system to handle normal rain conditions. The roof of the entrance pylon is drained by one undersized interior drain. The attic roof has gutters that lead water to four drains, all of which release water to the main roof and its drains. The depth of these gutters is marginal and in some places, due to the application of many roofing layers over time, does not perform as expected. During periods of heavy rain, the shallow depths are not sufficient to carry the water, thus resulting in spillage over the attic cornice. The main roof has only two 2" internal drains, one at each of the north and south ends. Evidence indicates the operation of these drains was marginal when the building was constructed and depended on constant care. Today, they are barely operational - if at all - due to the corrosion of the conduit and/or clogging by organic debris. During an earlier maintenance effort, holes were drilled in the concrete faces of the exterior walls to alleviate water build-up in the walls. The lack of operable drains creates additional problems by allowing the ponding of water on the roof. This places excessive loads on the roof, causing additional deflection and

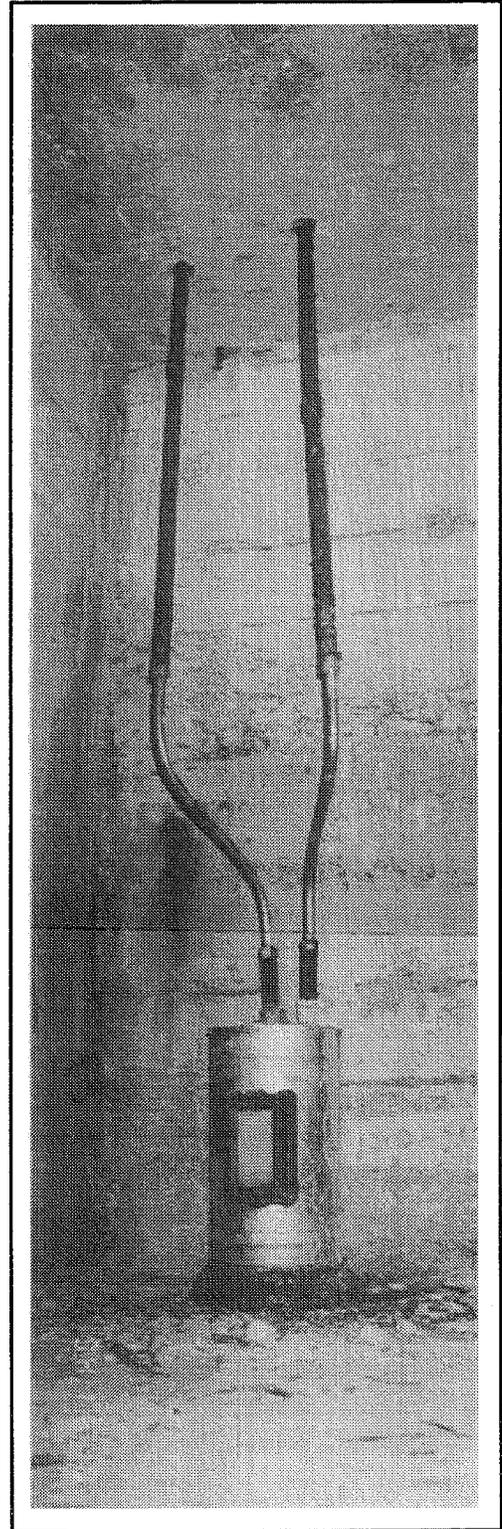
The inoperable deoderizer

to a "Walter and Inman deodorizer." These deodorizers are located in the sub-ceiling space above the storage closet, and appear to be inoperable. Since the building was unheated, another venting issue addressed the flow of air throughout the mausoleum space to prevent condensation. Ellis Lawrence sought to determine proper methods for dealing with this issue after the Hope Abbey Mausoleum exhibited problems with condensation.¹² Some mausoleum companies felt the building required maximum air circulation, while others suggested the buildings should be sealed tight or heated. Presently, condensation is still a problem within the Hope Abbey Mausoleum as evidenced by peeling paint, mildew and dampness.

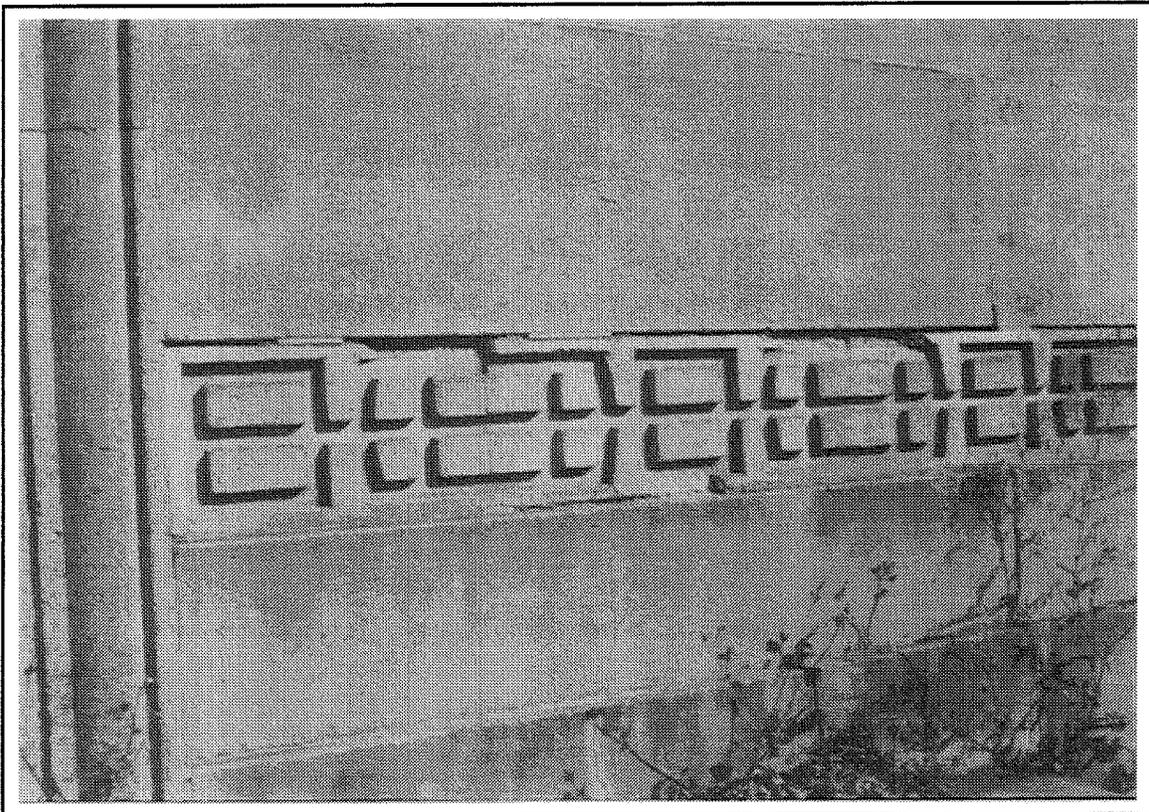
Loss of concrete from the high relief ornamental string courses

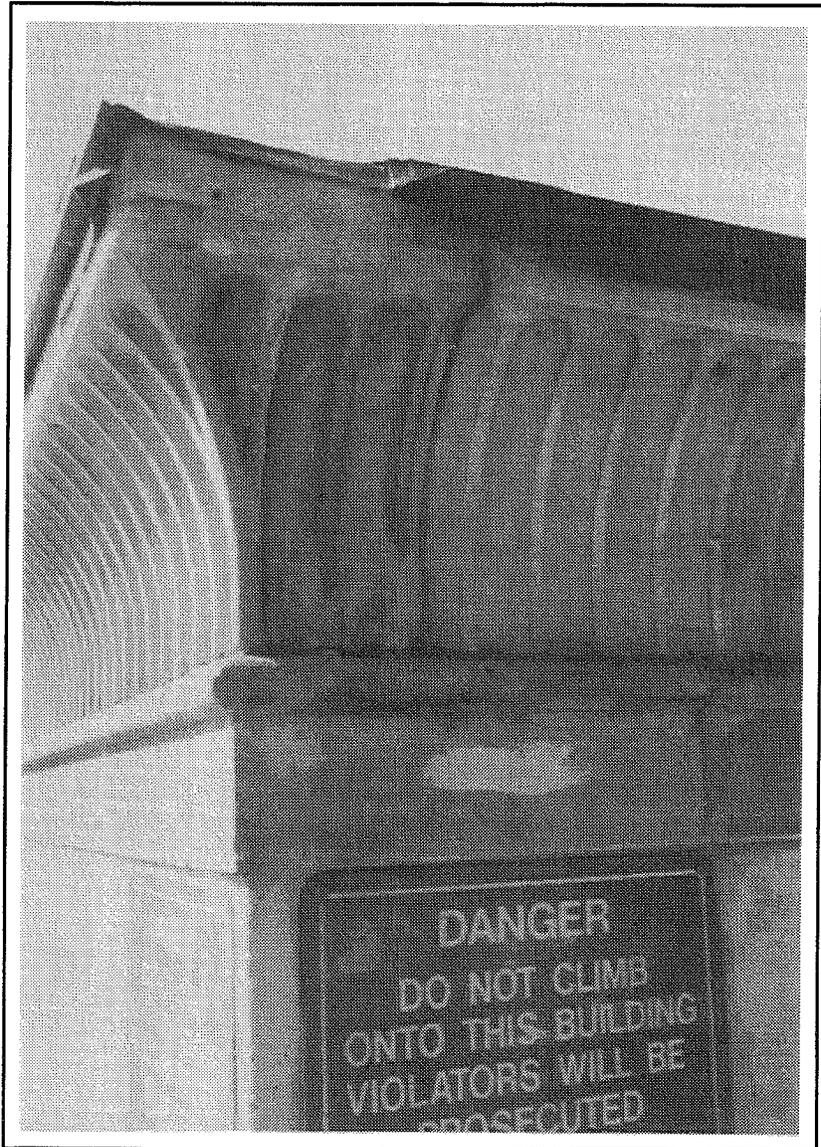
The mortar between the precast units is in fair condition. It is popping in some places, especially in areas of water problems. Although some of the 1/4" - 3/8" joints have been repointed, this has been poorly or improperly done in some places.

Detail of cavetto cornice

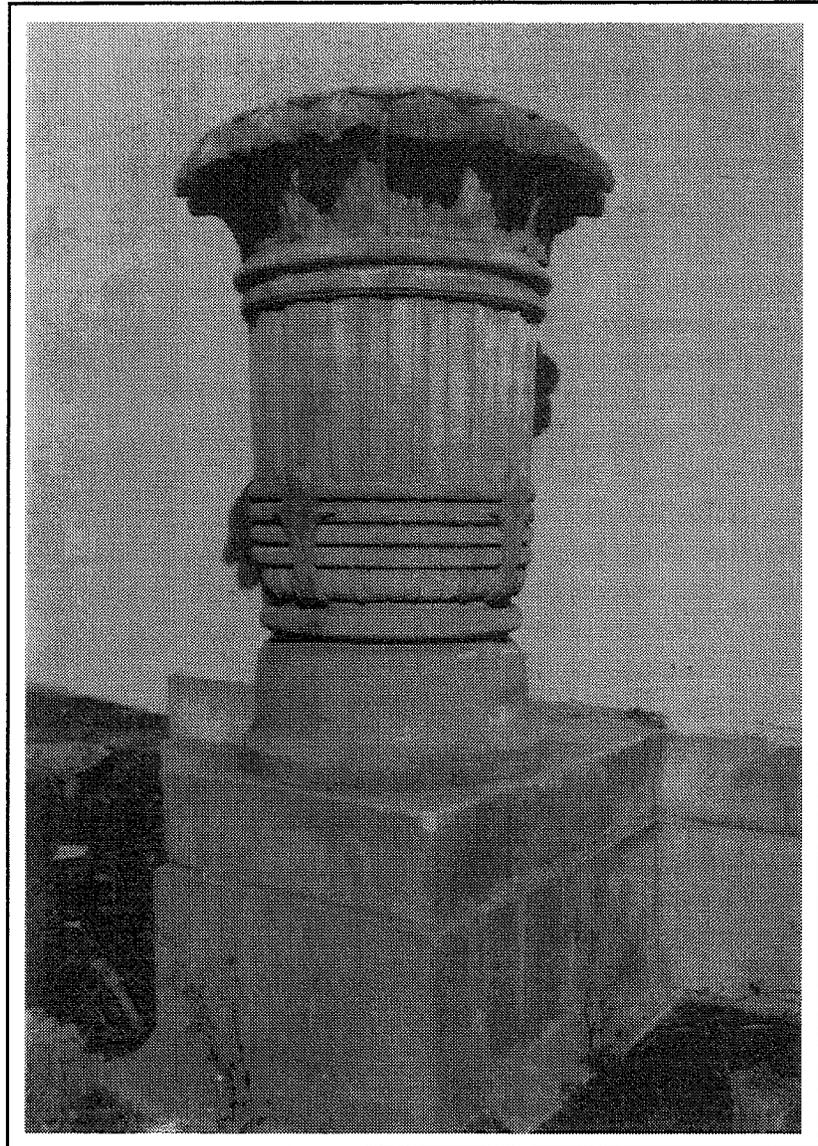
The urns

Two significant features of the mausoleum are the monolithic (over 6 feet) precast urns set on concrete bases gracing each side of the entry. Exposure to the weather has caused erosion of the horizontal surfaces of these urns. Lichen and calcite are present on the urns, indicating constant moisture is present. The metal ties that serve to secure the individual pieces are badly corroded and have contributed to the detachment of two pieces on the south urn. One of these fragments is currently stored in the mausoleum and may be used as a pattern for the necessary replication.

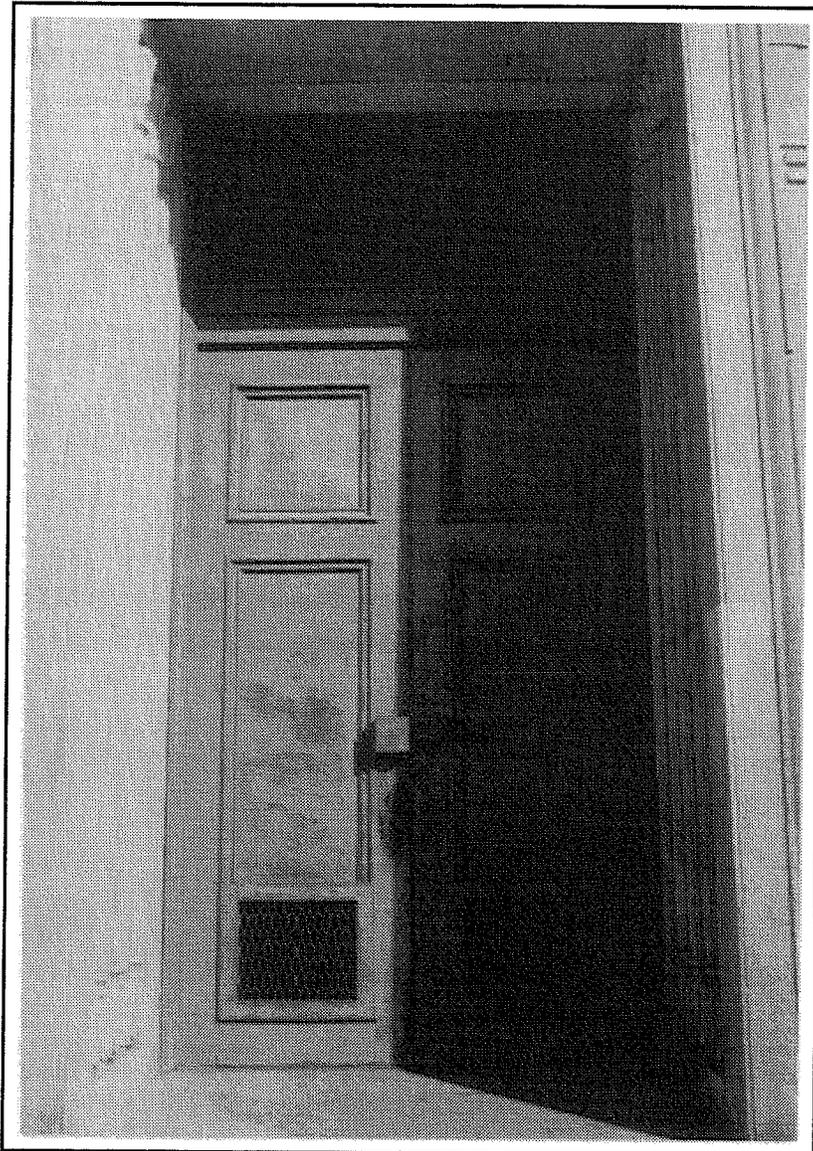
Cedar entrance doors with vandalized bronze cladding

The grilles in the bottom of the door should be removed and the opening patched to reflect the design of the original doors. If possible, repair rather than replace, the existing bronze cladding. This will require patching in such a manner as to reduce the visibility of seams. Replace missing elements, such as the doorknobs, holdbacks, and locks. The doorknobs should match the doorknob found on toilet room door. This is consistent with Ellis Lawrence's designs for the mausoleums in Salem and Portland. Unless evidence of the original holdback designs is found, these should be created based on the design of the holdbacks found at the Mount Crest Abbey Mausoleum in Salem. Clean and polish the restored door.

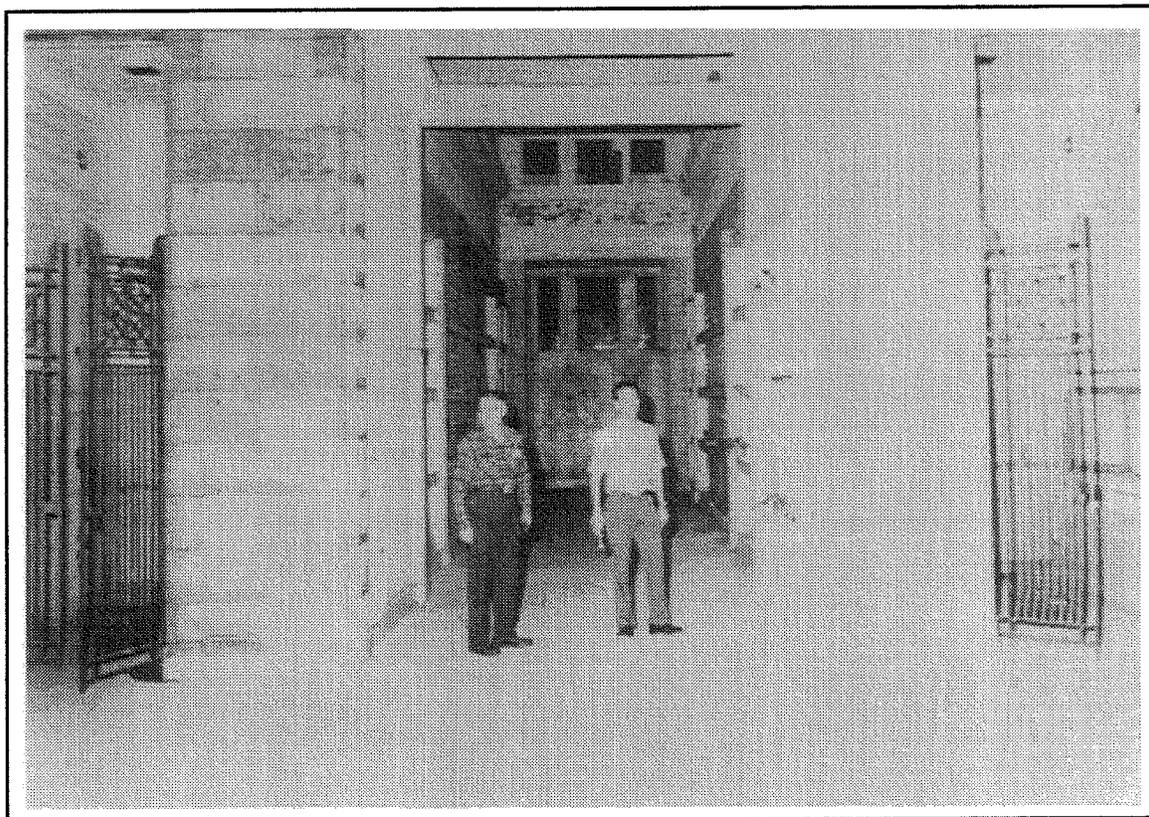
Historic image depicting clerestory, windows and bronze gates

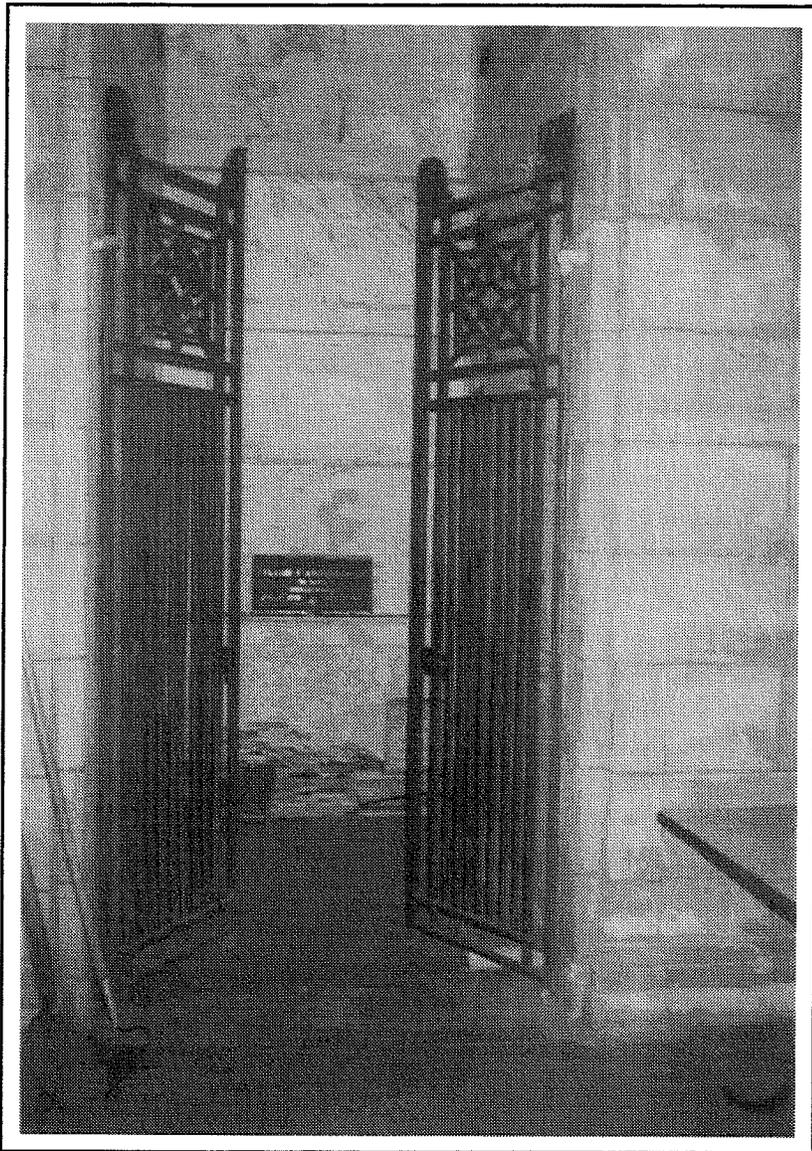
The bronze gates leading to the private (family) crypts (four) are in good condition, although they require cleaning and polishing. Some corrosion exists at the hinges and all but one of the gates are missing their locking mechanisms. The extant locking mechanism can be used as a model to reproduce the missing sets in the future.

Bronze gates at one of the family crypts

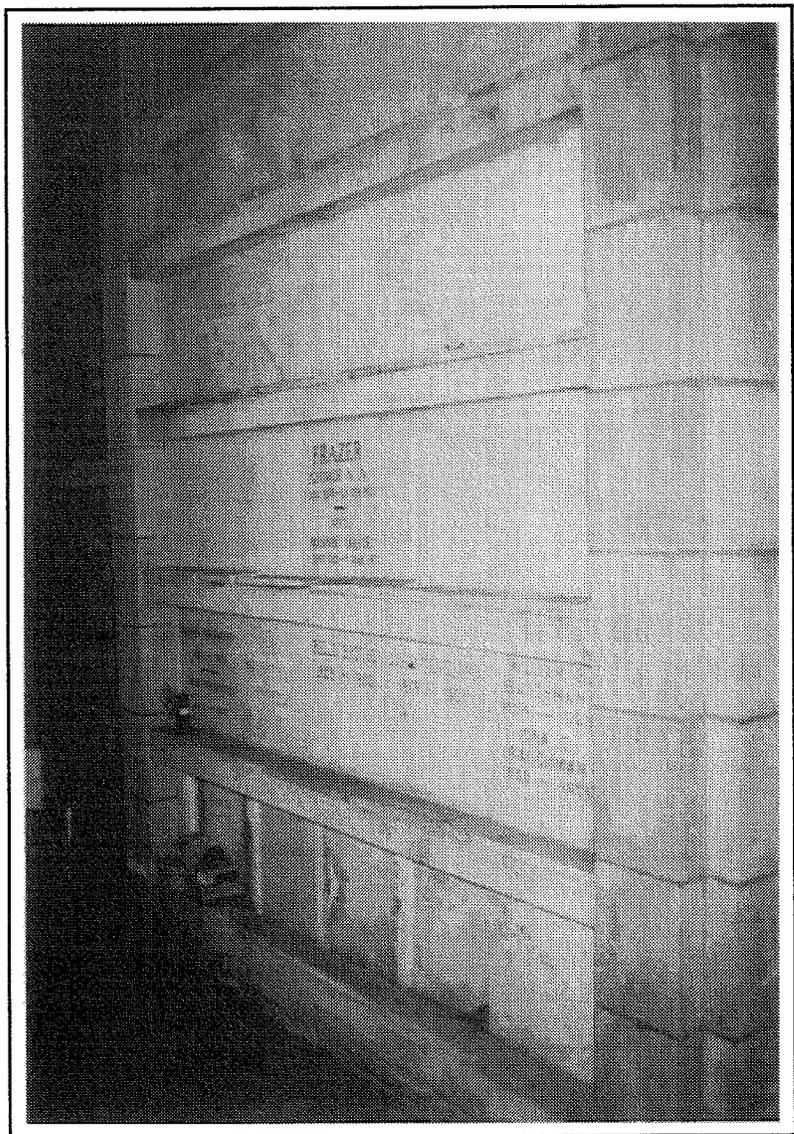
Image of deteriorated and broken marble at cremation crypts

marble slabs appears to be a result of previous cleaning efforts. Some slabs are loose as a result of corrosion of the metal ties that fasten them to the structure. This problem is most evident in areas experiencing water penetration, particularly at the 5 1/2" marble base.

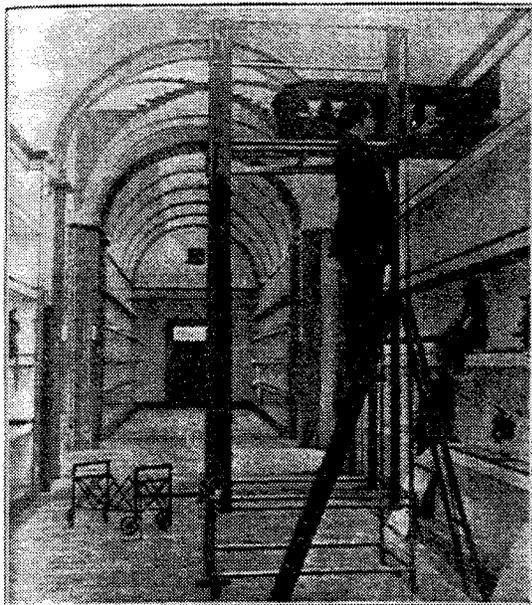
No. 1

THESE illustrations taken from the same point show how the new **Bomgardner** Mausoleum Elevator can be adjusted to meet all conditions.

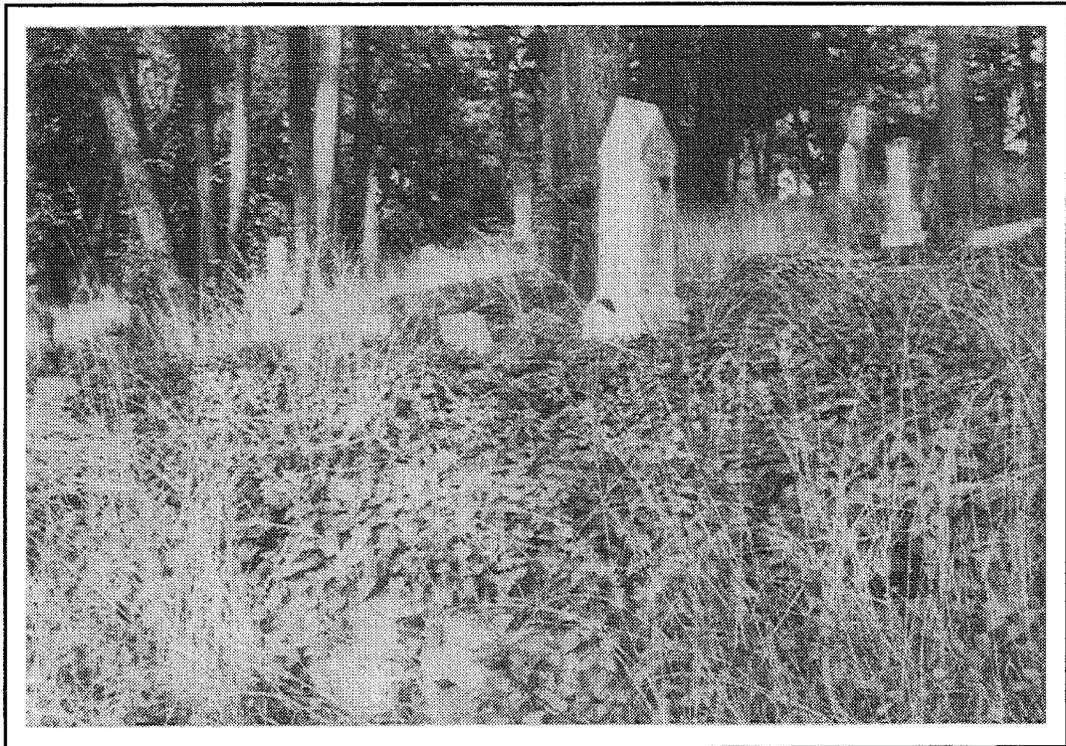
English ivy and grasses obscure the curbs and markers of a family plot

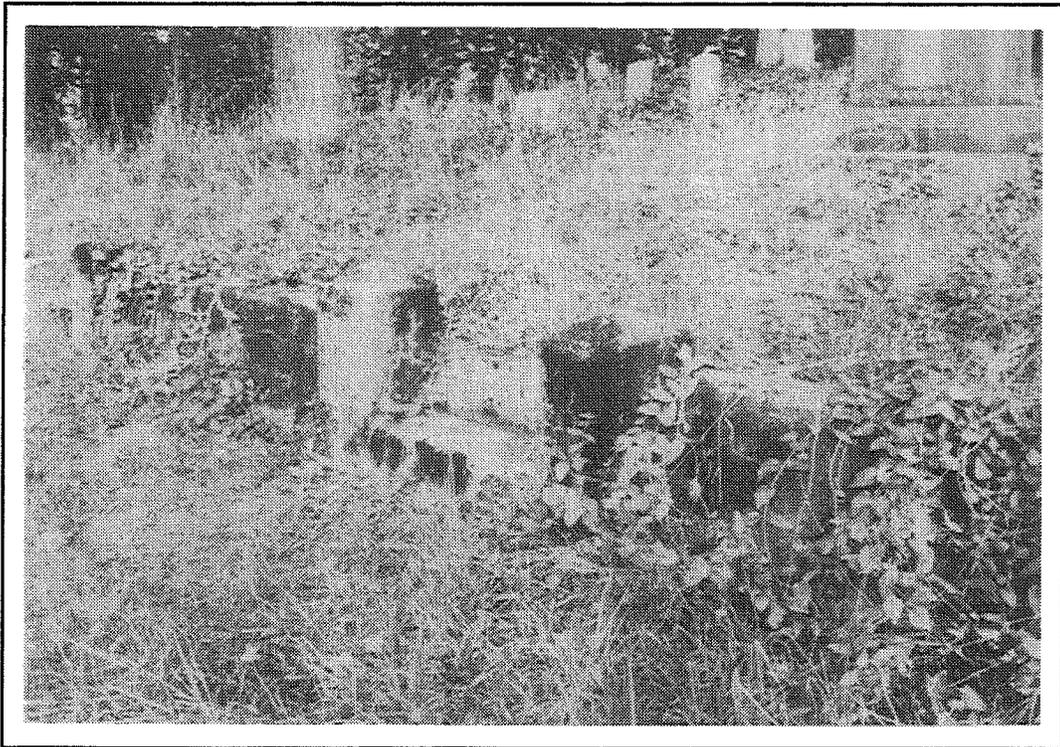
Moss covered concrete curb with entrance steps

The condition of these curbs ranges from good to severely deteriorated, with damage in the forms of cracking, spalling, delamination and sinking. The majority of damage to curbs throughout the cemetery has been caused by root systems of trees, shrubs and ornamentals, or by volunteer seedlings. Other damage has been caused by improper drainage, which has eroded the earth causing failure to the curbs. In some parts of the cemetery, the plot enclosures are located on steep slopes without terracing or other strategies for stabilization. In these instances the plot enclosures have deteriorated and fallen downhill.

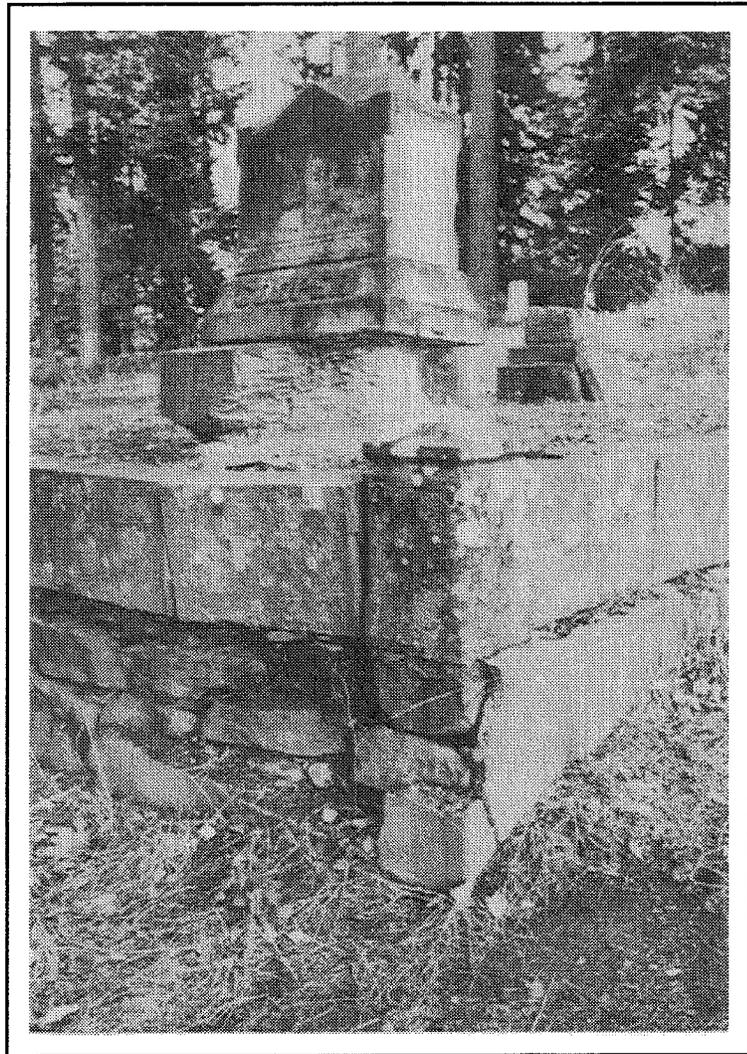
Because of the hilly setting this particular plot enclosure suffers from a loss of the concrete surface texture, severe spalling, failure of mortar joints, and severe cracking due to soil erosion.

Deterioration to the plot enclosure at the Thompson-Cooper plot

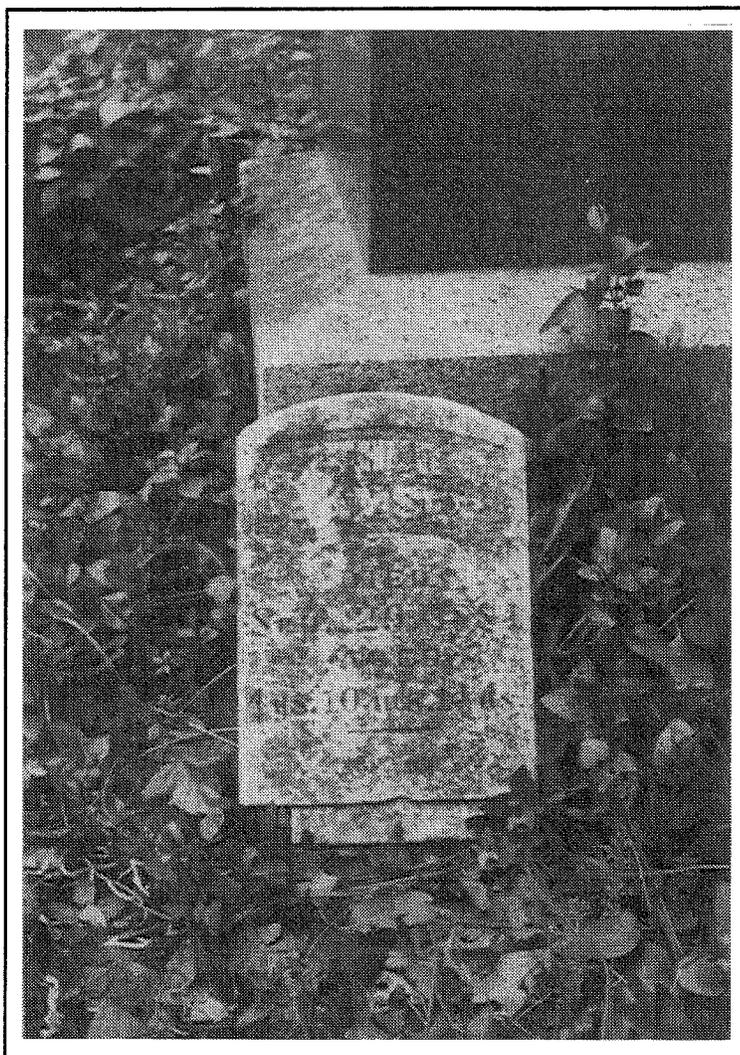
Lichen and moss covered marble tablet

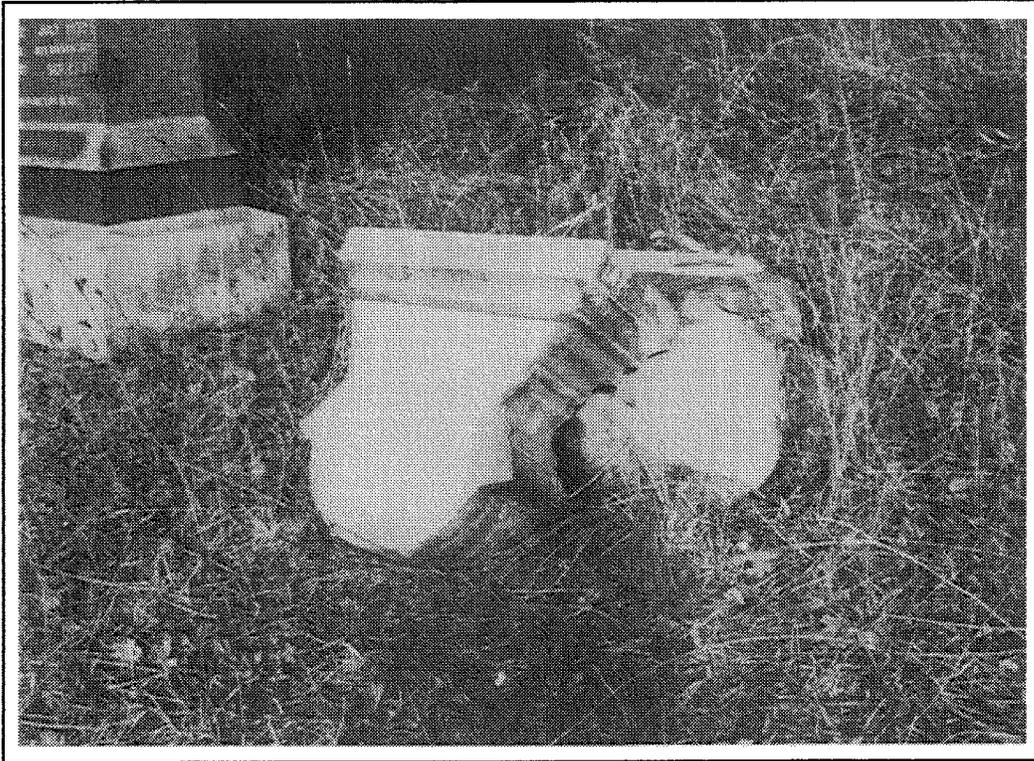
Marble marker toppled from its base

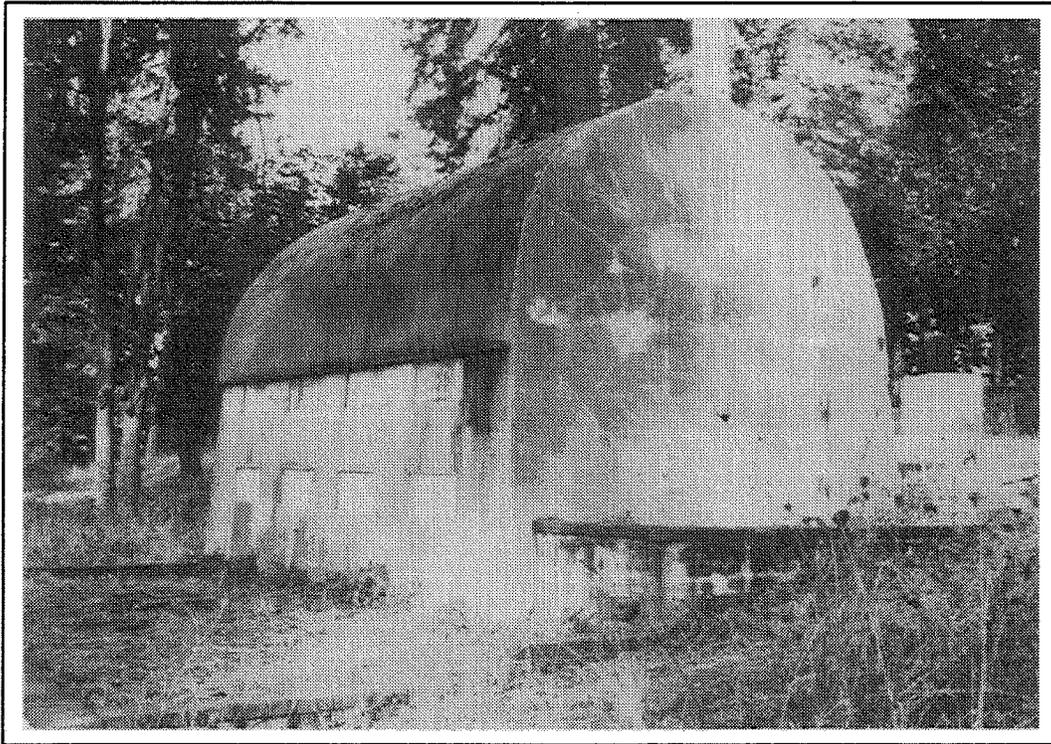
The Whiteaker Mausoleum, approximately 12' x 20' x 10', has been altered with an application of a cement covering system consisting of expanded galvanized metal lath, corner beads, and an impervious stucco that is seriously cracked with surface cracks and exhibits some evidence of water damage.

The Whiteaker crypt

The cement coating has greatly changed the mausoleum's exterior texture, the details of the corners and edges, and slightly altered its overall shape. In addition, the identifying marble plaques are now inset several inches. It is unclear what damage occurred during its application or how it has changed its resistance to moisture. No historical research has been done at this time to determine original materials, but several sources have indicated that the Whiteaker Mausoleum was once sheathed in copper, which was removed during World War II. Paint has been applied in patches to cover graffiti.

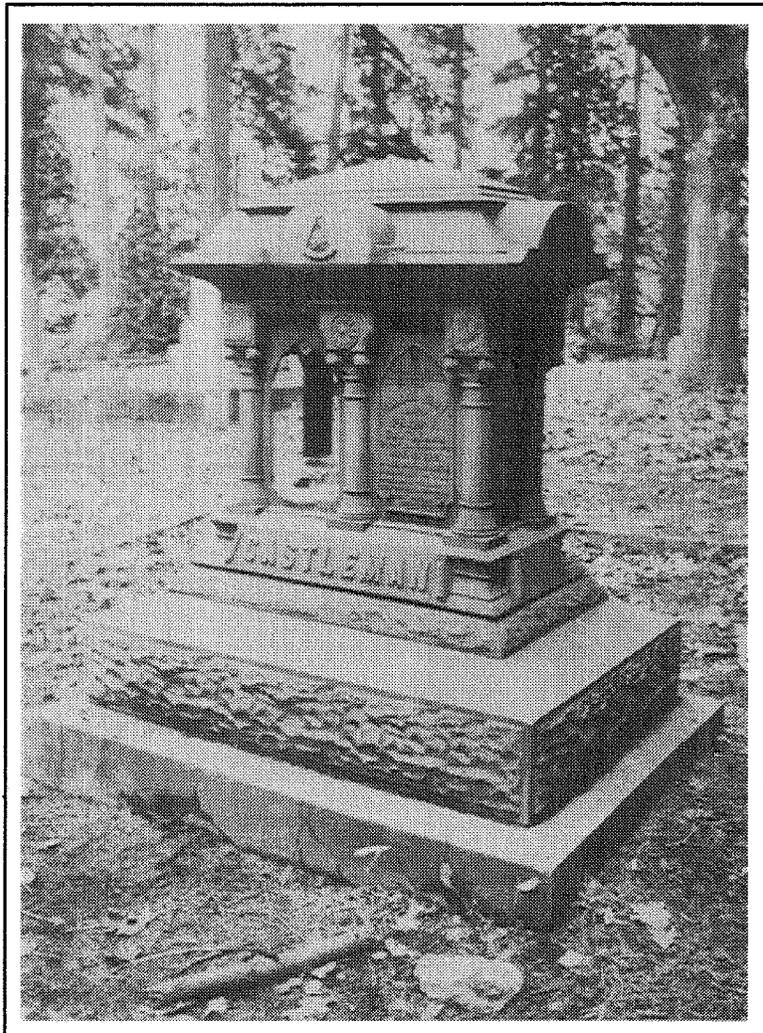
The finely detailed zinc Castleman monument

Since the zinc markers are fairly resistant to accumulation of dirt and debris, only gentle cleaning

with water and natural bristle brushes is recommended.

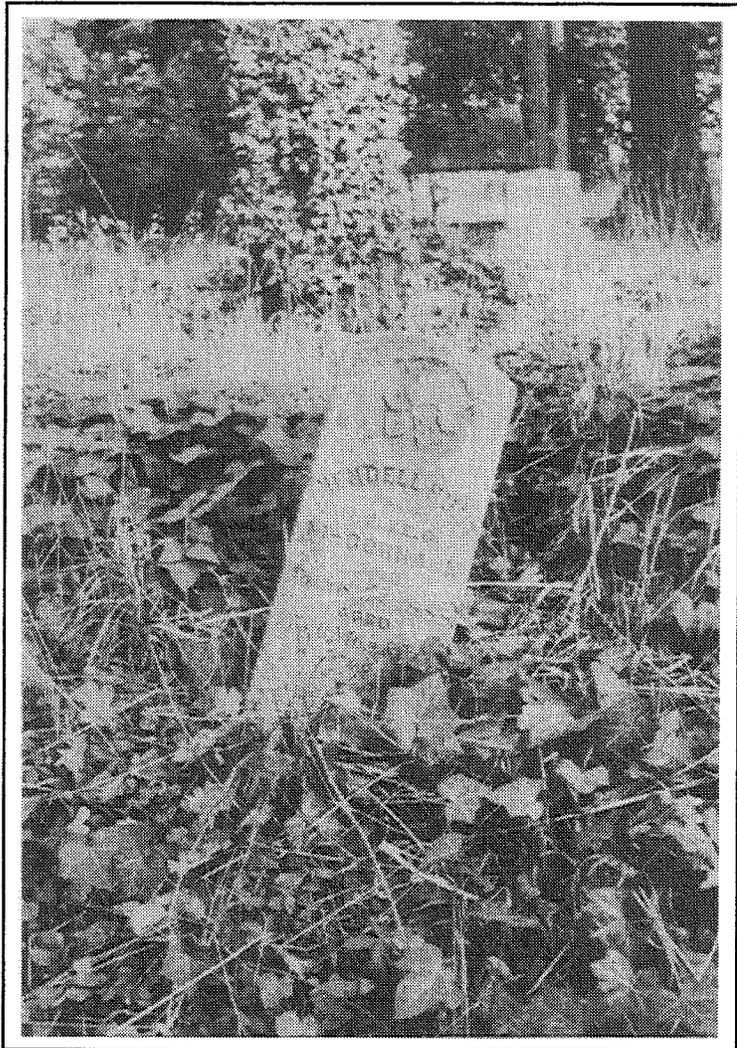
The tilted marble tablet marker of Wendell Hunt

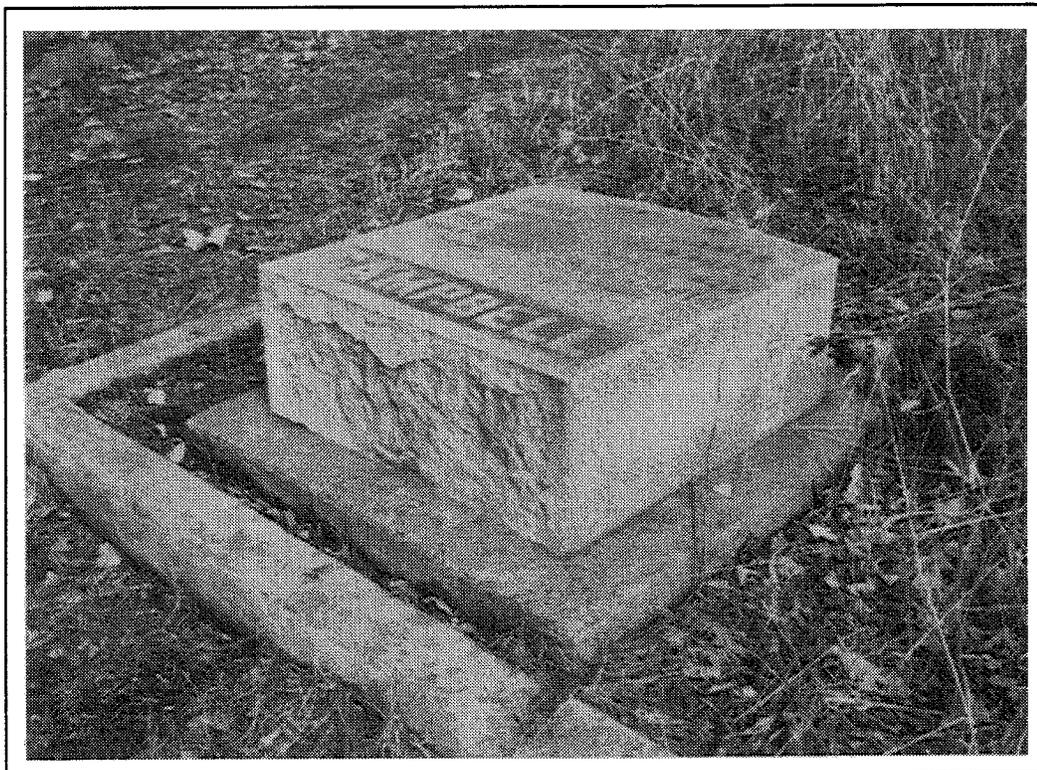
problems. If there is no expansion joint between the concrete and the marker, breakage at the base is likely. Also, wicking of salts from the concrete into the marker may cause

The granite Campbell marker that has been set in concrete, on its back

efflorescence or staining. The primary disadvantage of setting stones directly into concrete is that the stone cannot be removed in future for conservation treatment. Despite these disadvantages, in some cases it is the best method to prevent damage by vandals. This is particularly true for easily removable markers such as tablet stones. The decision to set a stone in concrete should be done only after a marker survey has evaluated these risks.

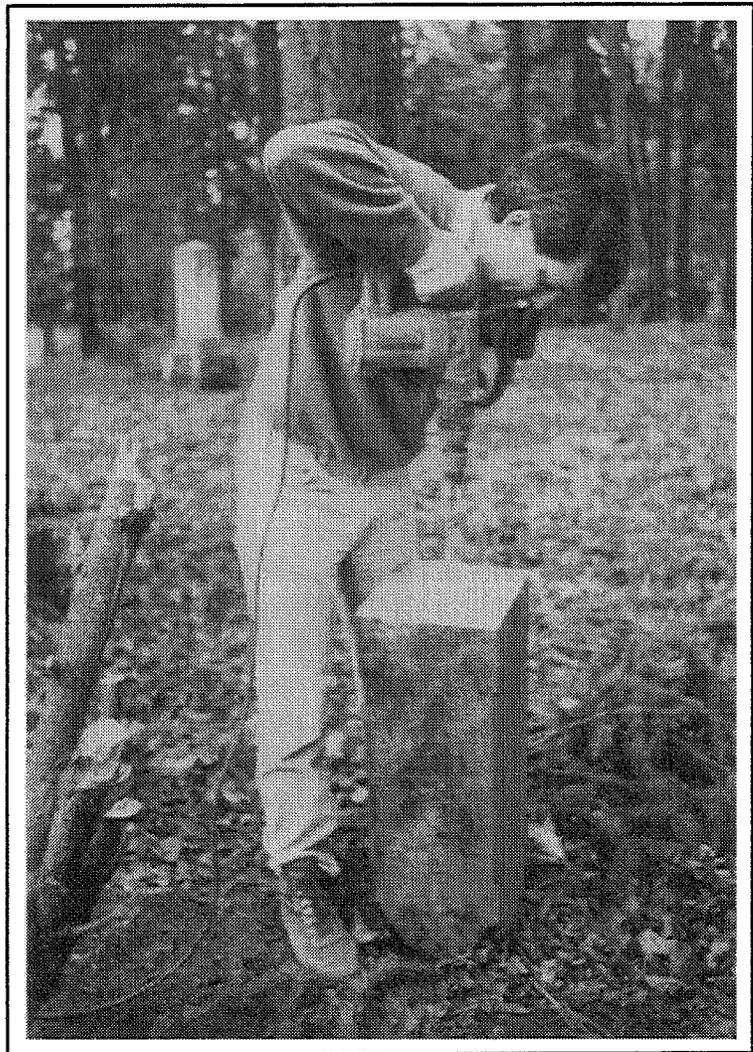
Dave Pinyerd drilling holes in a marker to accept the threaded nylon pins and polyester-resin adhesive

For structural breaks on stable stones, use threaded nylon pins (1/8"-1/4" diameter and 4"-6" in length, depending on the size of the stone and fragment), and adhesive to hold the fragments together. Begin by drilling holes in a staggered pattern to prevent splitting. The holes should be 1/8" larger than the pin and have a depth of at least four times larger than the pin diameter. Once again, prepare and dry fit the fragments before applying the adhesive. This method should not be used on weak or soft stones such as sandstone. Brace frames or clamps may be necessary to hold fragments together with the proper pressure until the adhesive has set. Some markers may require adhesion on a horizontal table or vertical frame set up.

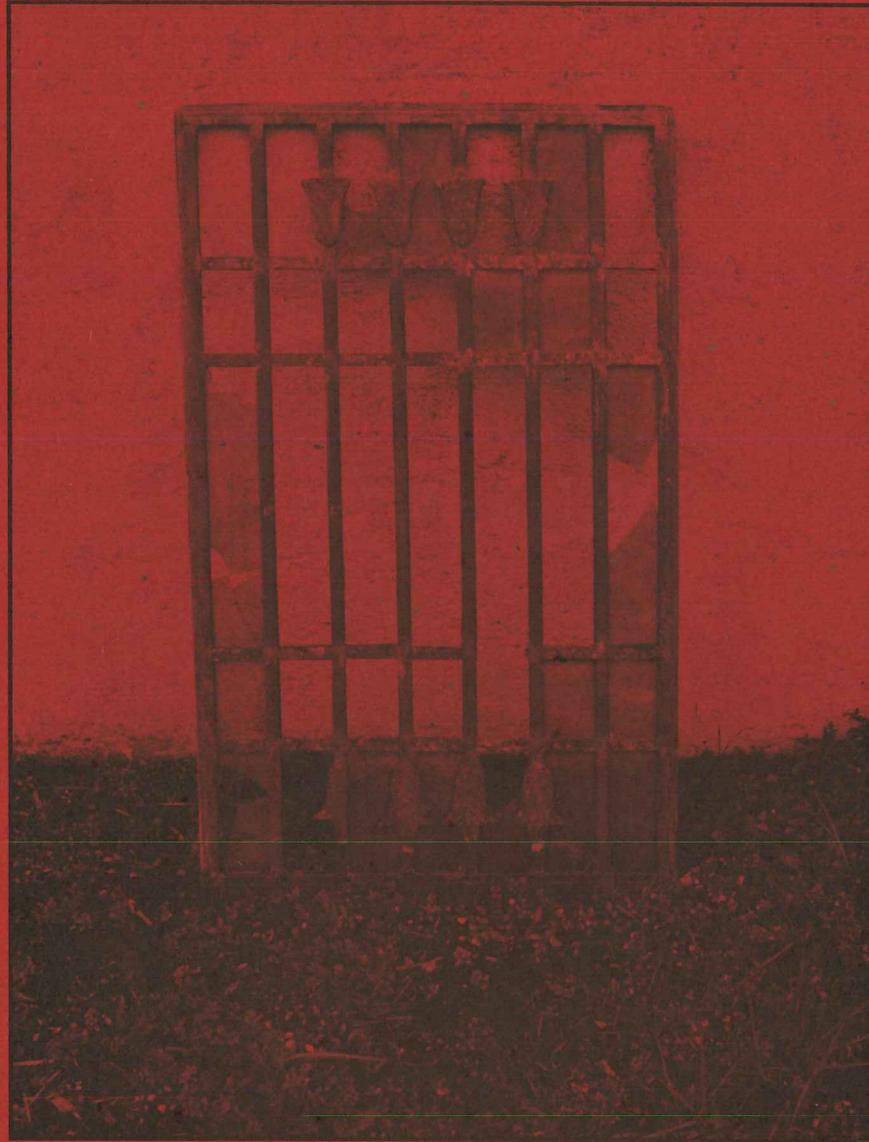
Vandalized
amber glass
window with
decorative
muntins.
