DOWNTOWN URBAN RENEWAL DISTRICT REPORT

REPORT ON THE DOWNTOWN URBAN RENEWAL DISTRICT PLAN

Map to Accompany Downtown Urban Renewal Slums and Blight Report 2016

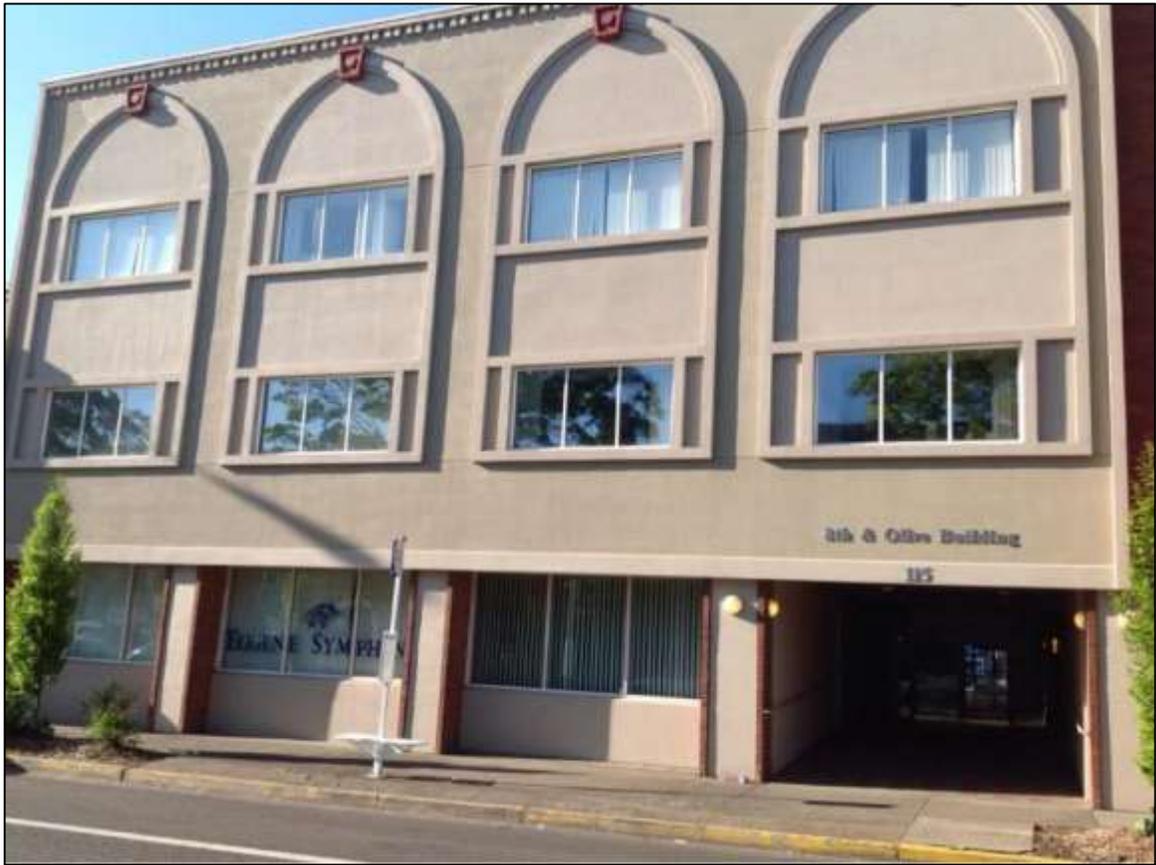
Property: 1	Name: 8 th and Olive Building	Determination of Blight: Yes
Taxlot(s): 1703311215300	1703311215500	Depreciation Ratio: 2.45
Property Notes: Building appears in good condition. Determination of blight ORS 457.010 (1)(g).

Photos show multiple sides of building.

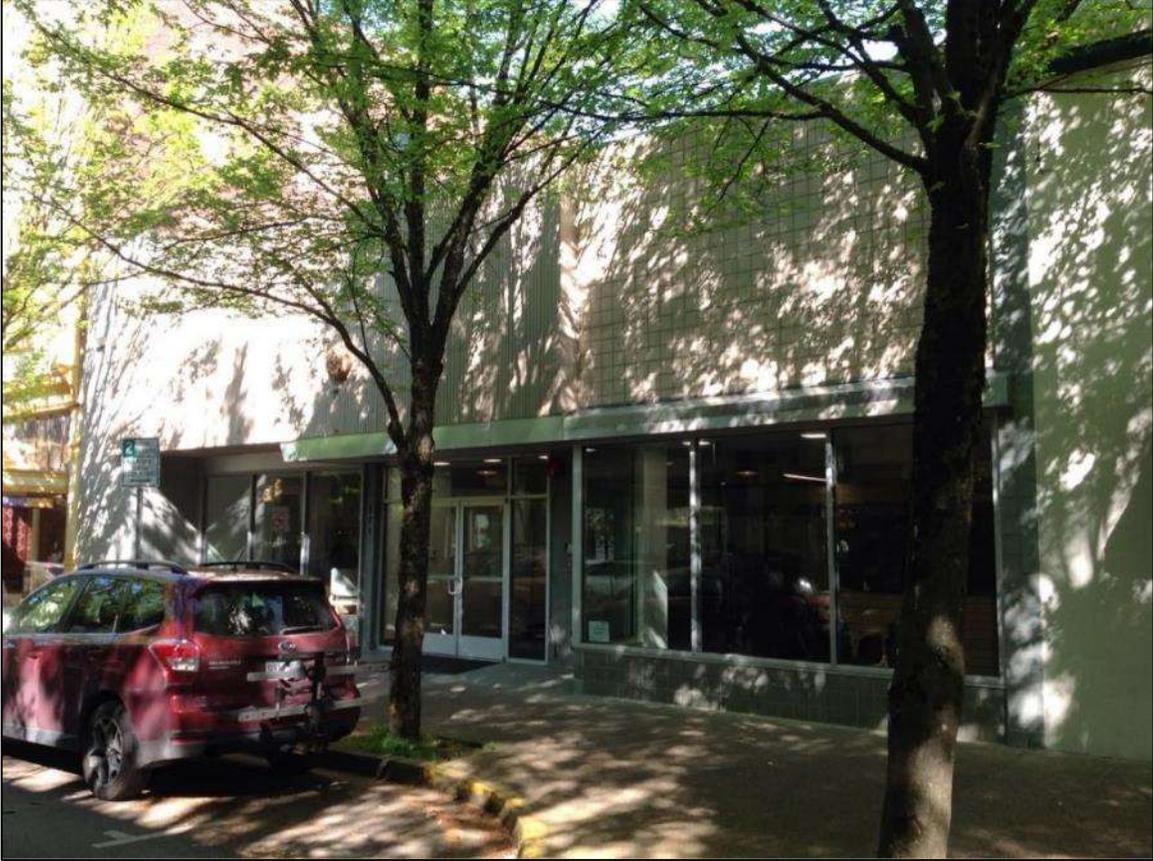
Property: 2	Name: AHM Brands	Determination of Blight: Yes
Taxlot(s): 1703311109300		Depreciation Ratio: 1.93
Property Notes:	Building appears in fair condition. One location has what appears to be tape holding tiles in place on west side. Determination of blight ORS 457.010 (1)(a)(A) and (g).

Photos: Top: Building facing Willamette Street; bottom left: sections with what appears to be taped tiles; bottom right: back side of building facing West Park Street.

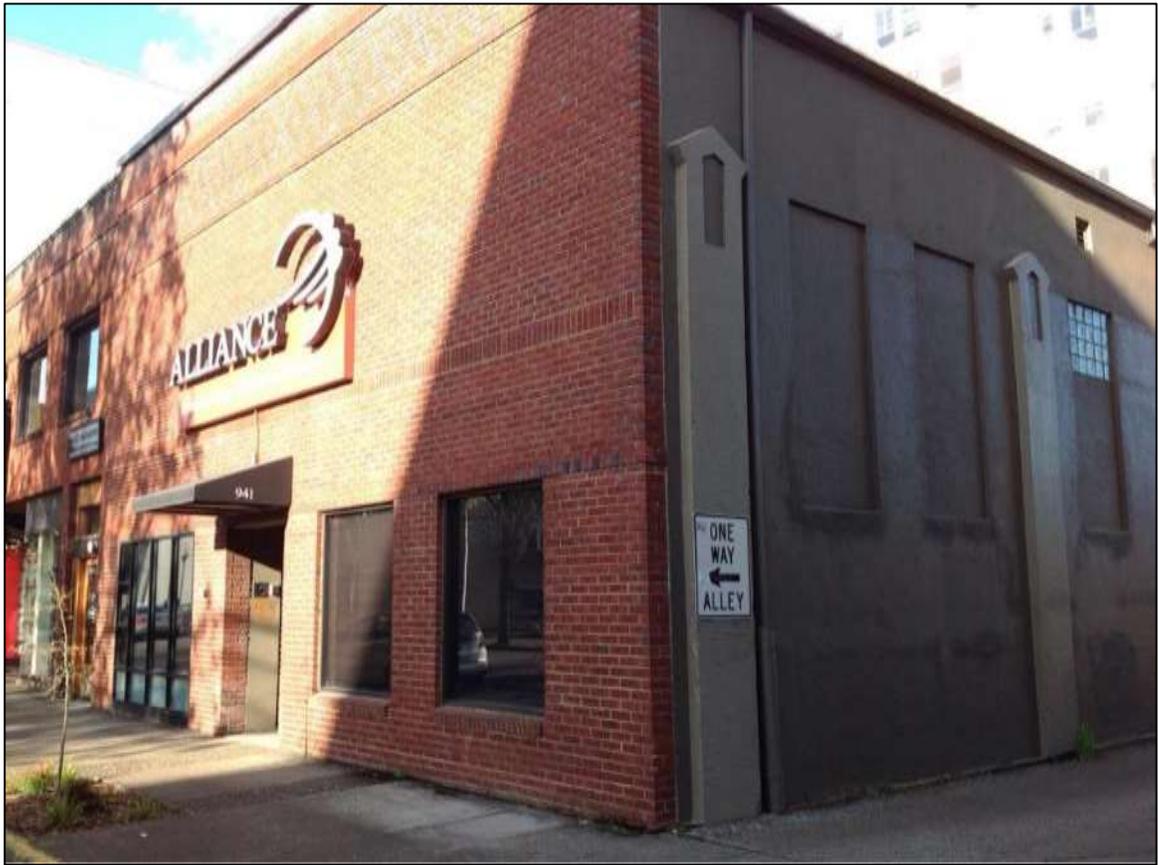
Property:	3	Name:	Alliance insurance	Determination of Blight:	No
Taxlot(s):	1703311406800			Depreciation Ratio:	6.75
Property Notes:	Building is in good condition.

Photos: Building front facing Oak Street.

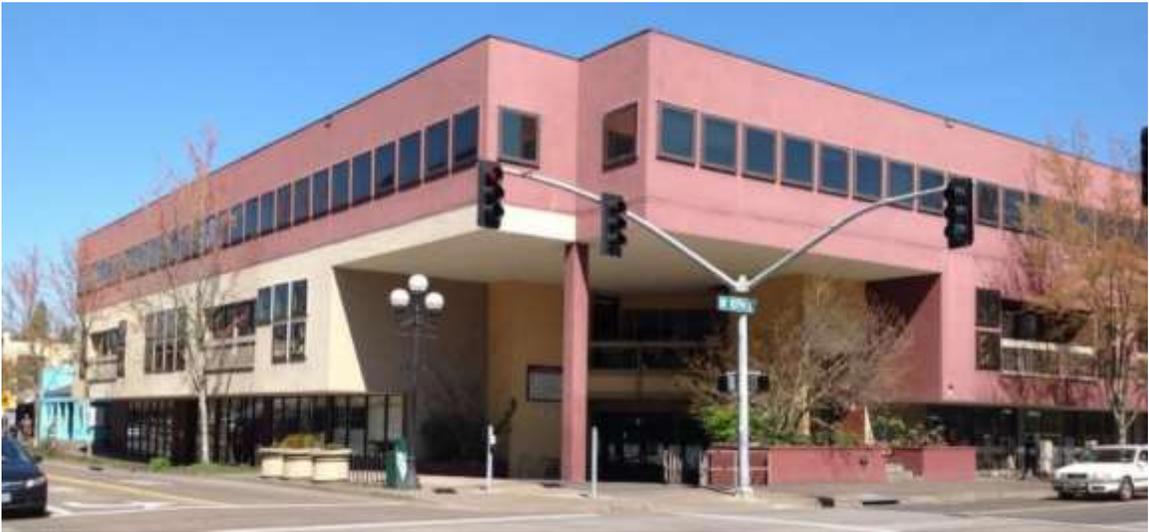
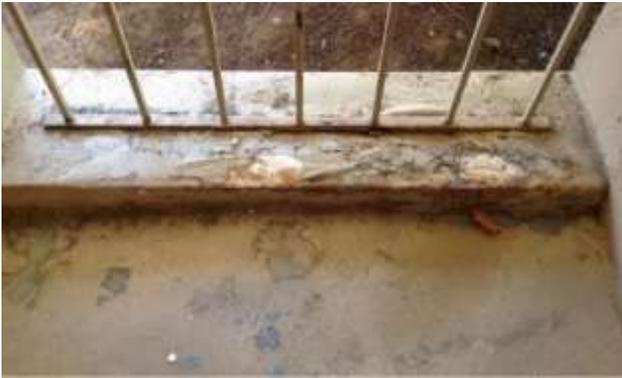
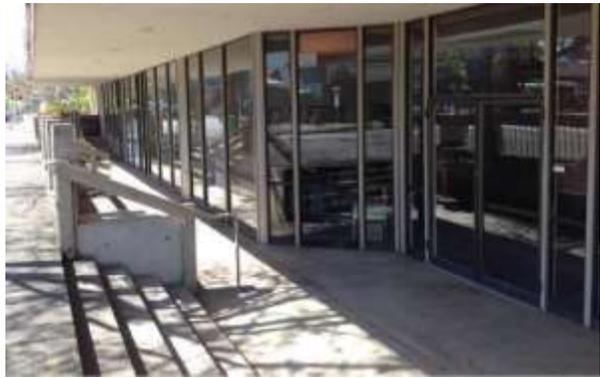
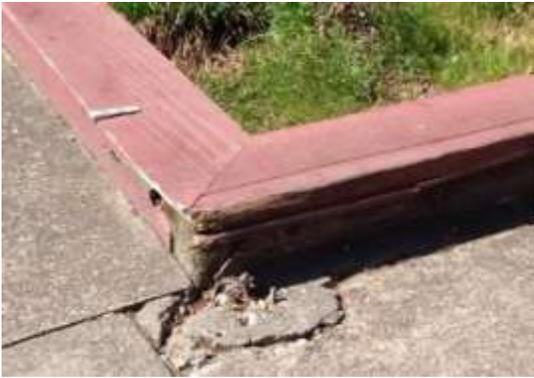
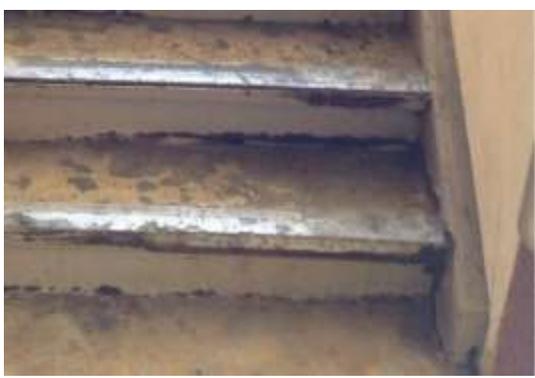
Property: 4	Name: Atrium Building	Determination of Blight: Yes
Taxlot(s): 1703311302600		Depreciation Ratio: 4.00
Property Notes:	Property is in fair conditions and has mostly city offices. There are signs of damage visible on the exterior, with damaged exterior stairs and older windows. The windows on the upper levels do not open regularly affecting ventilation. The property has underutilized outdoor open space and closed street side windows on south side. Blight determination based on ORS 457.010 (1)(a)(A), and (h) and includes seismic stability concerns.

Photos: Top: Building view from 10th Avenue and Olive Street; middle left: image of damage on interior stairwell window edge; middle right: underutilized open space facing 10th Avenue; bottom left: wood damage example; bottom right: exterior stairs damage.

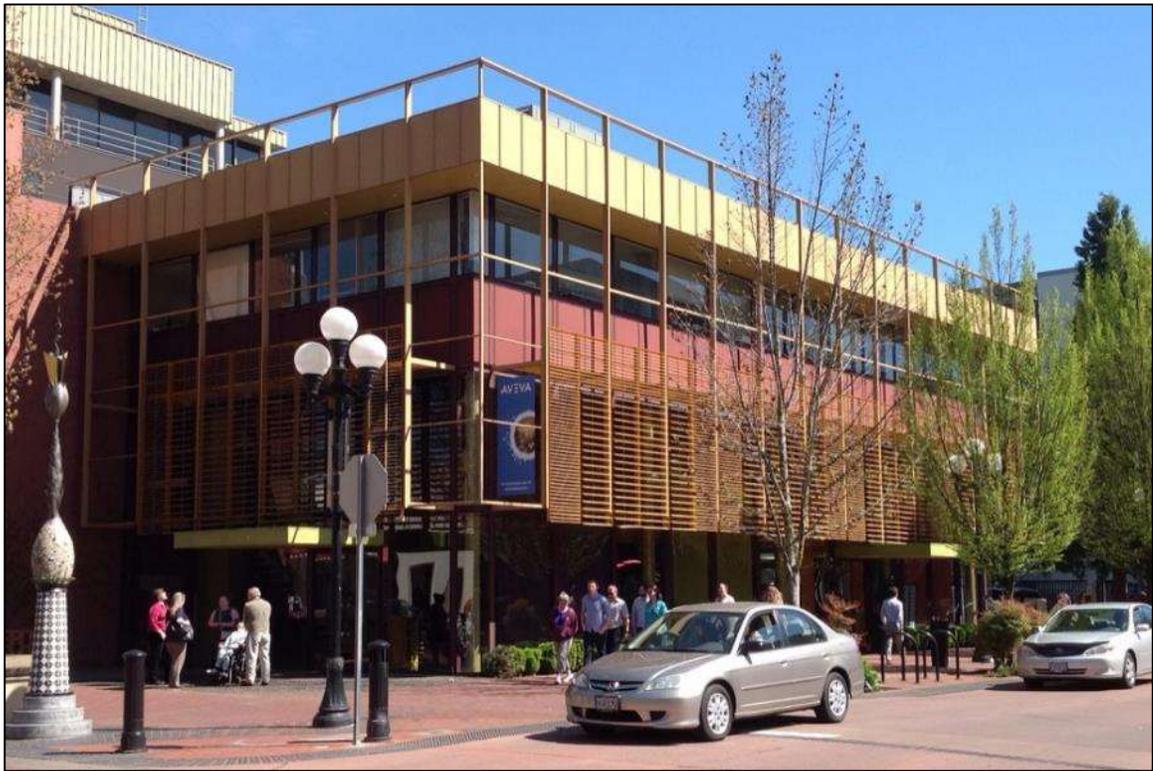
Taxlot(s):	1703311403900	Depreciation Ratio:	2.15
Property Notes:	The property appears in good shape. The building has some exterior damage along the building-ground line, including an area with piping exposed, one section appears boarded up on 2nd floor and the adjacent parking lot has damage. The adjacent parking is also underutilized space. Determination of blight ORS 457.010 (1)(g).

Photos: Top: front of building facing Broadway and Willamette Street; middle left: damage on building ground line; middle right: exposed pipes on building ground line; bottom: damage on parking lot.

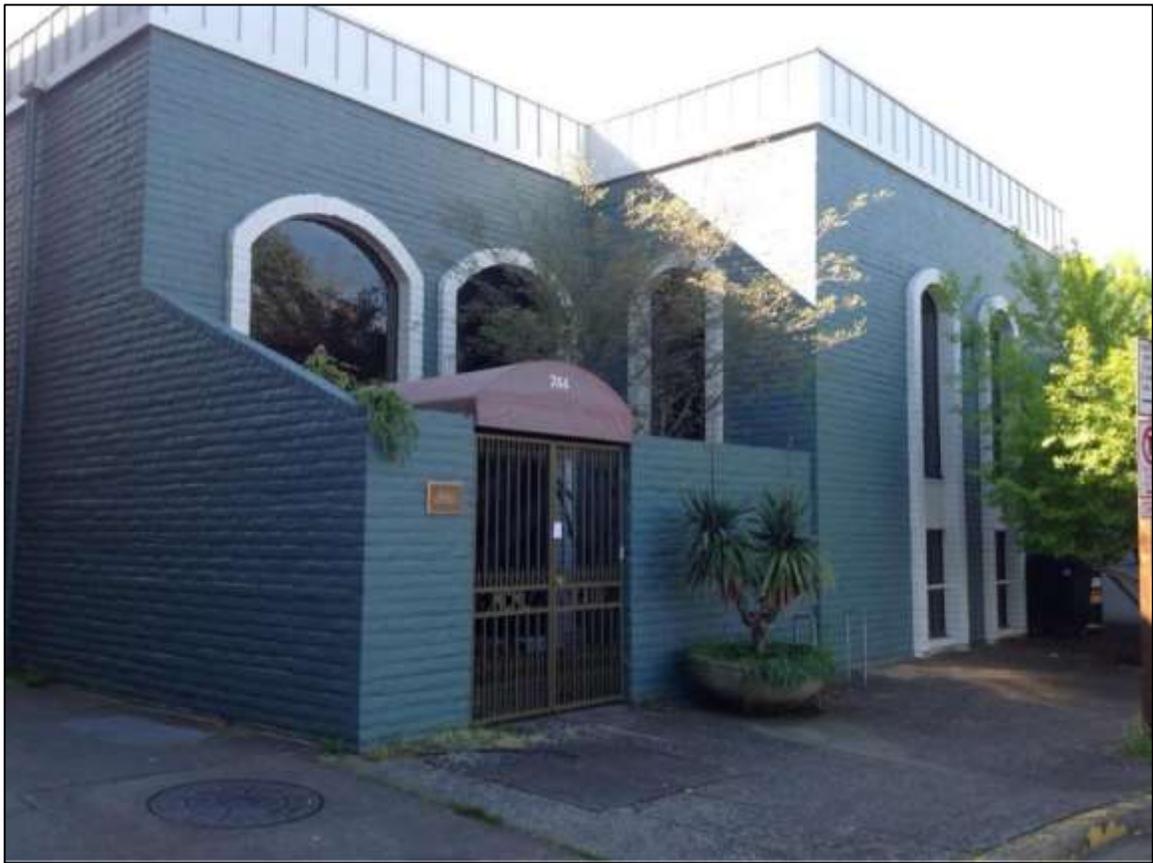
Taxlot(s):	1703311109001	Depreciation Ratio:	5.09
Property Notes:	Building appears in good shape.

Photos: Building front facing West Park Street.

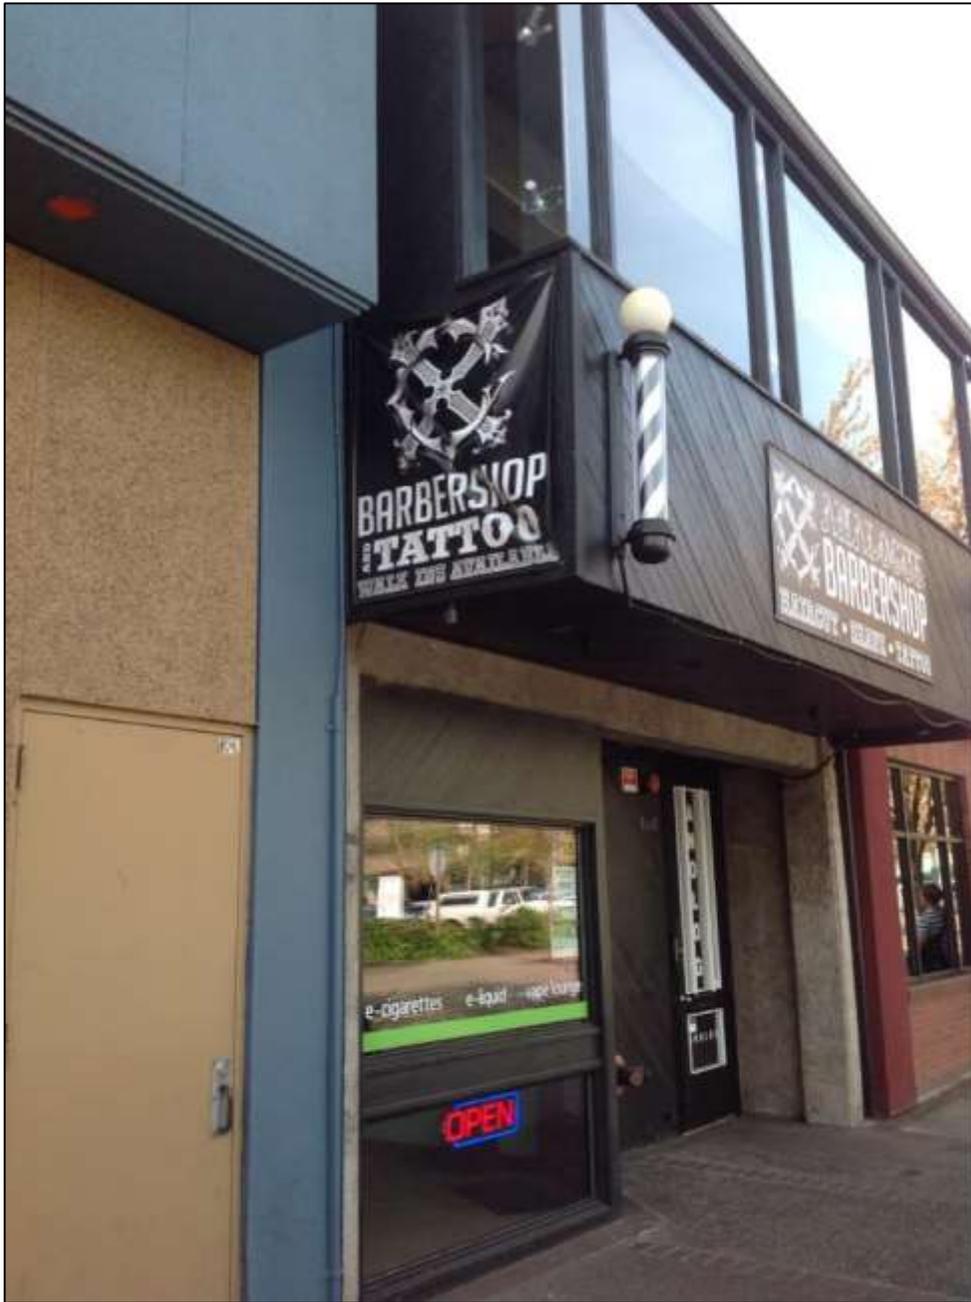
Property: 7	Name: Barbershop and Tattoo, Emerald Vapors	Determination of Blight:	No
Taxlot(s): 1703311304700		Depreciation Ratio:	6.62
Property Notes:	Building appears in good shape

Photos: Front of building facing Olive Street.

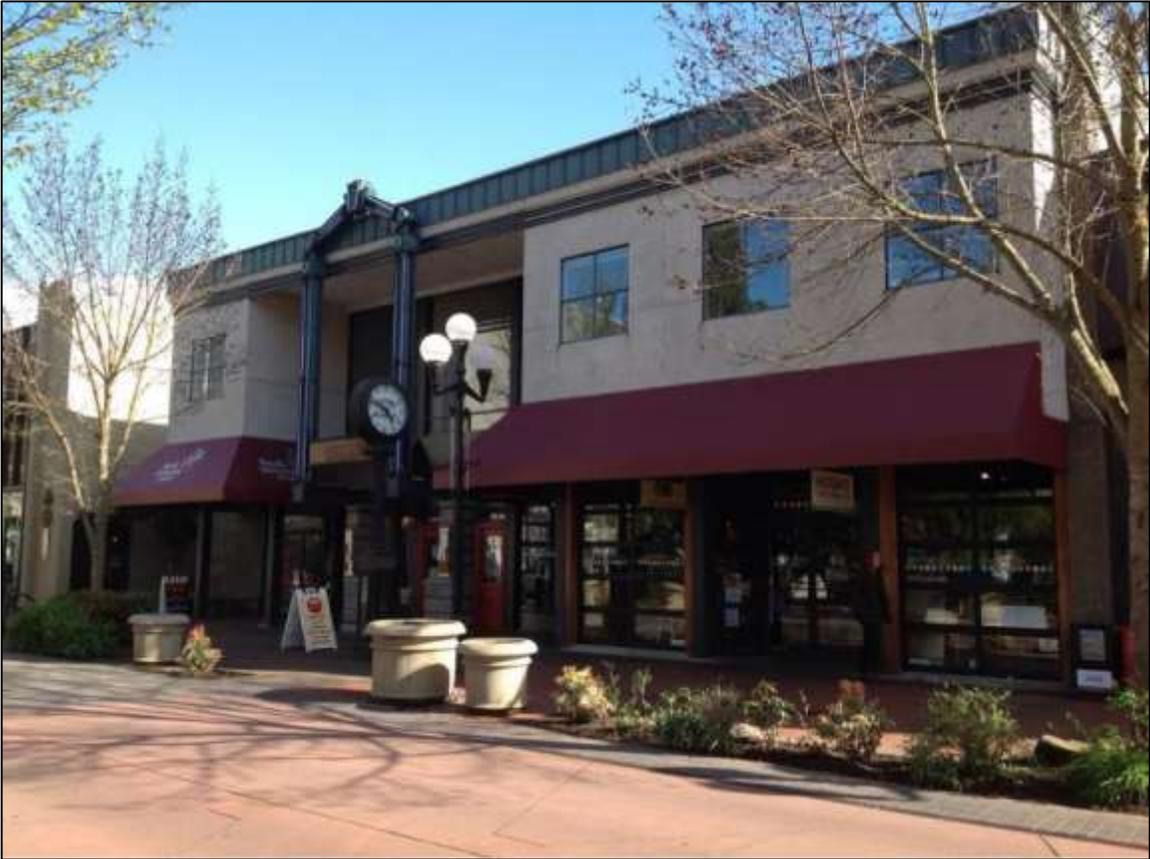
Property: 8	Name: Belly	Determination of Blight: No
Taxlot(s): 1703311405200		Depreciation Ratio: 4.38
Property Notes:	Building in good condition. Building has offices on second floor, bottom floor commercial.

Photos: Building front facing East Broadway.

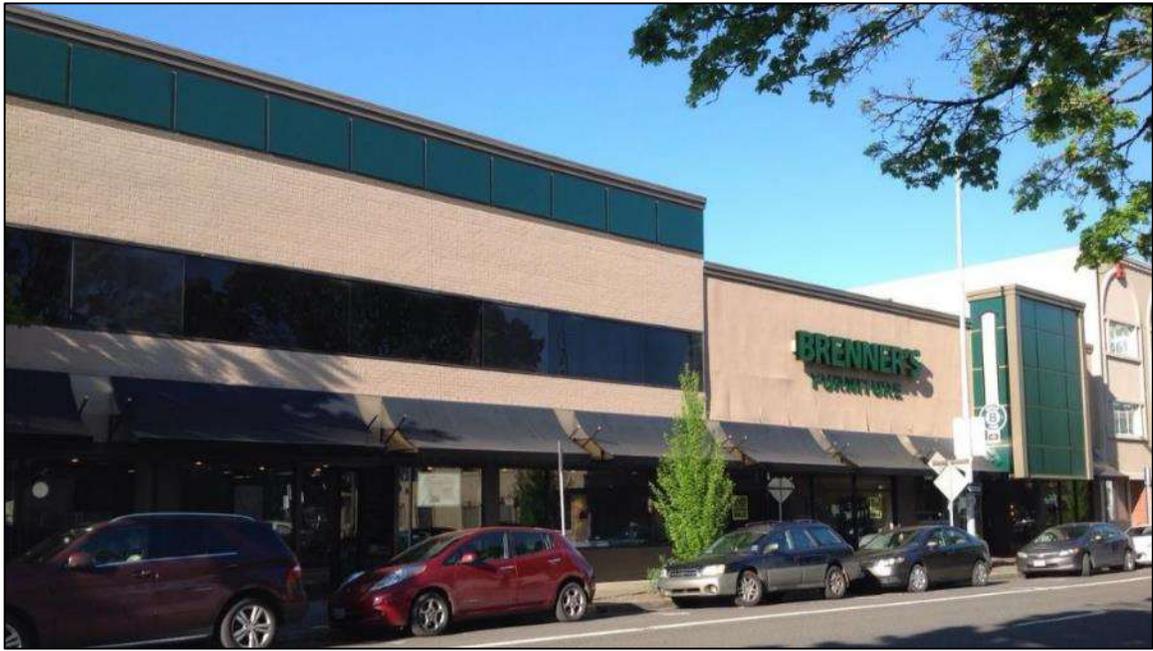
Property: 9	Name: Brenners Furniture	Determination of Blight: Yes
Taxlot(s): 1703311214900	1703311215400	Depreciation Ratio: 1.92
Property Notes:	Building is large, appears in fair condition. The facade section with tiles appear to be wearing. Determination of blight ORS 457.010 (1)(a)(A) and (g).

Photos: Top: front of building facing West 8th Avenue; bottom: close-up view of wear on façade tiles.

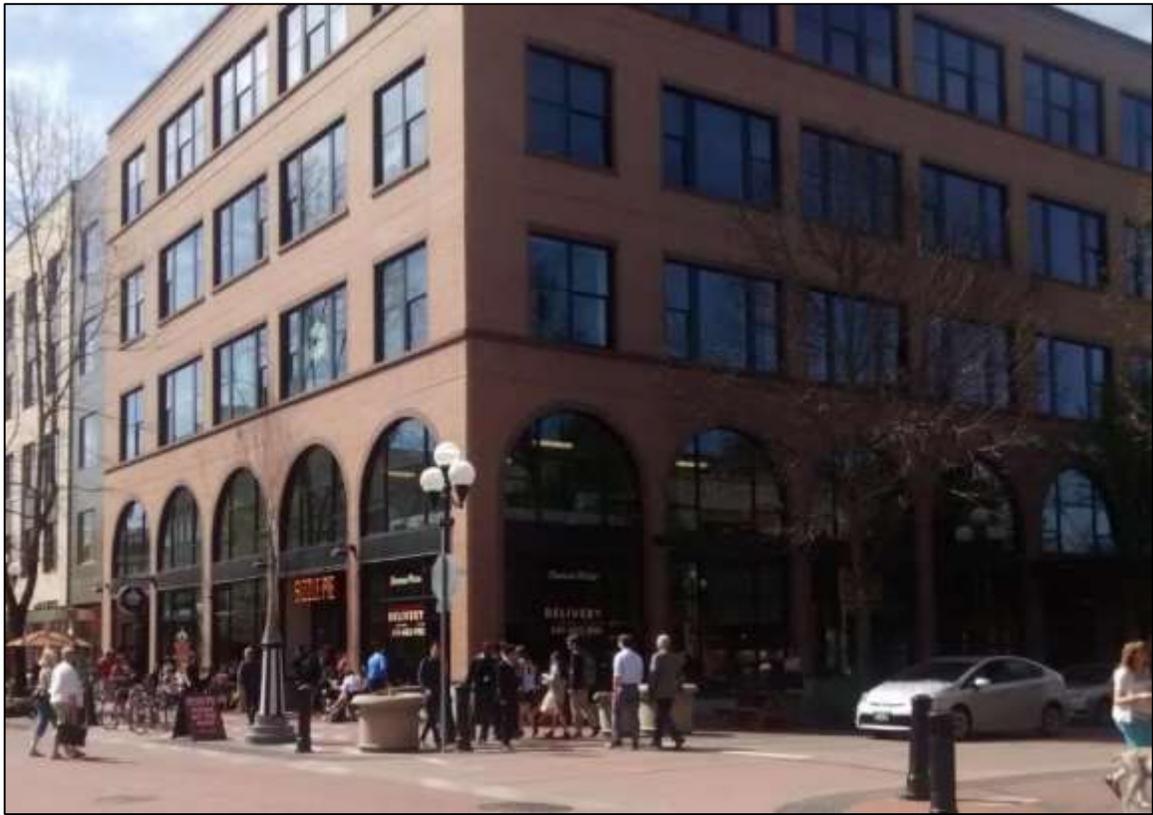
Property: 10	Name: Broadway Commerce Center	Determination of Blight: No
Taxlot(s): 1703311301300		Depreciation Ratio: 13.97
Property Notes:	Recently renovated (last five years). Building in good condition. Office on top 4 floors and commercial on bottom.

Photos: View of building on Broadway and Willamette Street.

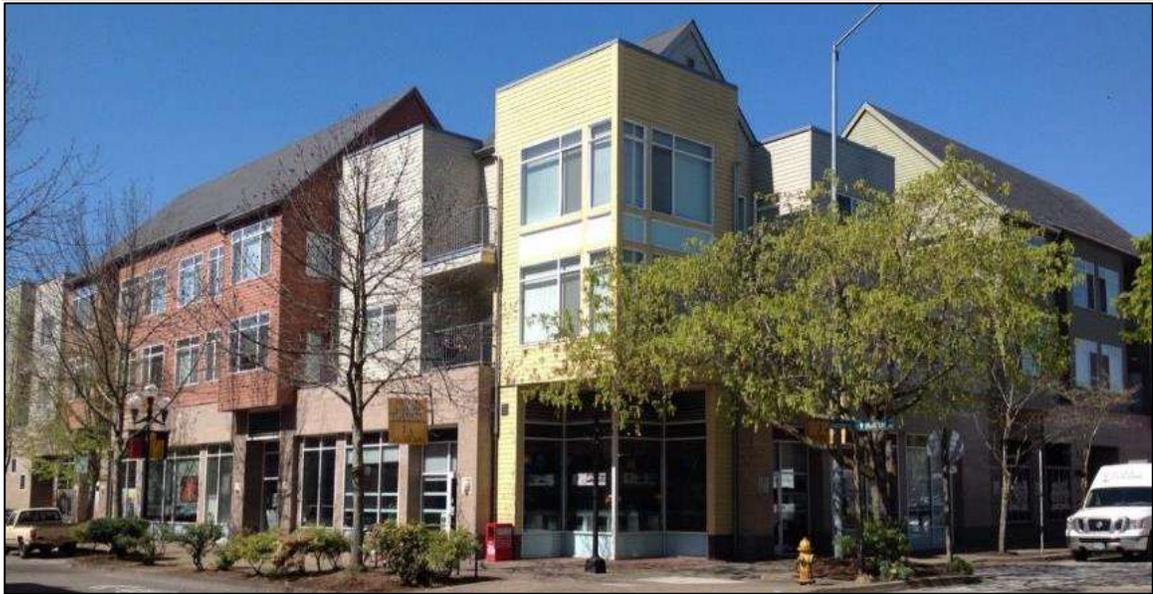
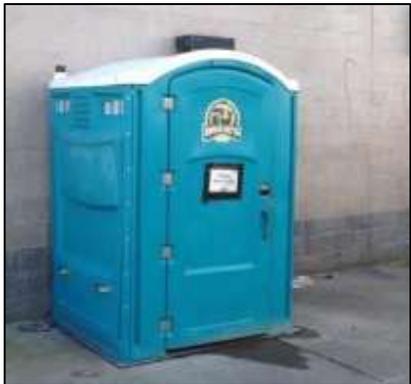
Property: 11	Name: Broadway Place North	Determination of Blight: Yes
Taxlot(s): 1703311316100	1703311316300	Depreciation Ratio: N/A
1703311316500	1703311316800	1703311316900
Property Notes:	Building is in good condition. . Property has upper level apartments, street level commercial, and lower level public parking. The building has closed restrooms which create added costs to taxpayer through continued maintenance, loss of population, underutilization of space. The use of a portable restroom adds to costs to taxpayer, increases safety concerns due to its alley location and closed environment, and adds to perceptions of area being blighted. Depreciation ratio cannot be calculated since land value is zero. Building is also adjacent to a poor condition building to the north not in district. Blight Determination based on ORS 457.010 (h) and (i).

Photos: Top: building on NW corner of Broadway and Charnelton Street; bottom: portable restroom in alley north of building.

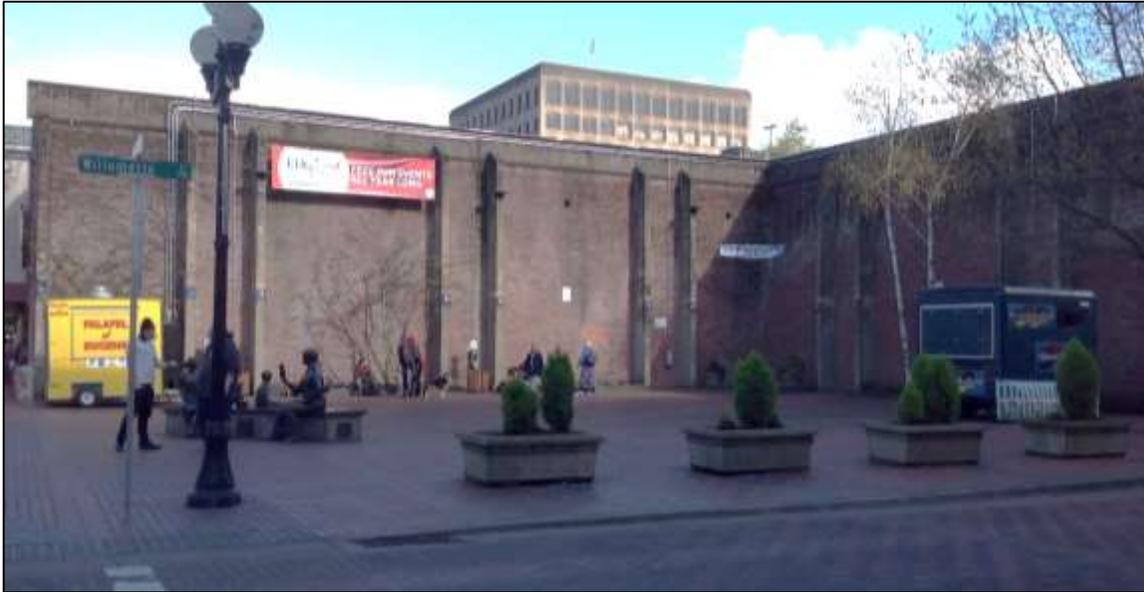
Property: 15	Name: Broadway Plaza	Determination of Blight: Yes
Taxlot(s): 1703311404801		Depreciation Ratio: 0.10
Property Notes:	This property is a public open space plaza. The property is underutilized, does not have utilities such as running water, or amenities such as a drinking fountain, restrooms, or shade. The area also has concerns for safety based on past vandalism. Blight determination by ORS 457.010 (1)(g), (h), and (i).

Photos: View of property from Broadway and Willamette Street.

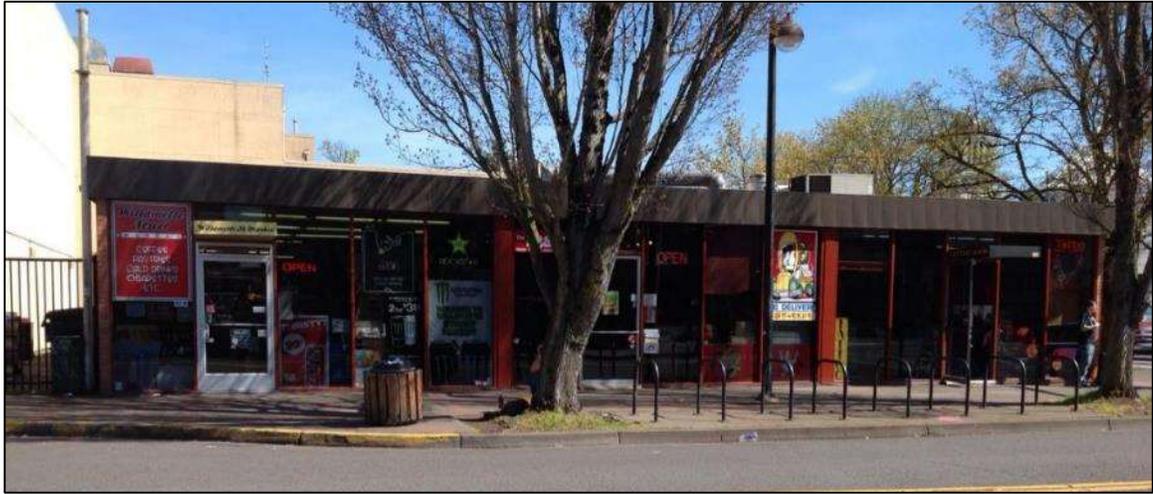
Property: 16	Name: Business	Determination of Blight: Yes
Taxlot(s): 1703311412900		Depreciation Ratio: 0.92
Property Notes:	Buildings appear in good condition. Property is a series of storefront businesses in single story building, including a smoke shop, salon, tattoo parlor and mini-mart. There is a fenced off alleyway behind the building that is underutilized space and is used for garbage. Blight determination by ORS 457.010 (1)(g) and (h).

Photos: Top: view of business from Willamette Street; bottom, view of alley around businesses.

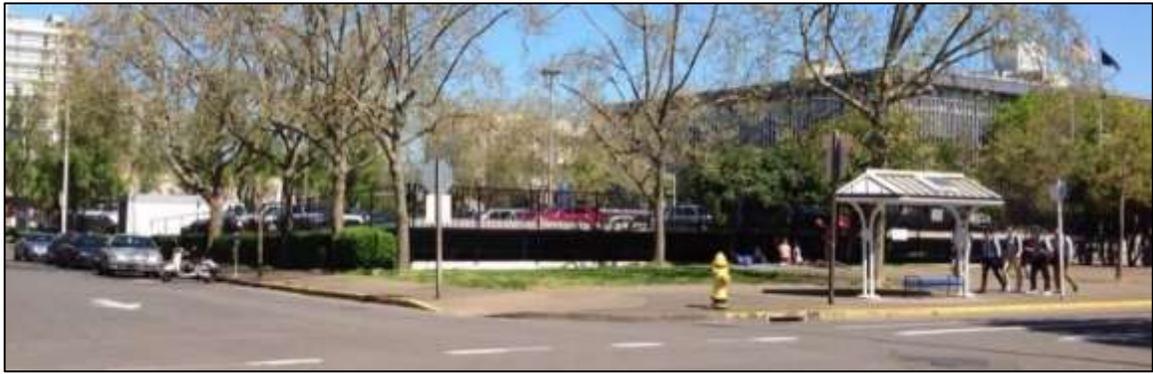
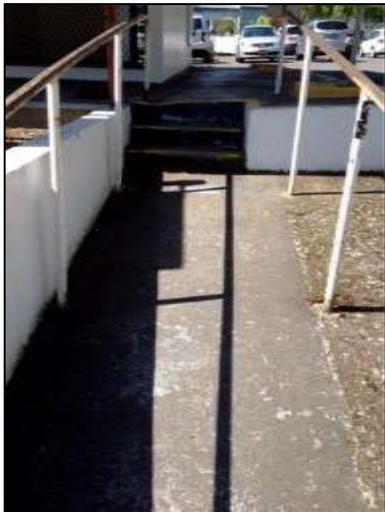
Property: 17	Name: Butterfly Lot	Determination of Blight: Yes
Taxlot(s): 1703311109500		Depreciation Ratio: 0.06
Property Notes:	This property is a two level parking structure with second level below ground. The property is deteriorated with large pot holes, rusty access stairwells, graffiti, and deteriorated building. Surrounding the property there are uneven sidewalks and numerous utility boxes in green spaces. The angle of the pedestrian access ramps is questionable. Determination of blight with ORS 457.010 (1)(a)(B), (g), and (h).

Photos: Top: view of property from 8th Avenue at West Park Street; bottom left: pedestrian walkway; bottom right: stairwell on property to lower level.

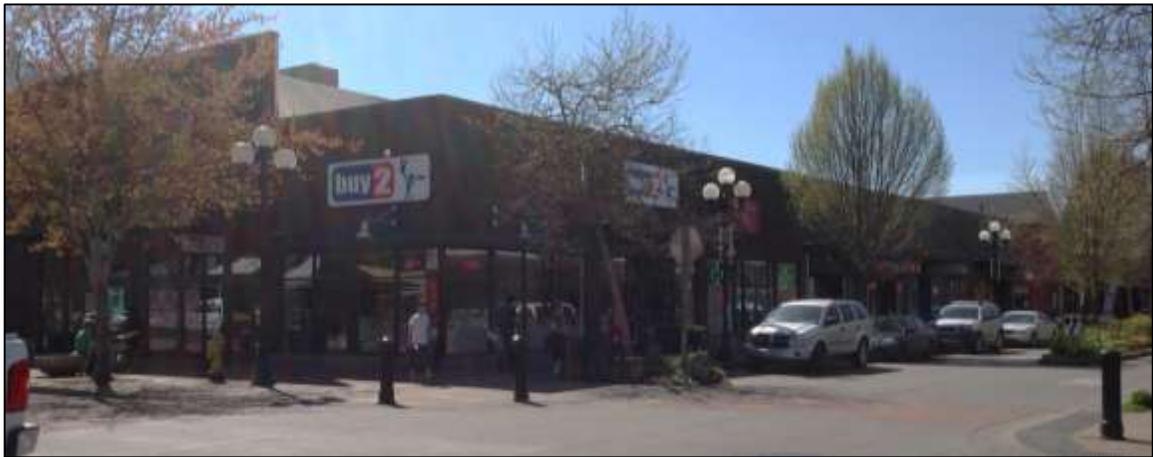
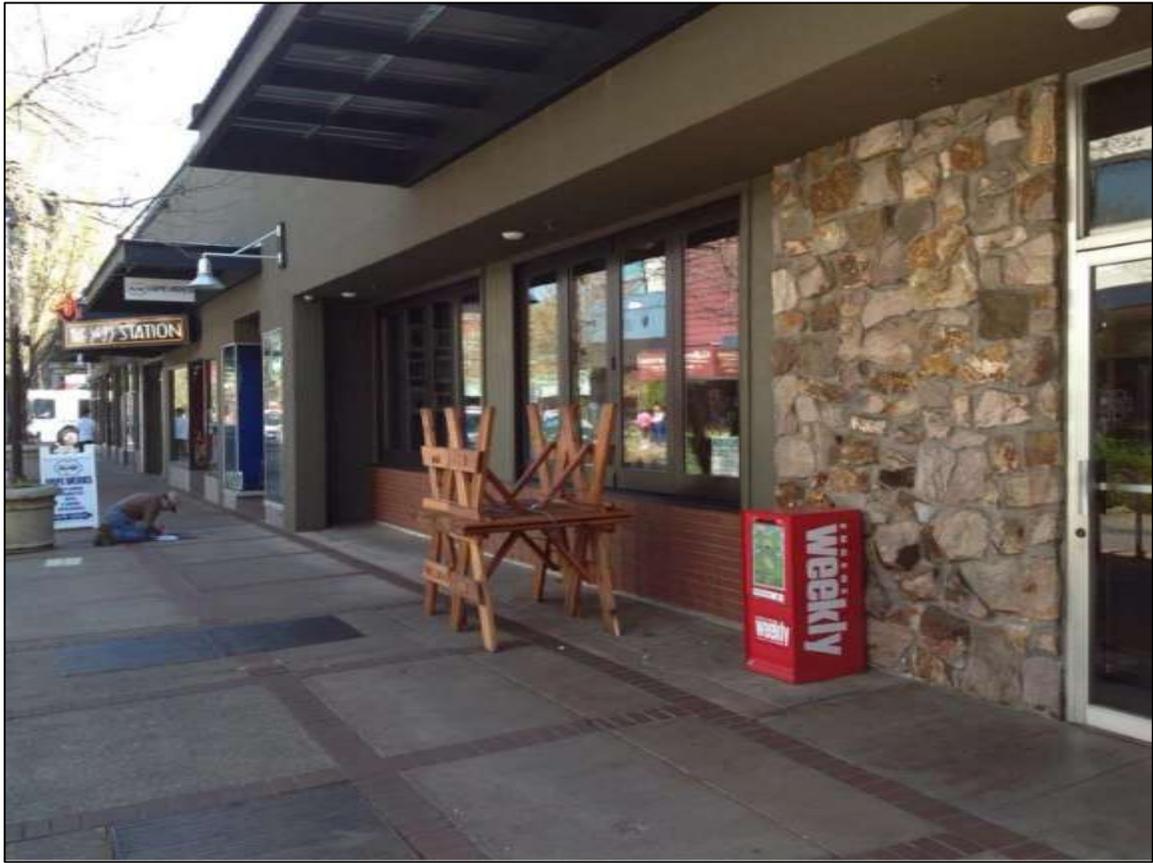
Taxlot(s):	1703311304900	Depreciation Ratio:	3.90
Property Notes:	The building appears in good condition. Several stores occupy this single story block including Subway, Buy 2, and the Jazz Station. Determination of blight ORS 457.010 (1)(g), and (h).

Photos: Top: view of property from Broadway and Olive Street; bottom: view of property looking east on Broadway.

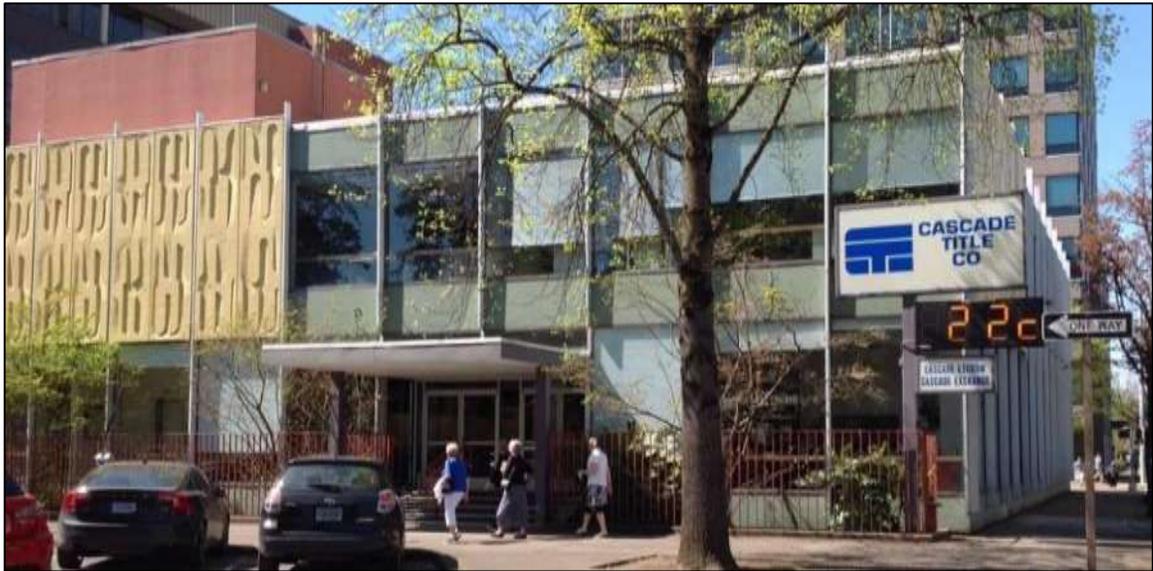
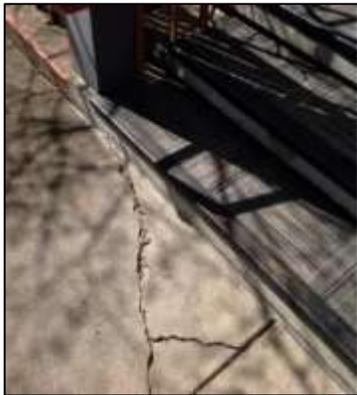
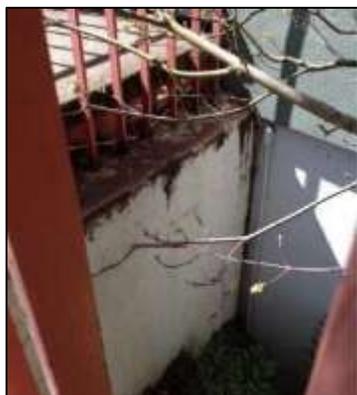
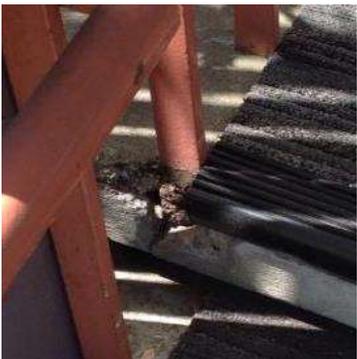
Property: 19	Name: Cascade Title	Determination of Blight: Yes
Taxlot(s): 1703311404600	Depreciation Ratio:	3.52
Property Notes:	Building appears in relatively good condition. It is an older building, but has some wear such as cracks in pavement. Determination of blight ORS 457.010 (1)(g).

Photos: Top: View of property from West 8th Avenue and West Park Street; middle left: image shows example of cracks in pavement on sidewalk outside building; middle right: image shows wear; bottom: image shows damage in cement at base of stair railing.

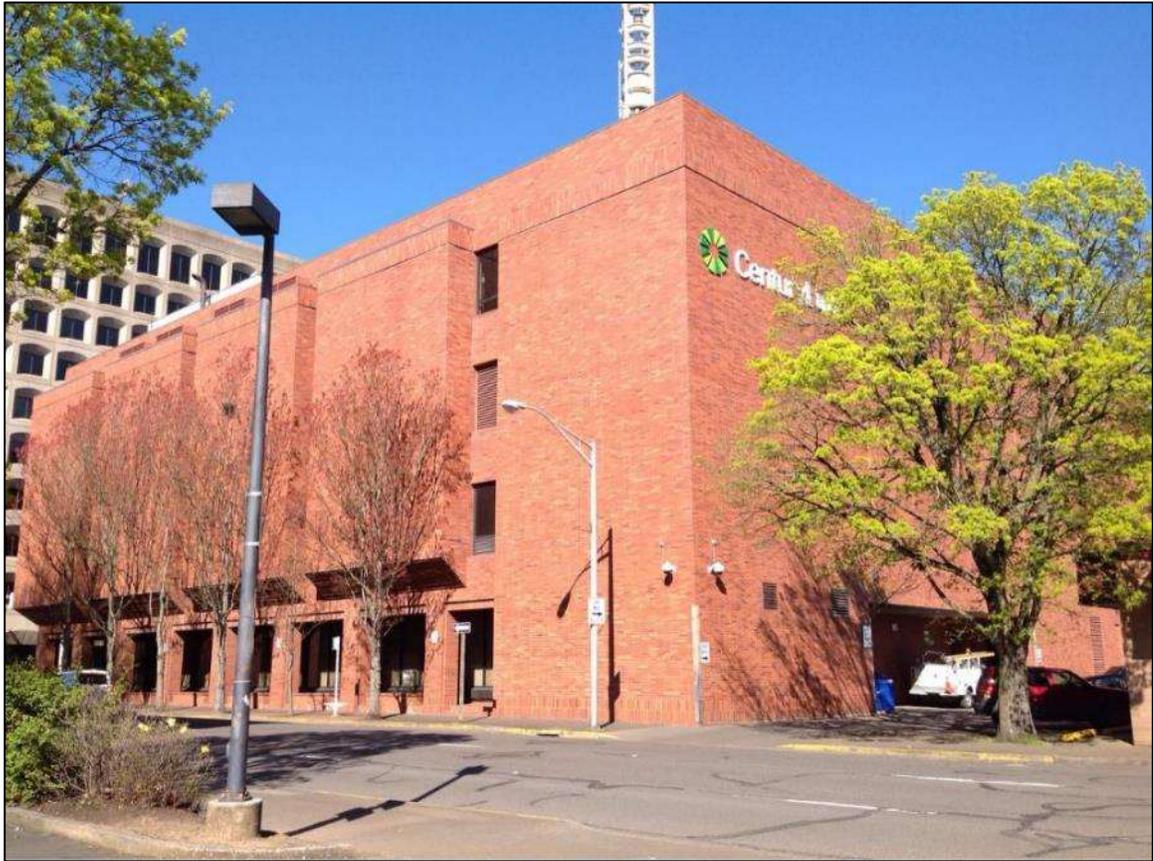
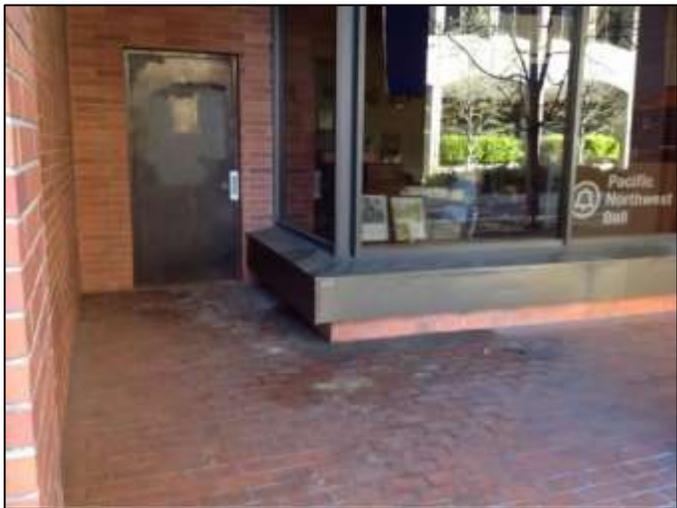
Taxlot(s):	1703311411500	1703311411600	Depreciation Ratio:	NA
Property Notes:	Property appears in good shape. The building is a telecommunications building with a brick exterior, street level windows on two sides for store, museum and offices. The property also has empty space on north and west side. The building design does not allow easy building re-use. Determination of blight ORS 475.010 (h).

Photos: Top: view of building facing Oak Street; bottom: example of empty space outside museum on north side.

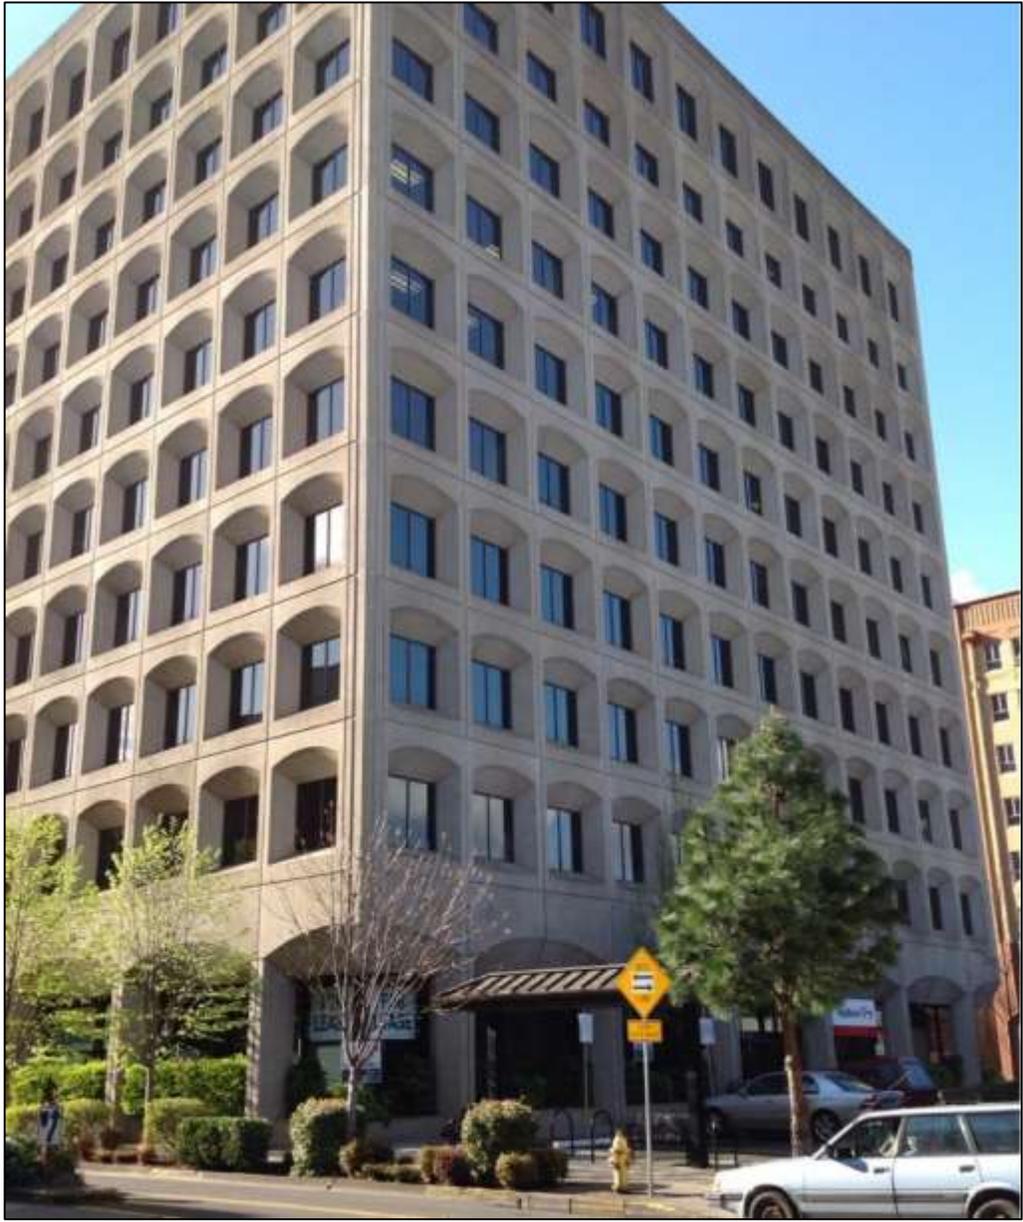
Taxlot(s):	1703311406900	Depreciation Ratio:	16.22
Property Notes:	The property appears in good condition. The property has a ten story office building, however half of bottom floor appears to be vacant.

Photos: View of building on Oak Street.

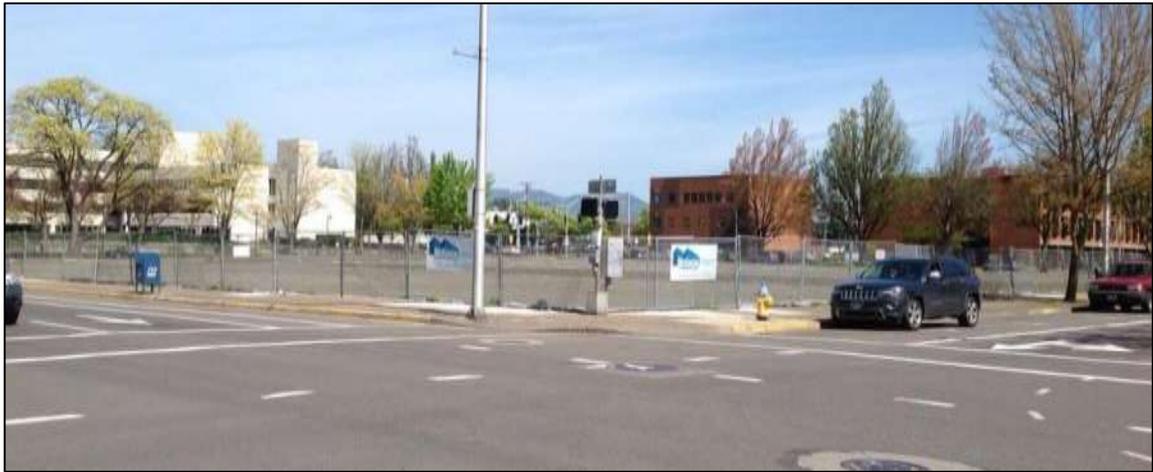
Property: 22	Name: City Hall block	Determination of Blight: Yes
Taxlot(s): 1703311110600		Depreciation Ratio: 0
Property Notes:	The property is vacant after previous City Hall was removed. The southwest portion of the block in the plan area is intended for the new Eugene City Hall plaza, and plans for the eastern half block in the plan area are currently undetermined. Property is vacant and underutilized. Determination of blight is based on ORS 457.010 (1)(g), (h) and (i).

Photos: View of property from East 8th Avenue and Pearl Street.

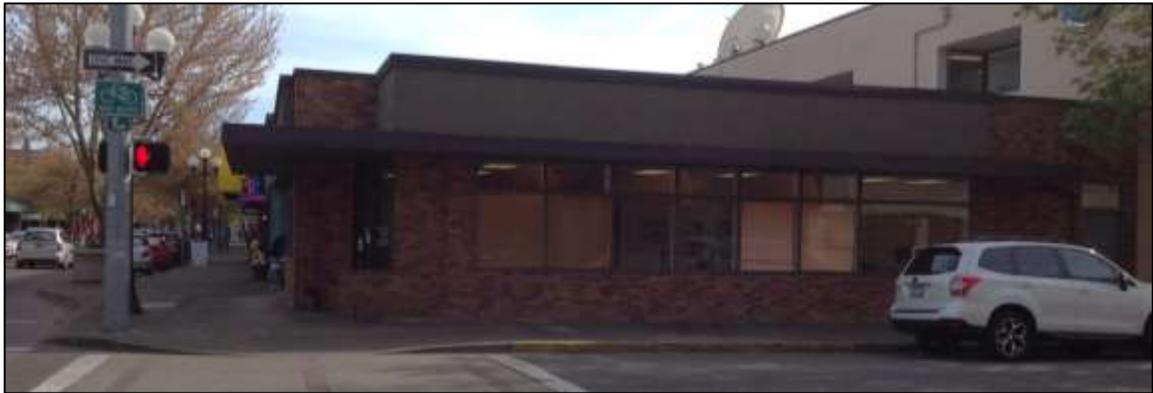
Property: 23	Name: City of Eugene Auditor	Determination of Blight: Yes
Taxlot(s): 1703311303900		Depreciation Ratio: 2.05
Property Notes:	Building appears to be in good condition. Determination of blight based on ORS 457.010 (1)(g) and (h).

Photos: View of building on 8th Avenue.

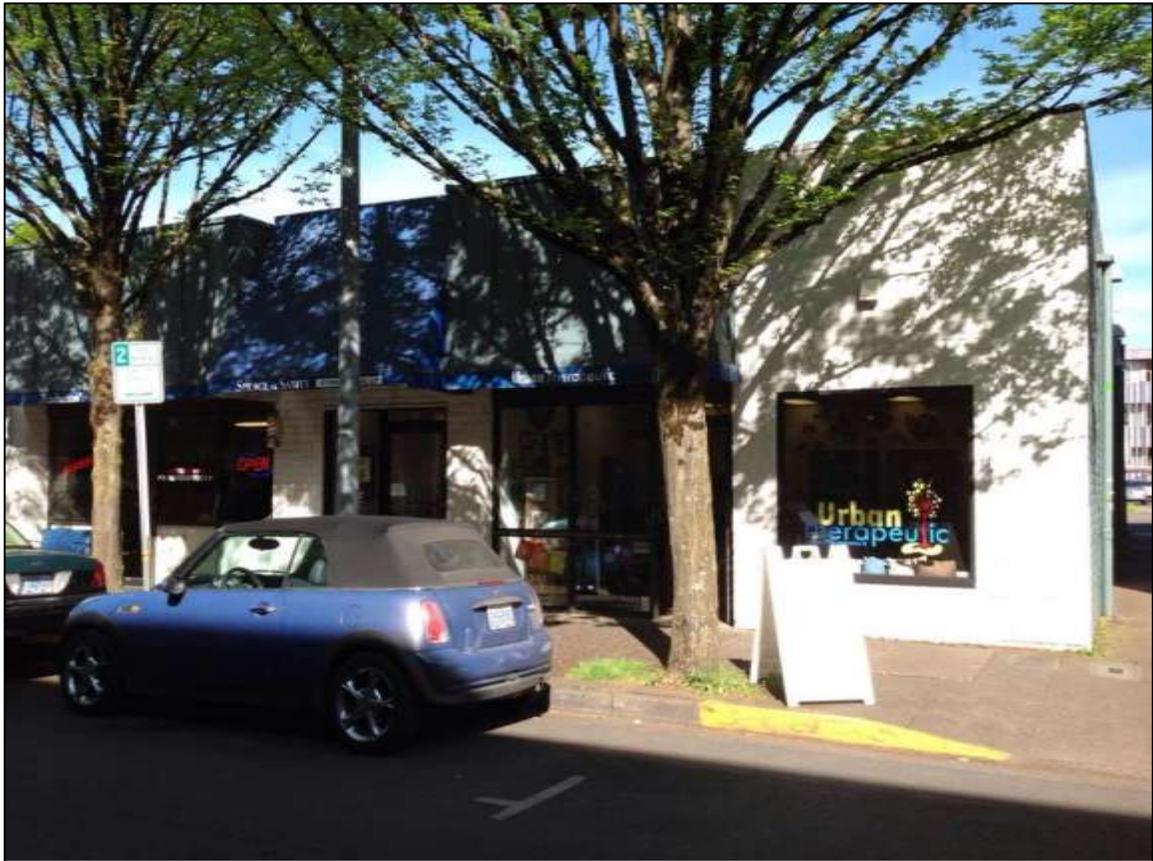
Property: 24	Name: Commercial and office	Determination of Blight: Yes
Taxlot(s): 1703311109000		Depreciation Ratio: 2.75
Property Notes:	Property appears in good condition. Building is a single story with commercial and office uses. Determination of blight based on ORS 457.010 (1)(g) and h.

Photos: Front of building facing Willamette Street.
