DOWNTOWN URBAN RENEWAL DISTRICT REPORT

REPORT ON THE DOWNTOWN URBAN RENEWAL DISTRICT PLAN

Map to Accompany Downtown Urban Renewal Slums and Blight Report 2016

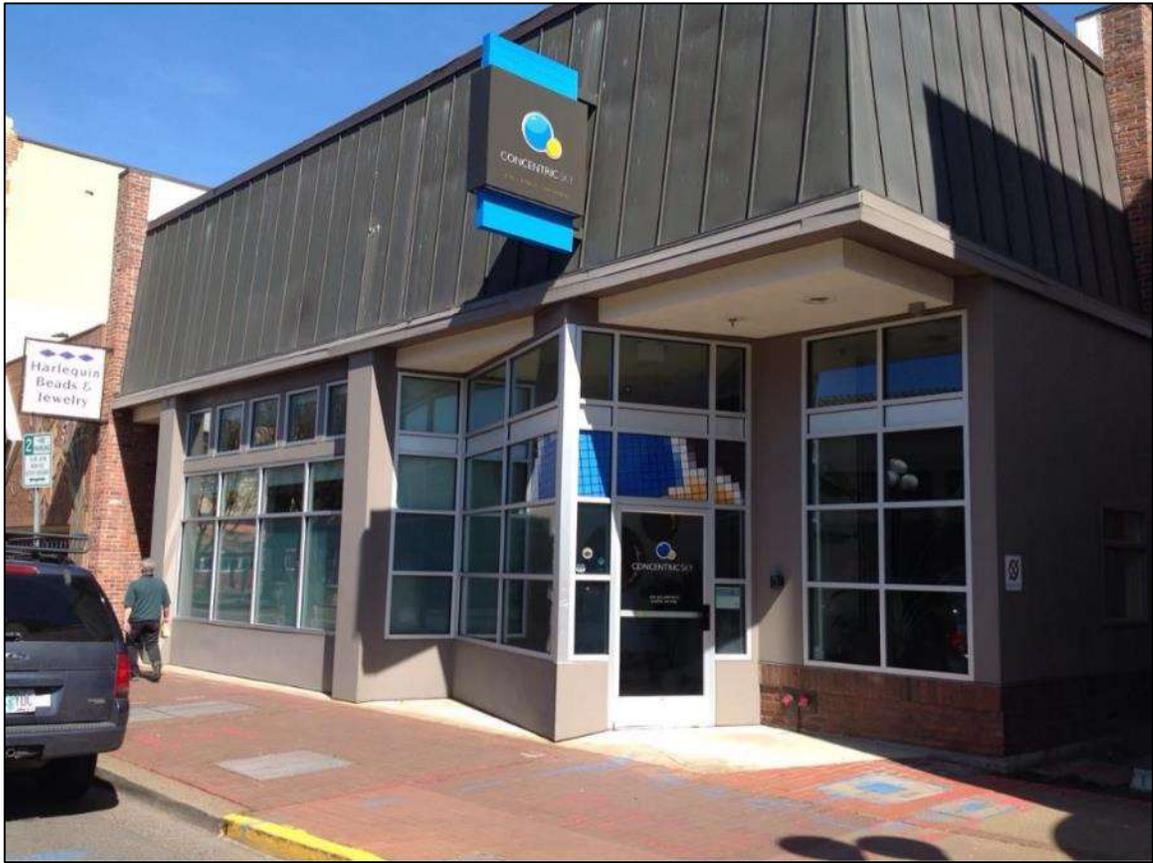
Property: 25	Name: Concentric Sky	Determination of Blight: No
Taxlot(s): 1703311412700		Depreciation Ratio: 4.76
Property Notes:	Property appears in good shape. There is a large hole in pavement in back of building.

Photo: Top: front of building facing Willamette Street; bottom: damage in pavement in back of building.

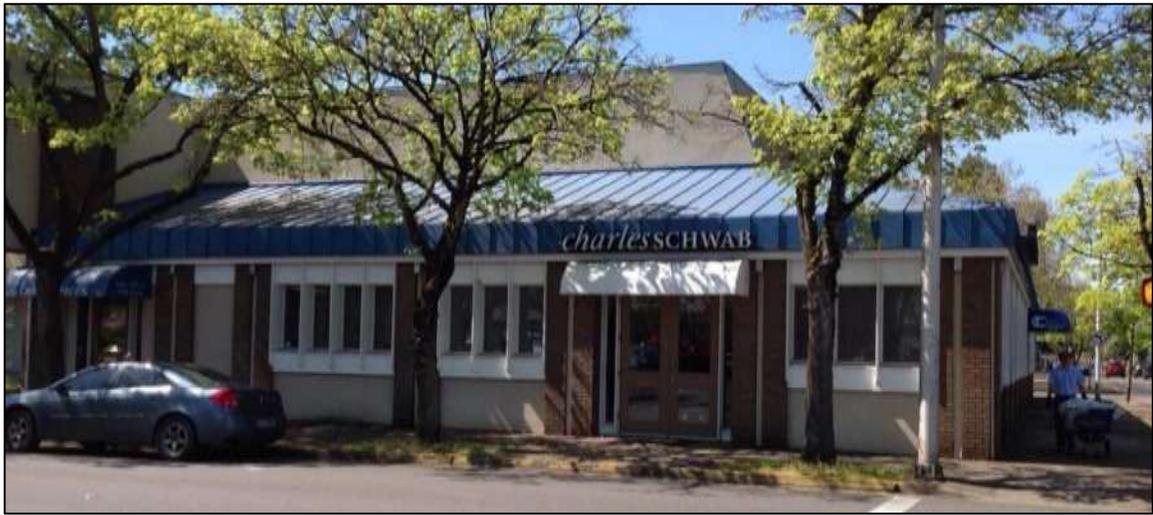
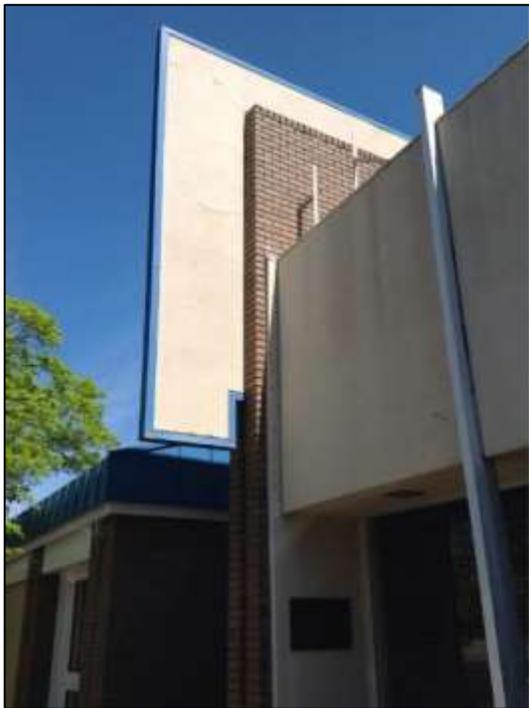
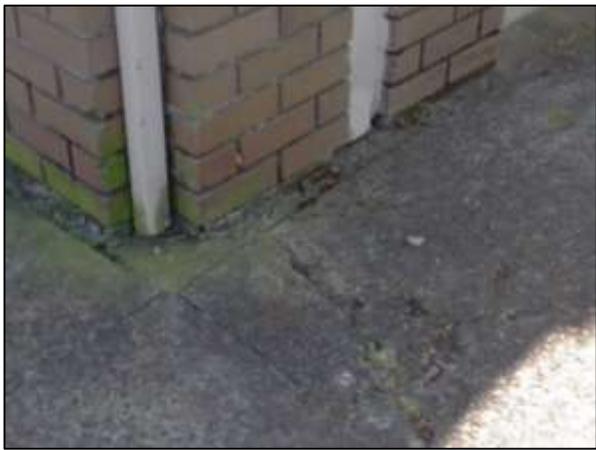
Property: 26	Name: Court Reporters and law offices.	Determination of Blight:	Yes
Taxlot(s): 1703311402300		Depreciation Ratio:	2.07
Property Notes:	Building appears to be in good shape. Has minor blemishes from ages, rust from outdated metal awning, cracks in facade in a spot. Building shows evidence of graffiti that has been painted over in multiple locations. Building has a part of façade that extends out over sidewalk. Determination of blight based on ORS 457.010 (1)(g) and (h).

Photos: Top: View of property East 8th Avenue and Pearl Street; bottom left: façade piece that extends our over sidewalk; bottom right: damaged and cracked cement walkway at base of building.

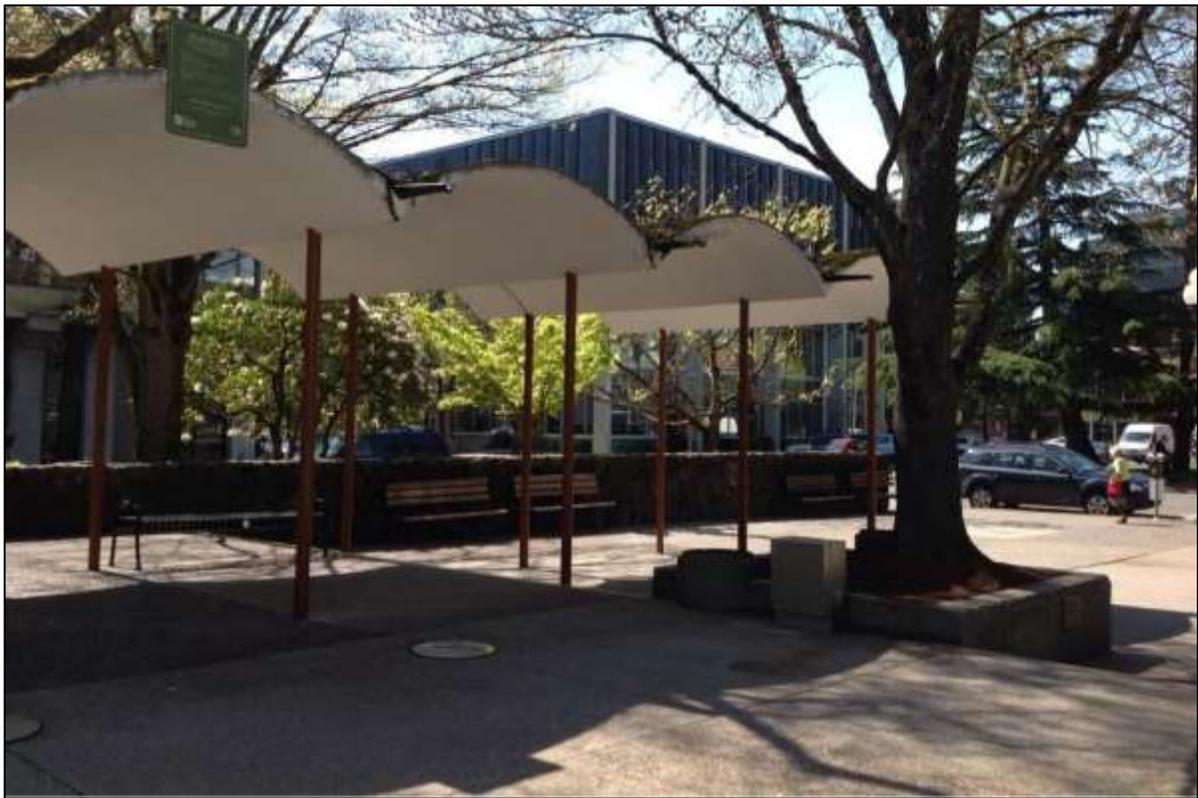
Property: 30	Name: East Park block	Determination of Blight:	Yes
Taxlot(s): 1703311404700		Depreciation Ratio:	0.05
Property Notes:	East park block. Sidewalk is broken and uneven. Ramps not flush with sidewalk (ne corner). Structure does not appear maintained with plants visibly growing on top. There is metal protruding from open area in multiple places, garbage littered around, some benches have rusty metal frames with peeling paint and an area with a broken light fixture in wall. Property does not have a permanent, but has a portable restroom. Determination of blight based ORS 457.010 (1)(b), (e), (g), (h), and (i).

Photo: Top: view of shelter; bottom left: growth on shelter; bottom right: broken and exposed light fixture

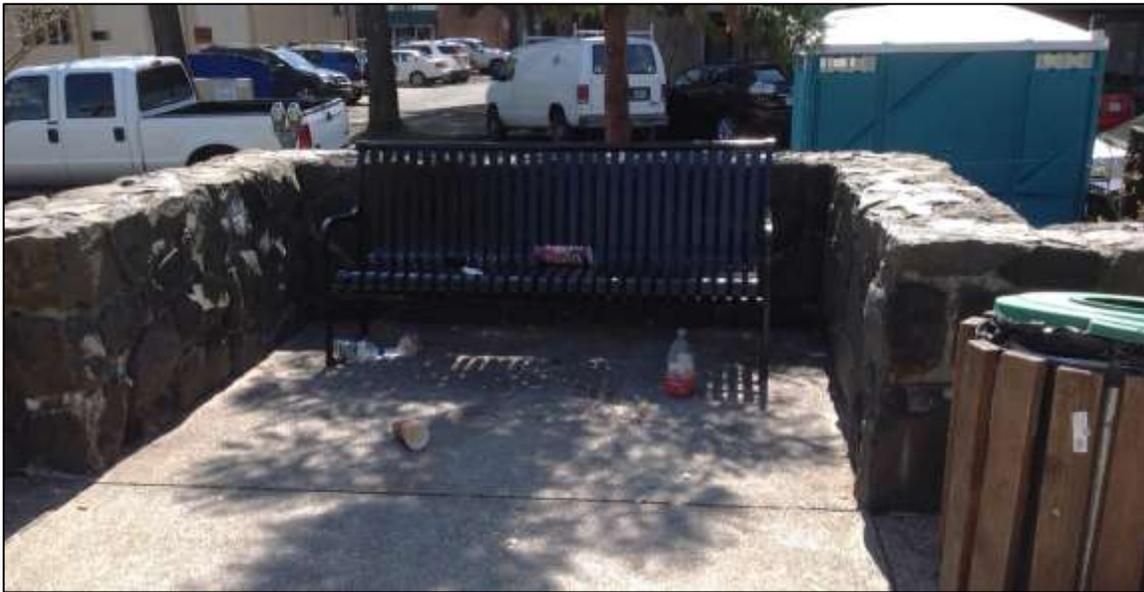
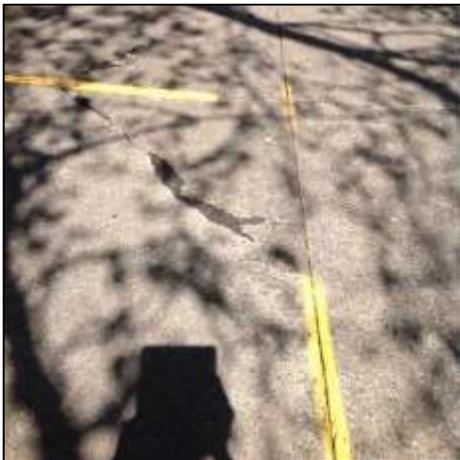
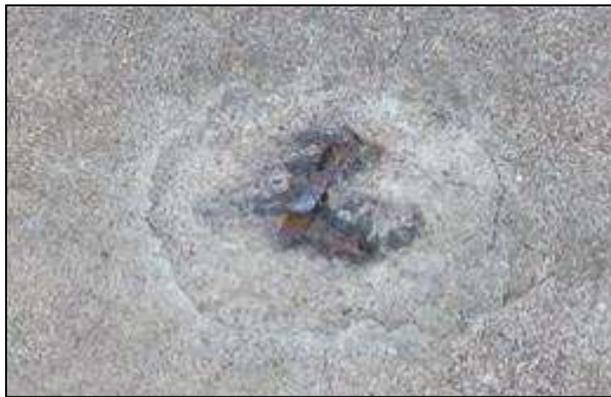
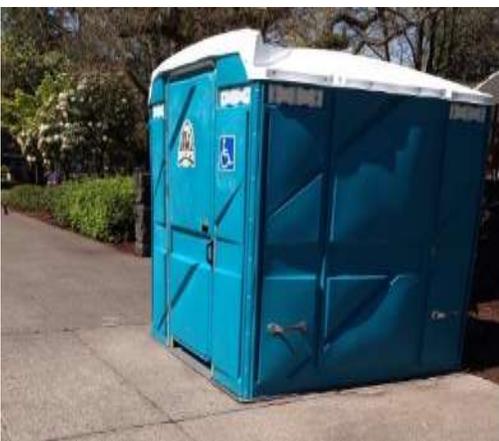
Property 30 images continued.

Photo: Top: Garbage in areas; middle left: example of areas with broken, uneven walkways; middle right: example of areas with metal coming out of walkways; bottom left: portable restroom; bottom right: park bench with peeling paint and rust.

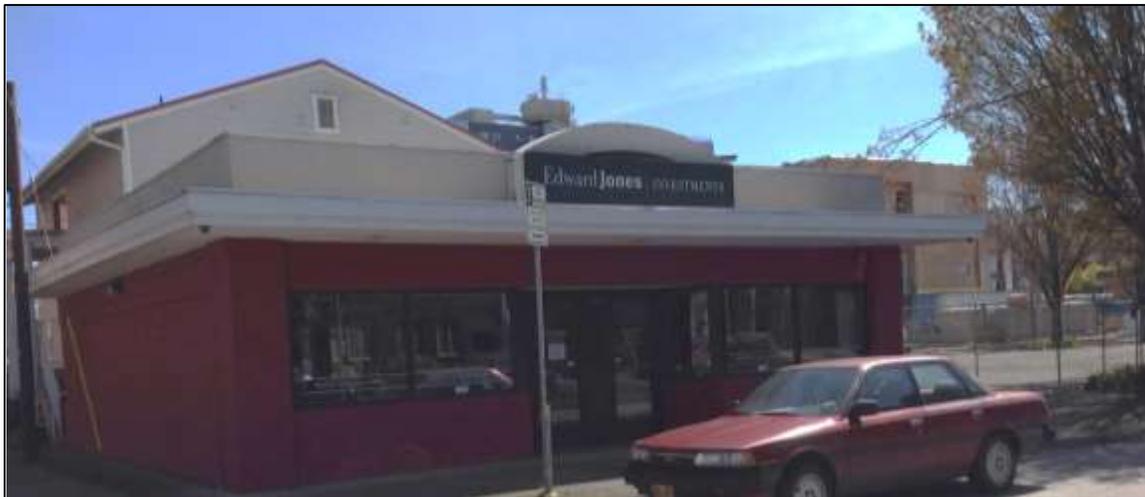
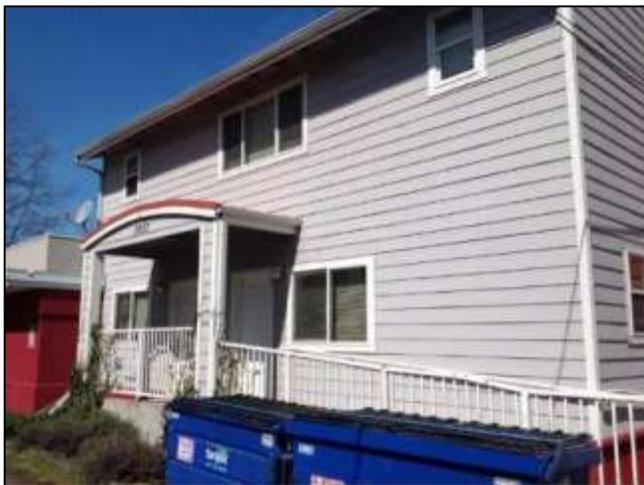
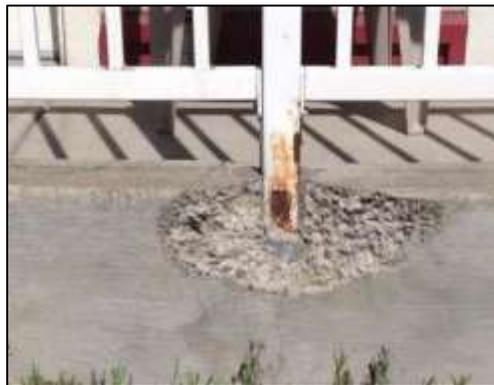
Property Notes:	Property is in fair condition and has two buildings. The buildings are built out to the lot line resulting in no open space for tenants. This also results in garbage for the residential units being placed very close to doors. Minor cement damage noted on patio. Units are accessible by ramp. Also, units are bounded east and south by blighted vacant property. Determination of blight based ORS 457.010 (1)(g).
------------------------	---

Photo: Top: front of building facing Charnelton Street; bottom left: image shows proximity of garbage to font door; bottom right: image shows concrete deterioration.

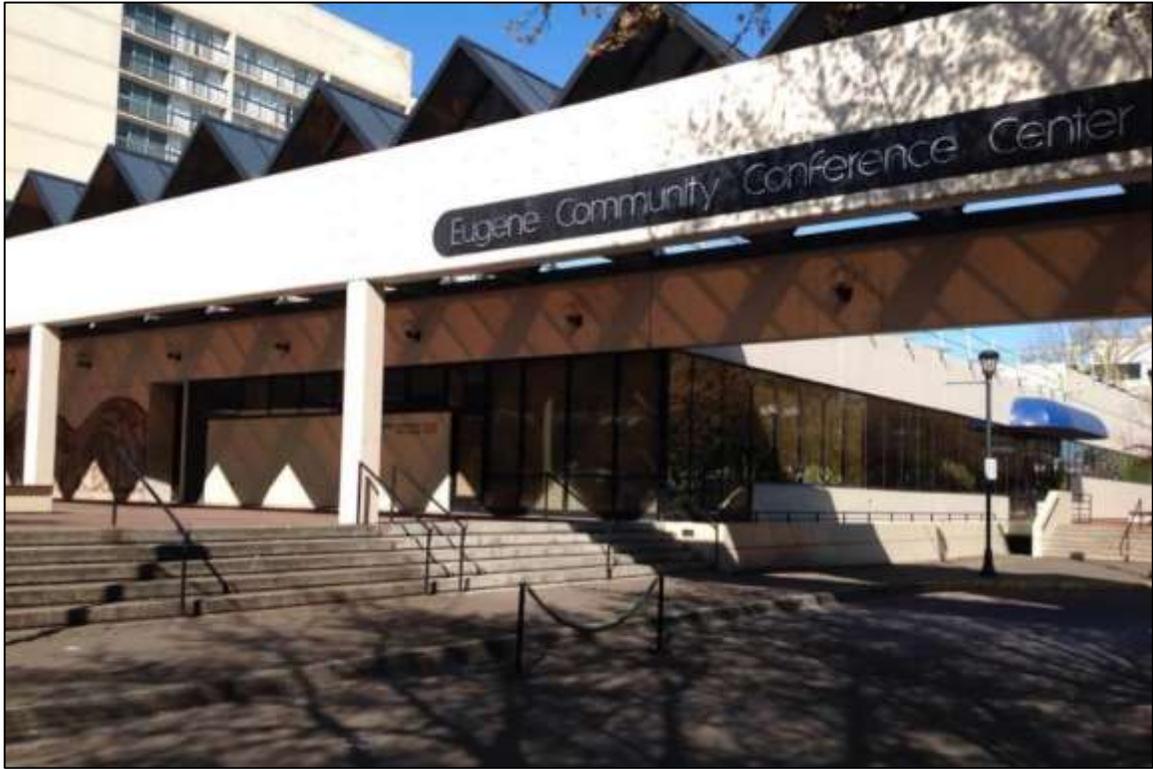
Property: 32	Name: Eugene Conference Center	Determination of Blight: Yes
Taxlot(s): 1703311107600	1703311107700	Depreciation Ratio: 6.39
Property Notes:	Property consists of outdoor area and building. Building appears in good shape. Outdoor area is in poor shape with broken tiles and cracked cement, this area also appears underutilized. This property is next to the Eugene Hilton. Building appears to be getting re-roofed. Determination of blight based ORS 457.010 (1)(a)(A), (a)(B), and (h), including seismic stability concerns.

Photo: Top: View of property from East 7th Ave; bottom left: damage on outdoor awning, bottom right: image shows example of uneven sidewalk.

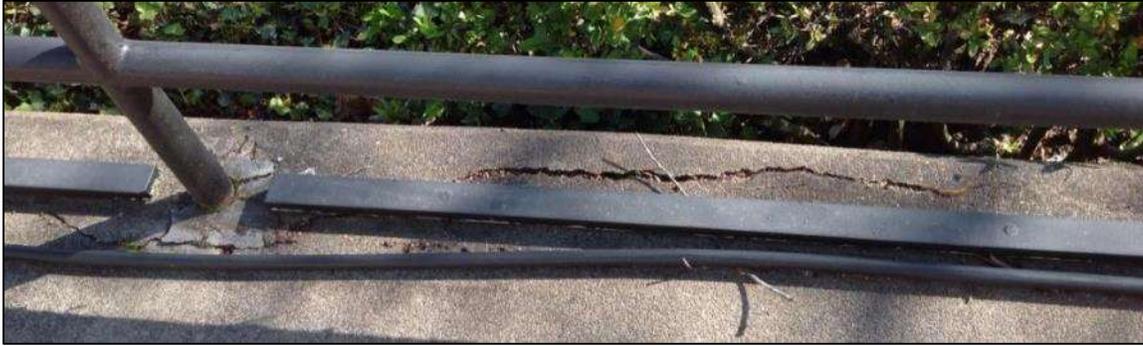
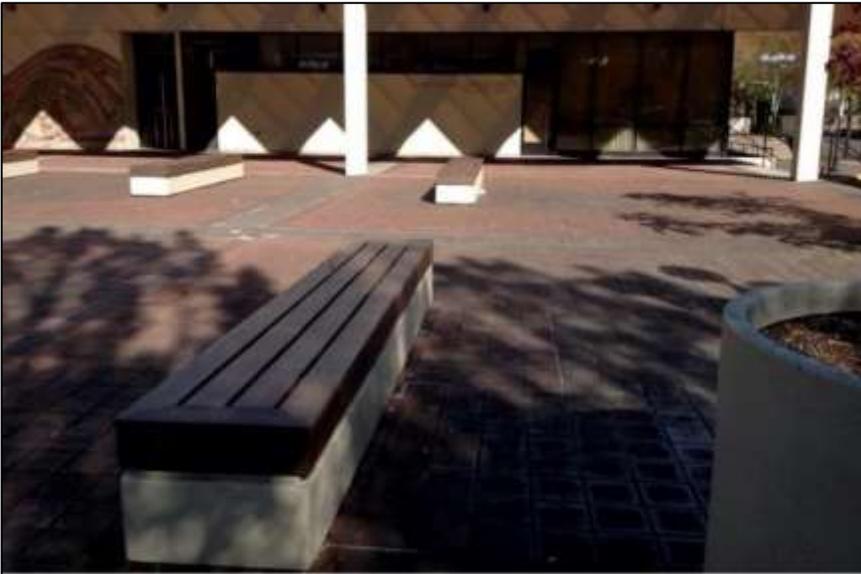
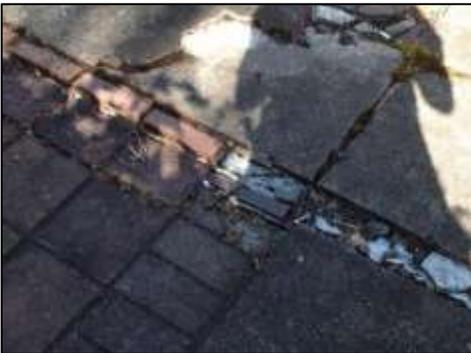
Property #32 images continued.

Photo: Top: image shows cracked cement along railing; middle: large open space; bottom: example of broken walkway.

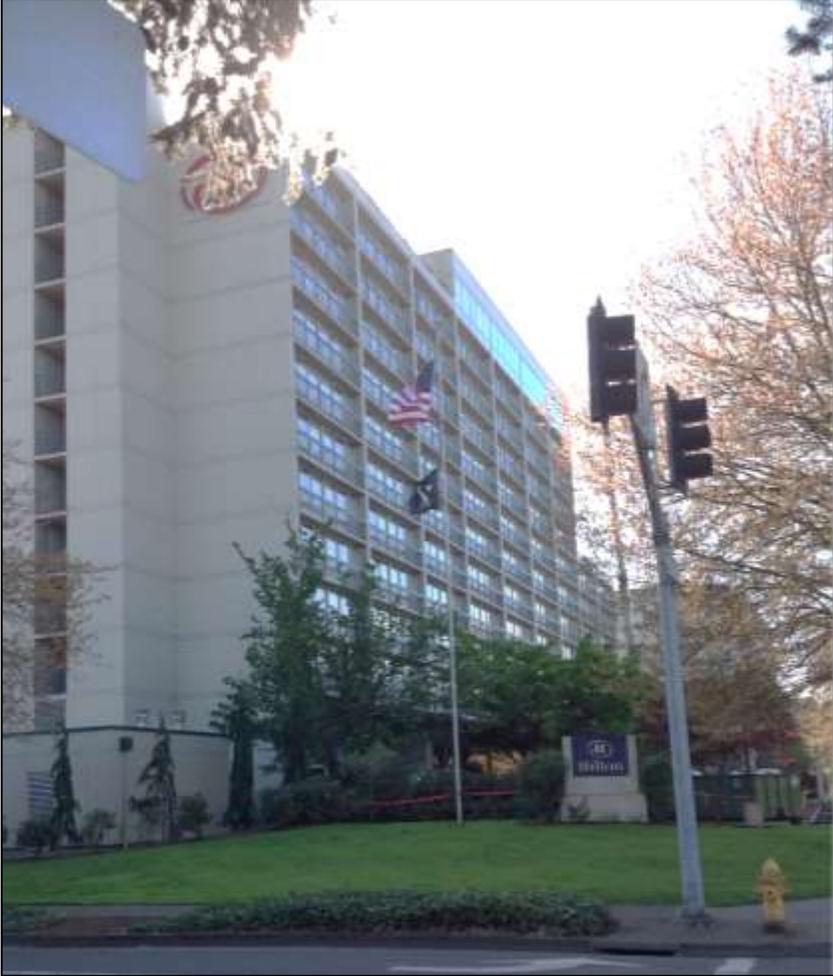
Photo: Top: image of property from Oak Street and East 6th Avenue; bottom left: image shows rebar in deteriorated stairs; bottom middle: cracks shown on stairwell; bottom right: image shows example of visible repairs.

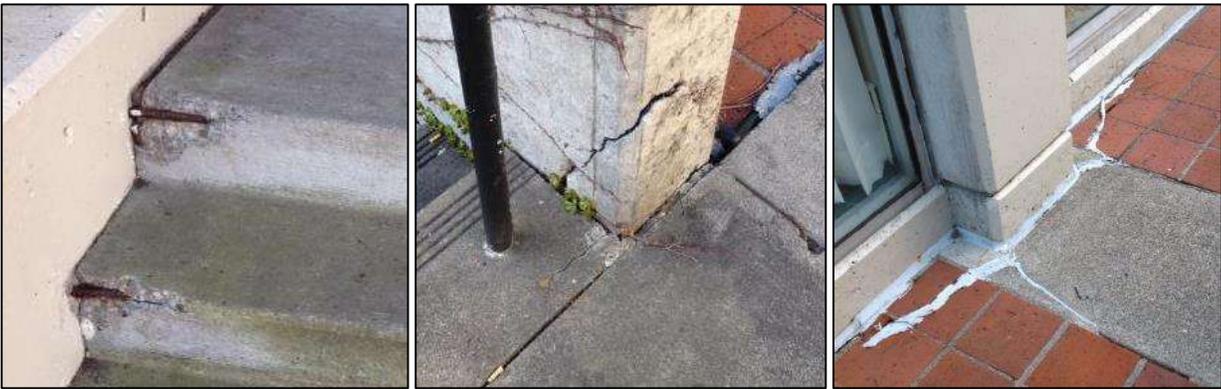
Property: 33	Name: Eugene Hilton Hotel	Determination of Blight:	No
Taxlot(s): 1703311107601		Depreciation Ratio:	11.30
Property Notes:	Building appears in fair shape. The steps from the sidewalk have deteriorated so rebar shows. There are lines visible on building cement surface, and the walkway on east side has steep ramp with cracked tiles.

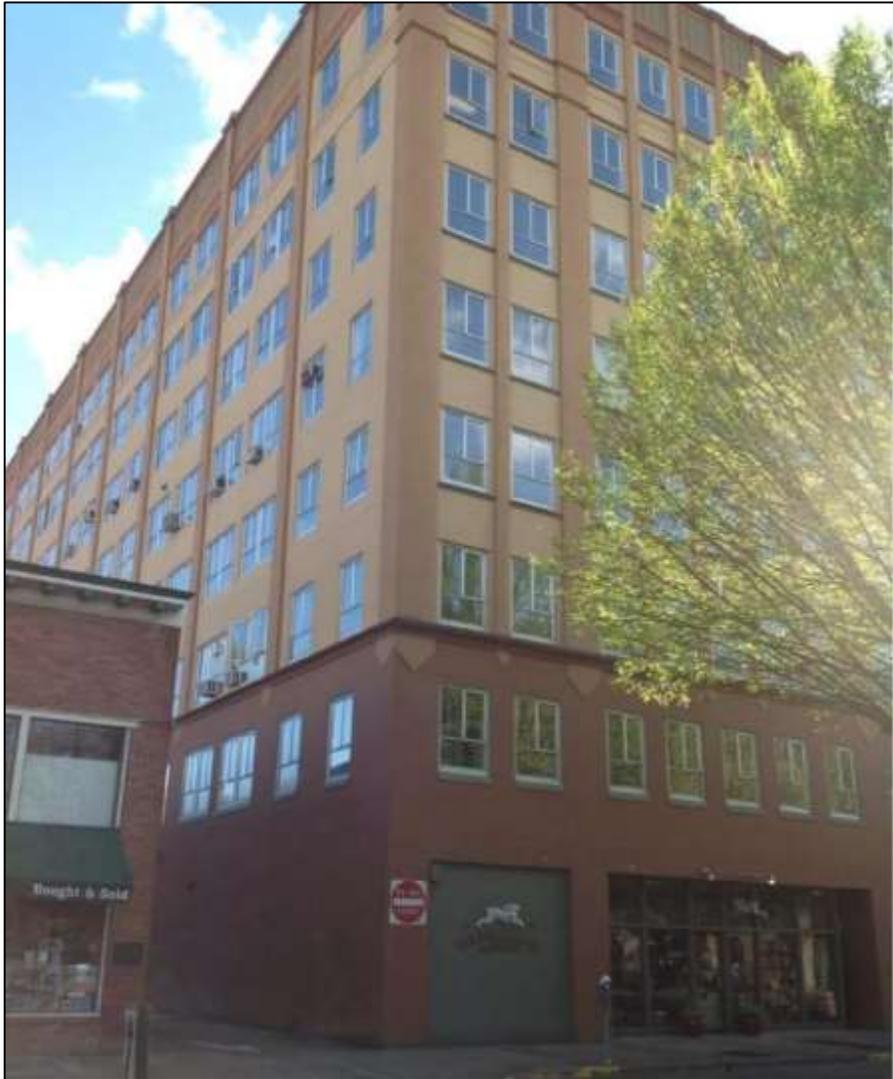
Photo: Top left: view of property from East Broadway; top right: image shows example of façade wear; bottom: cracks in pavement at base of building.

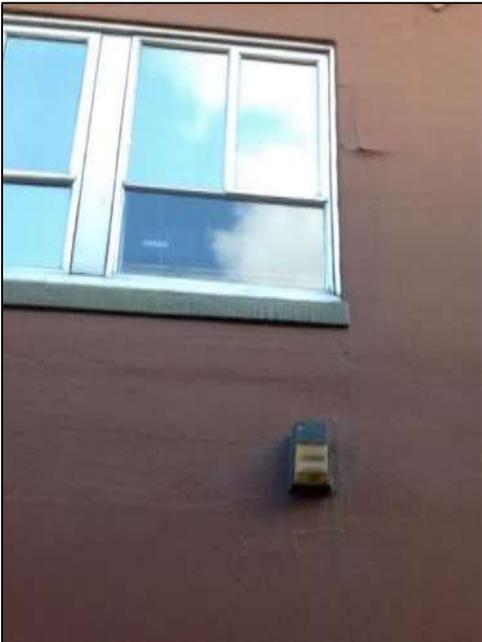
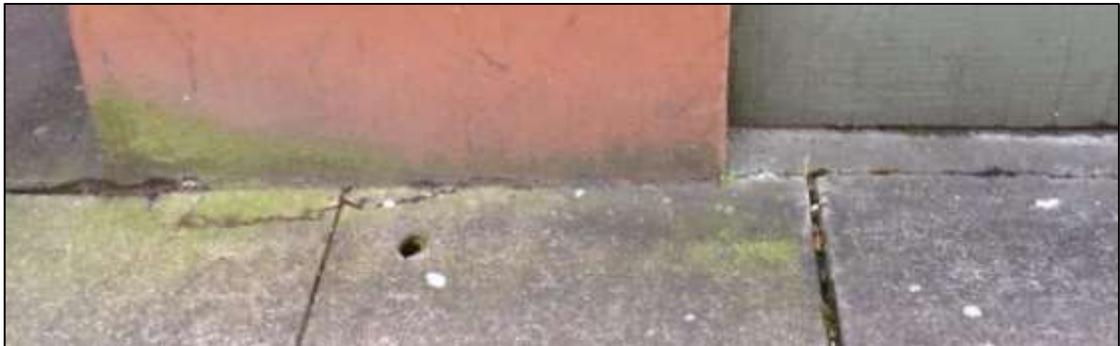
Taxlot(s):	1703311406600	Depreciation Ratio:	7.99
Property Notes:	Building appears in good condition and has a few blemishes such as cracks at base of building. Locations area also visible where building exterior has wear.

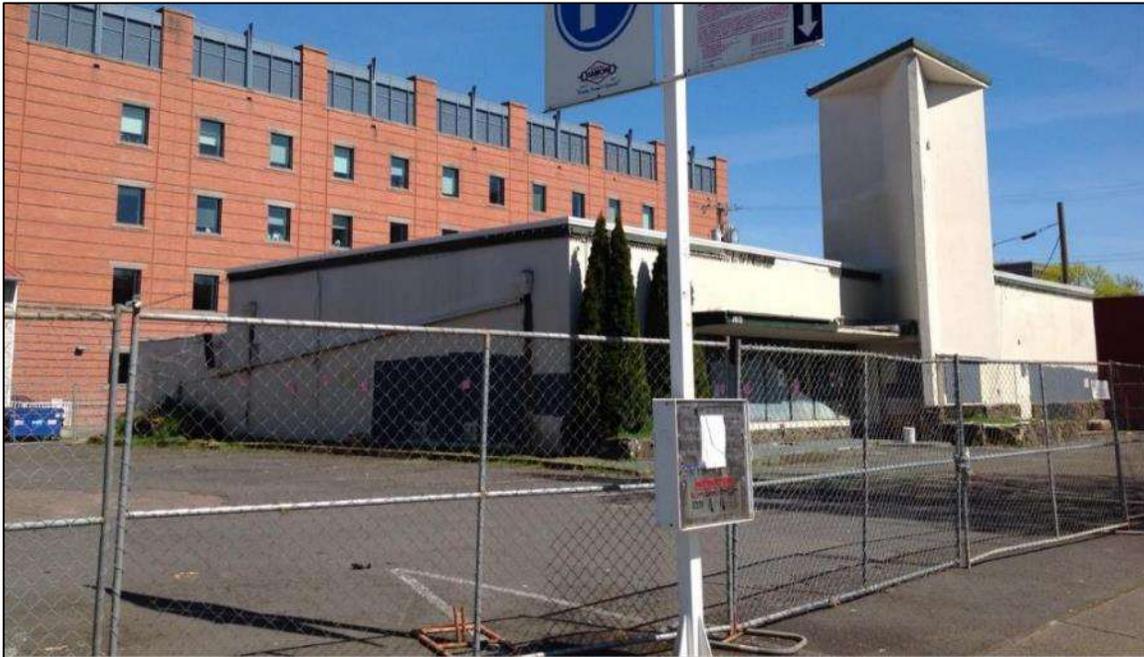
Photo: Top: shows property from SW corner of 11th Ave and Charnelton St, Library can be seen in background; bottom left: shows property from se corner; bottom right: damage to pavement that provides access to parking area behind building.

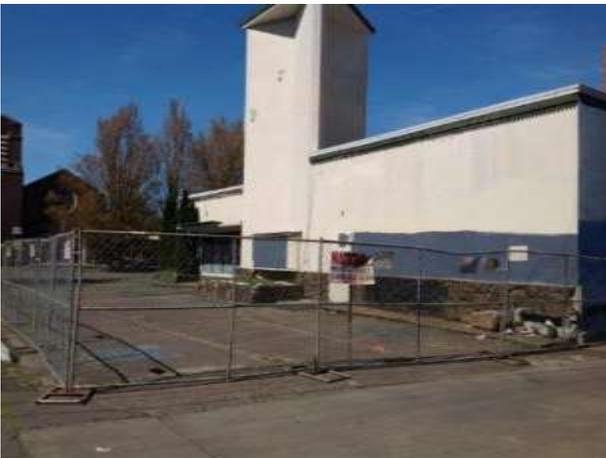
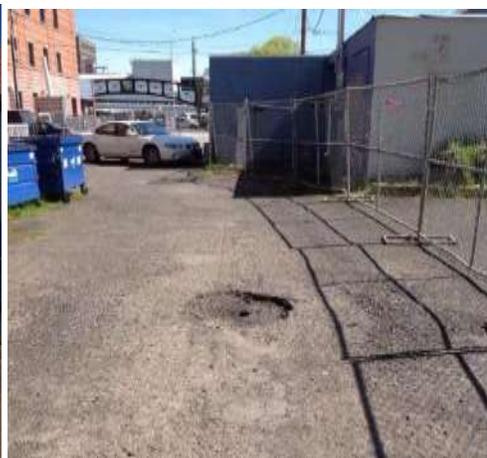
Property is formers "Docs Pad", then a salon. Property contains a dilapidated building and parking. This property did have paid parking for a while. Currently property and parking is fenced off. Old light fixtures abut property on south side. An area behind the building is used for parking and pavement is broken with large holes. Building itself has graffiti, large cracks, broken pieces, and garbage. Determination of blight based ORS 457.010 (1)(a)(A), (a)(B), (a)(E), (b), (e), (g), (h), and (i).

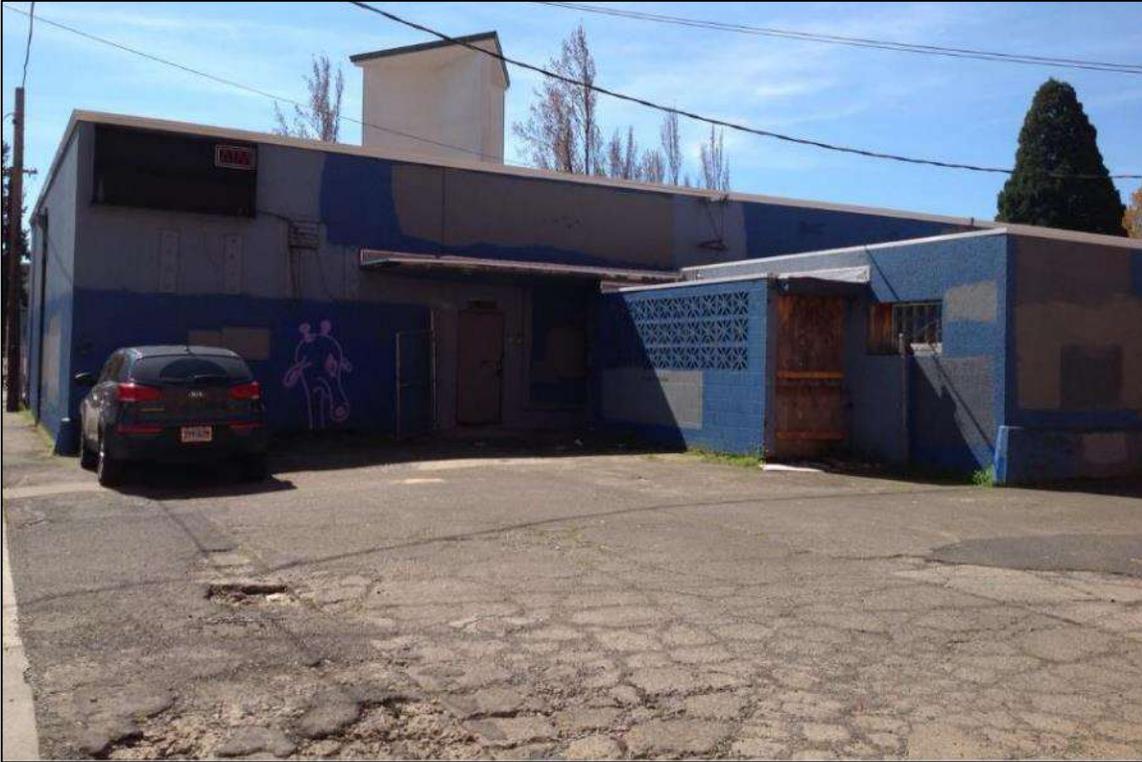
Property #37 images continued on next page.

Photo: top and bottom images show back side of building with damage, broken fencing, deteriorated building, overgrown vegetation, graffiti and damaged pavement.

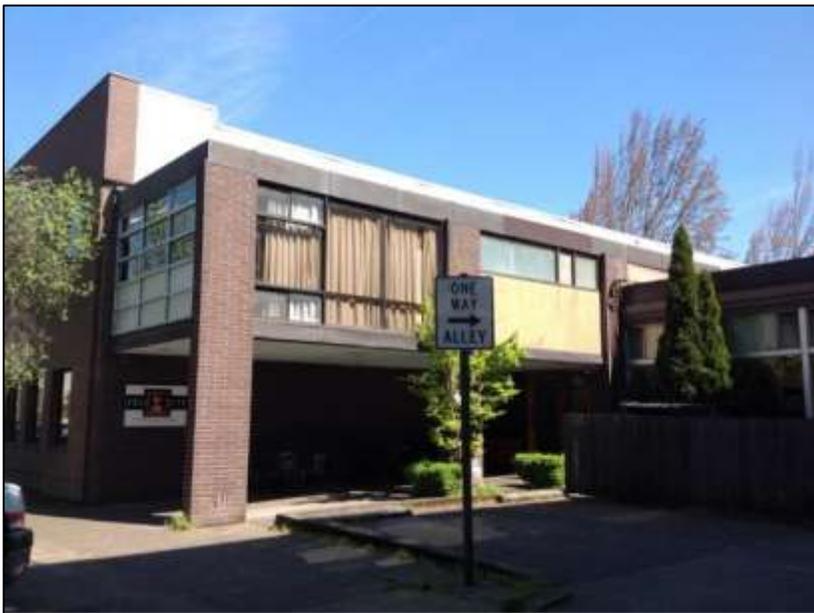
Property Notes: This property appears in good condition. Building has two levels, second level is on west side and appears older. Alley has evidence of graffiti in several spots indicating a possible public safety issue. Determination of blight based ORS 457.010 (1)(g).

Photo: Top: front of building on Pearl Street; bottom: image shows back of building on Park St.

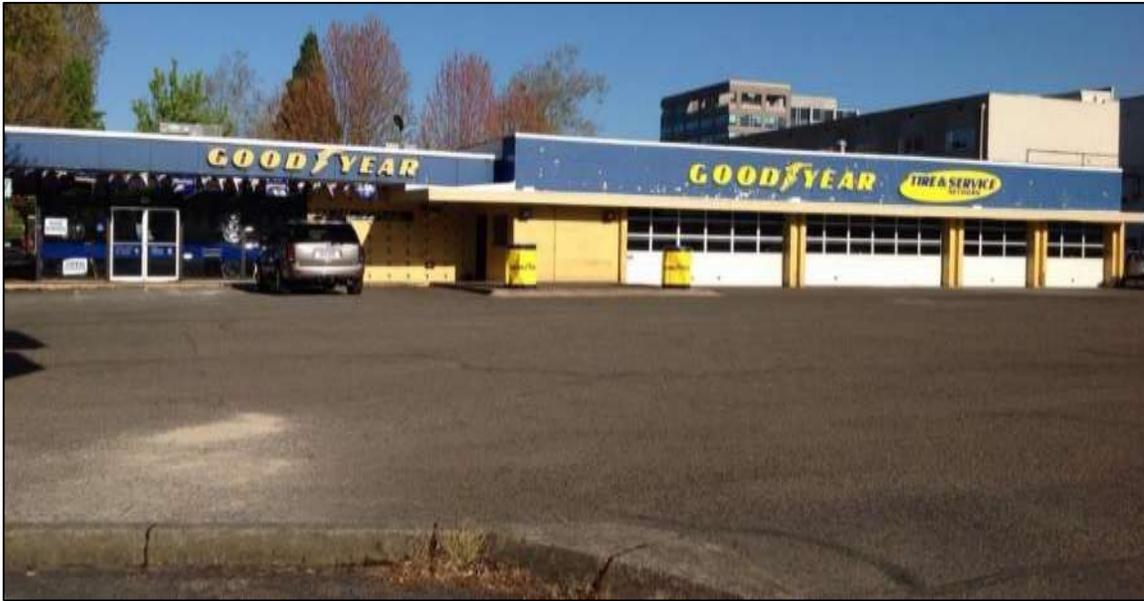
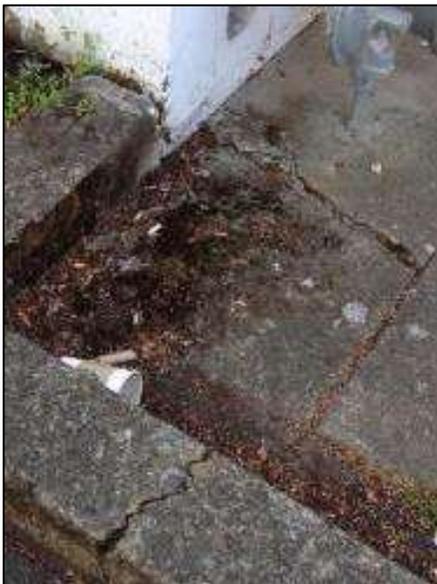
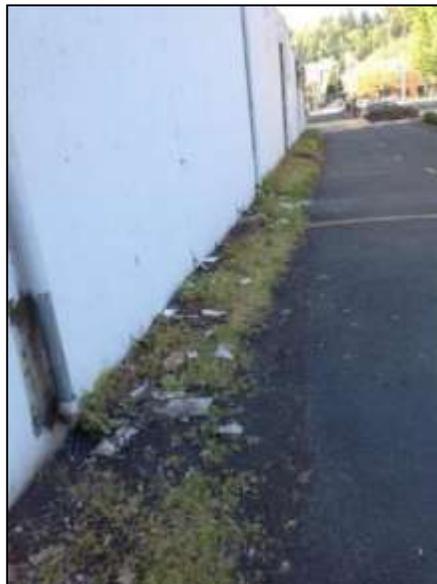
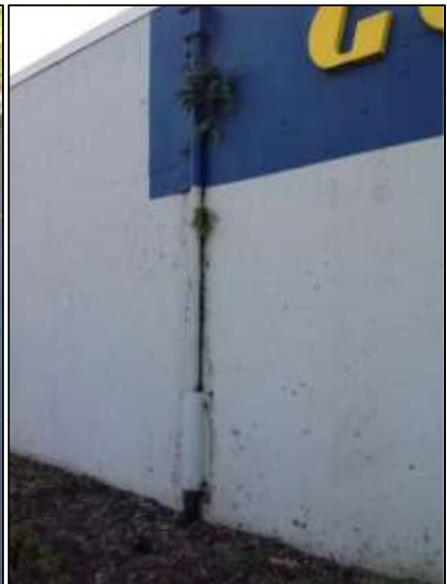
Property:	41	Name:	Goodyear Tires	Determination of Blight:	Yes
Taxlot(s):	1703311214600		1703311214700	Depreciation Ratio:	0.29
	1703311215100				
Property Notes:	Property appears in poor shape. Building has peeling paint with moss and plants growing on back. There are garbage and overgrown weeds on rear east location. The property is large about 1/4 block and half appears to be parking. Public sidewalks around building do not look maintained, this adds to further deterioration and perceptions of blight in area. Determination of blight based on ORS 457.010 (1)(g) and (h)

Photo: Top: view of property from Charnelton Street; bottom left shows example of cement damage; middle: shows garbage and overgrown vegetation on east side of building; bottom right: shows plants growing on side of building.

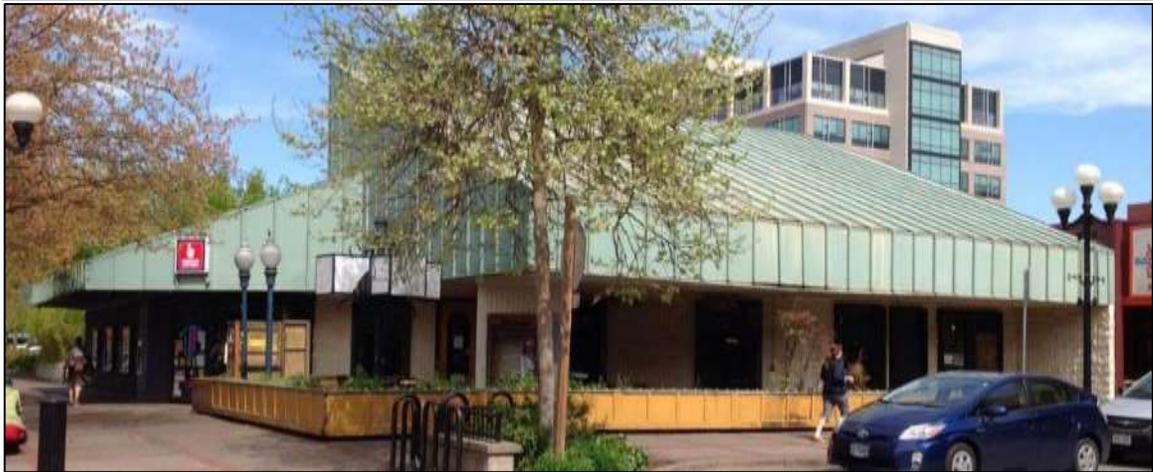
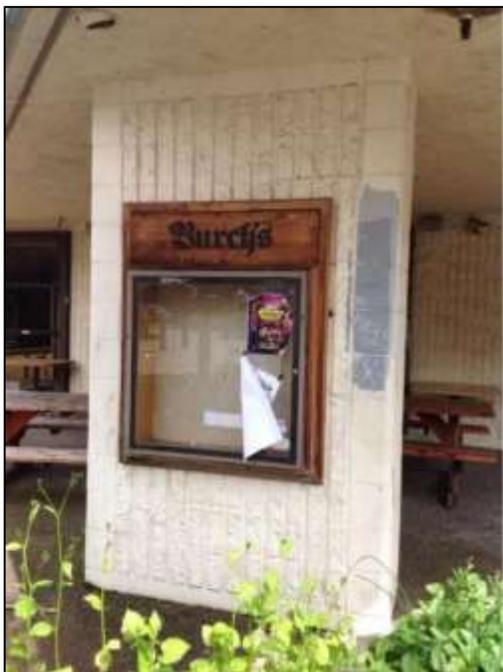
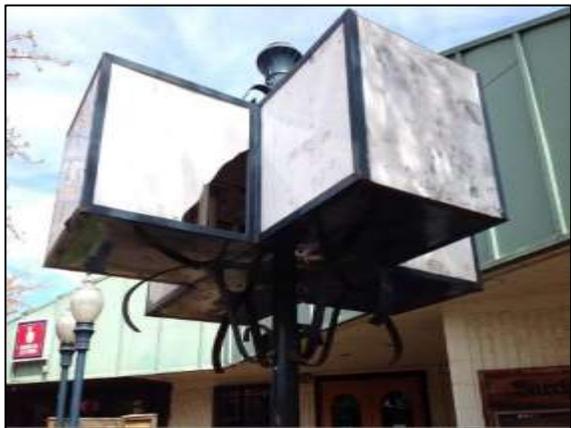
Property: 45	Name: Horsehead	Determination of Blight:	Yes
Taxlot(s): 1703311303000		Depreciation Ratio:	0.54
Property Notes:	Property is in poor condition. The building is older and deteriorating. The property has two outdoor seating areas: one south and the other north. South seating area has broken fixtures, graffiti, and the building has damage. The south area has a wooden enclosure that look like planter boxes, which are broken with metal exposed and the planters are overgrown and not maintained. Northern outside area has tables and looks to be used as lunch area. There is a small store in the building on the west side of the building. The building is deteriorated with peeling and broken sections. Determination of blight based on ORS 457.010 (1)(a)(B), (b), (g), and (h)

Photo: Top: image shows south side of property, viewed from Broadway and Olive Street; bottom left shows deterioration of property and graffiti; bottom right: image shows broken light in south area.

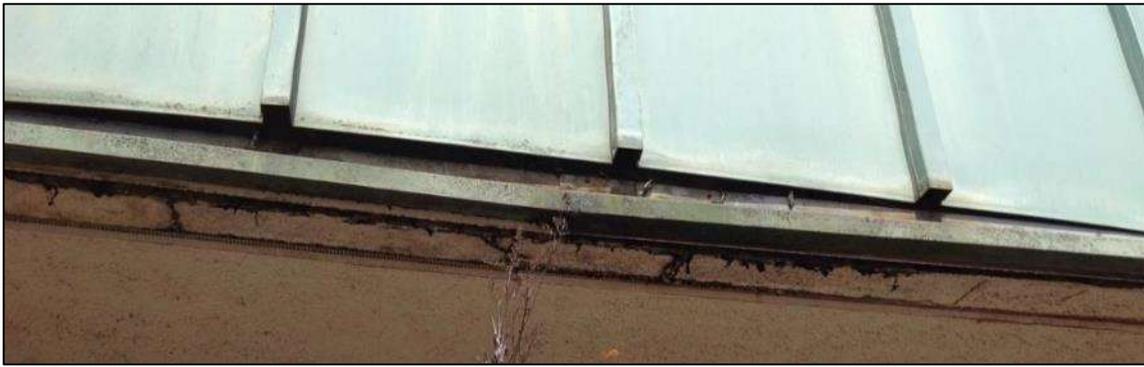
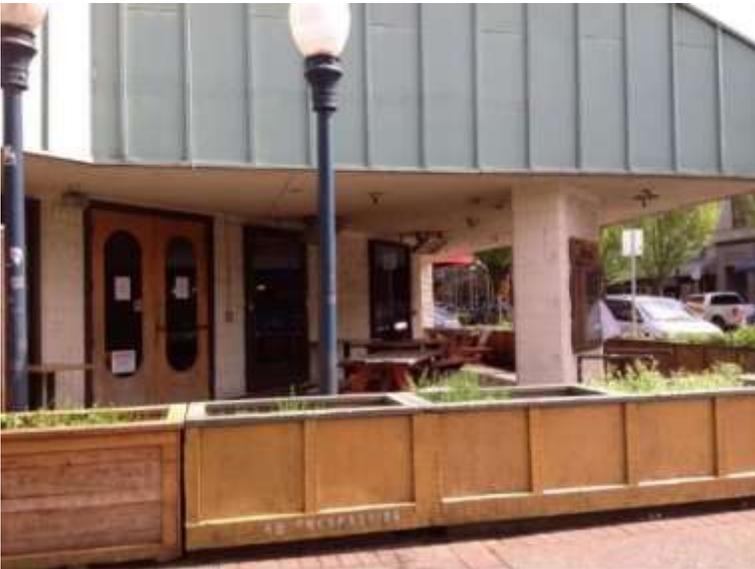
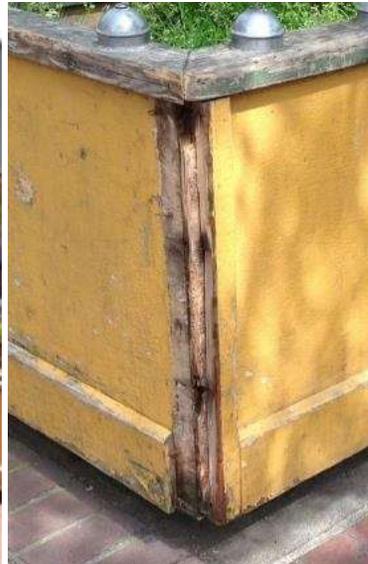
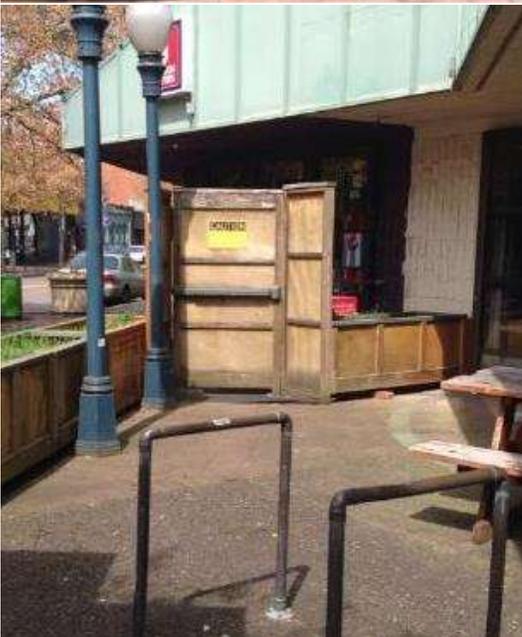
Property #45 images continued.

Photo: Top: image shows building deterioration; middle left: image shows south outside seating area, middle right: shows damage to planter in south outside seating area; bottom: shows exit door for south outside seating area.

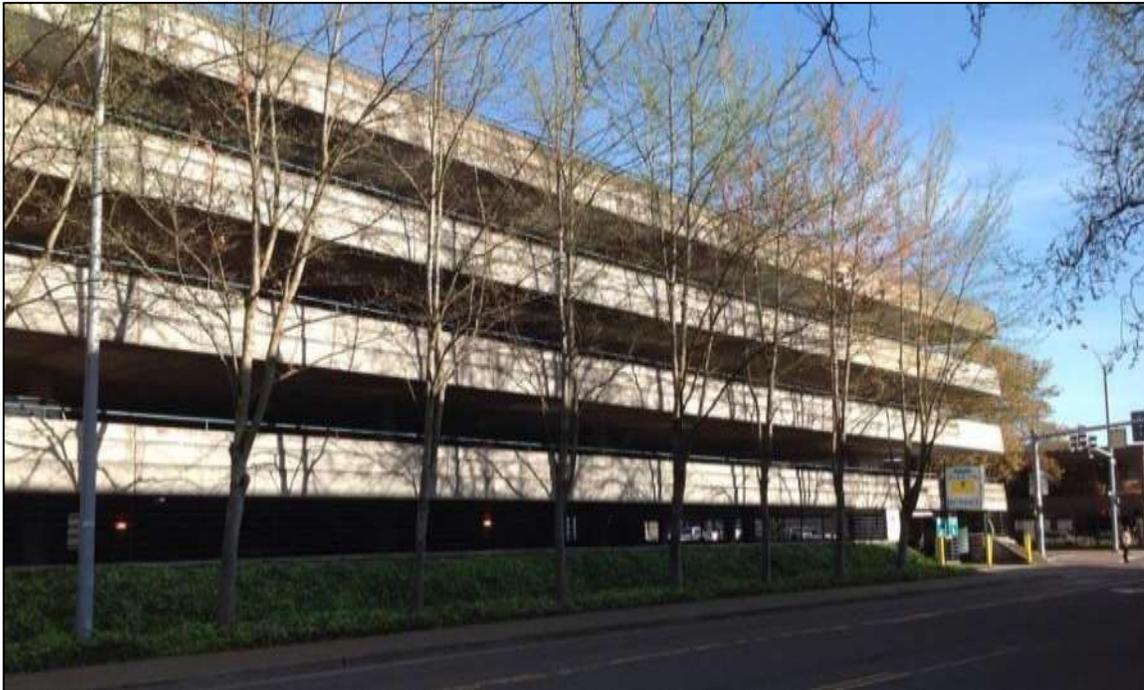
Photo: Top: view of property from Olive Street; middle left: cracks visible on structure; middle right: image shows an example of white material in cracks in structure; bottom: image shows example of window with water damage inside.

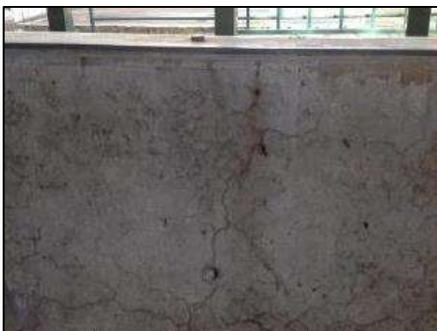
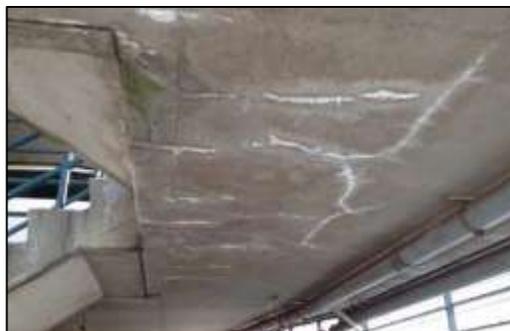
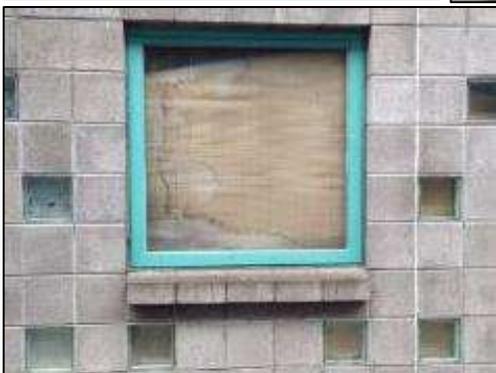
Property Notes: Property is a cement parking garage. The property has visible surface cracks, some that have a white substance coming out of them. There are windows on alley side that have visible water damage inside. Determination of blight based on ORS 457.010(1)(a)(A).

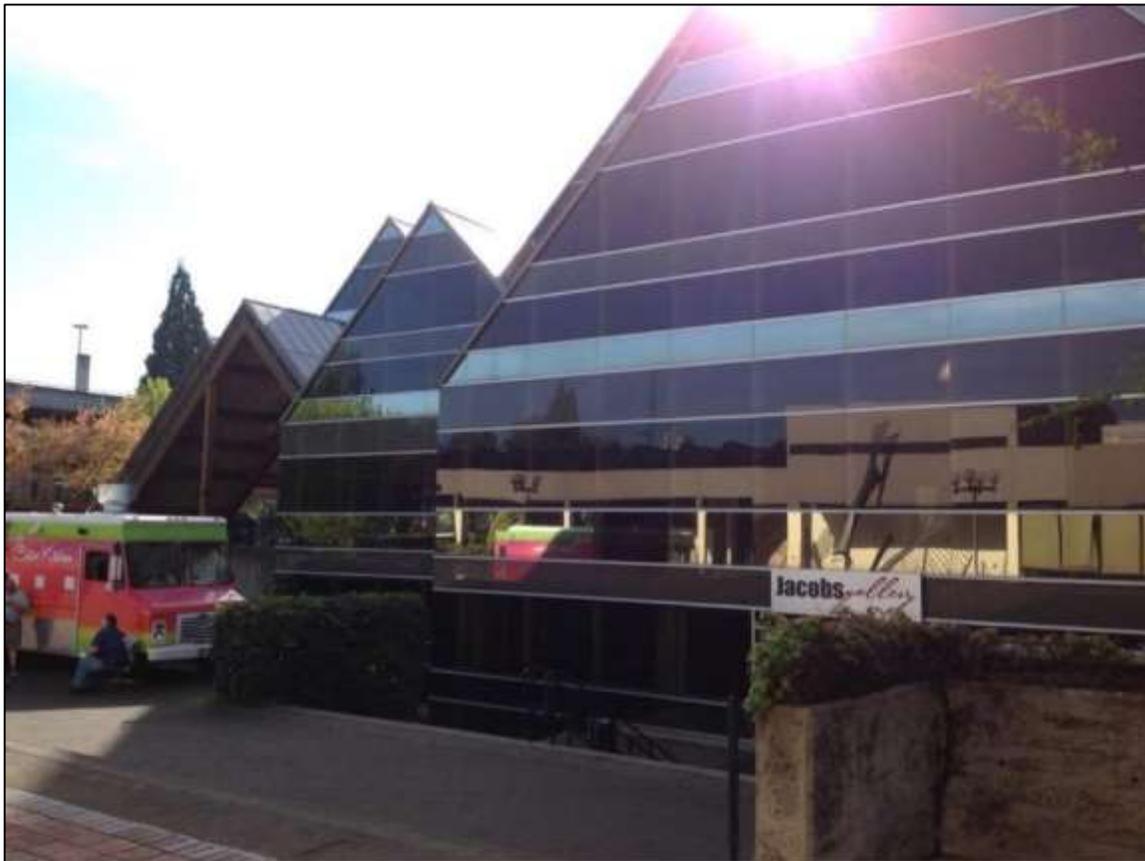
Taxlot(s):	1703311206400	Depreciation Ratio:	11.43
Property Notes:	Property is in fair condition. The property consists of a building, alley and open space. A large portion of the property is underutilized open space and combined with adjacent underutilized open space of conference center these areas are underperforming their potential. Accessibility is low for those with assisted walking devices or wheelchairs, even strollers with steep ramps, bumpy sidewalks. The property has deteriorating features and cracks are visible on building facade. In the building, a large gallery has closed leaving even greater underutilization. The building also has potential seismic stability concerns. Blight determination based on ORS 457.010 (1)(a)(A) and (h).

Photo: View of building from pedestrian pathway between conference center and Hult Center.
