DOWNTOWN URBAN RENEWAL DISTRICT REPORT

REPORT ON THE DOWNTOWN URBAN RENEWAL DISTRICT PLAN

Map to Accompany Downtown Urban Renewal Slums and Blight Report 2016

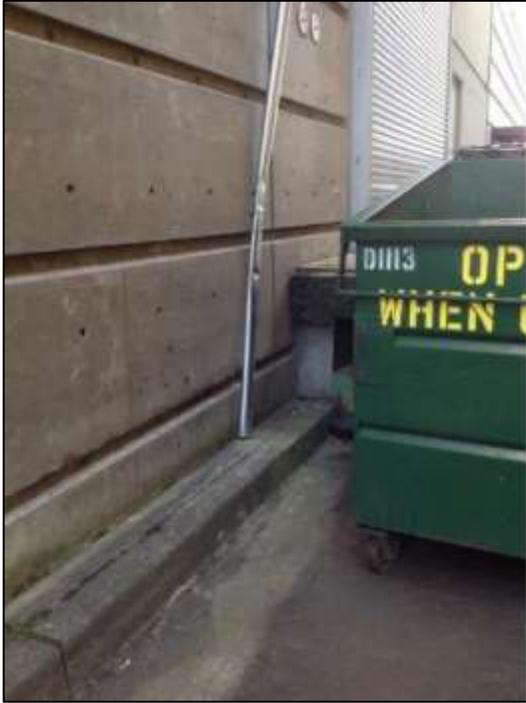
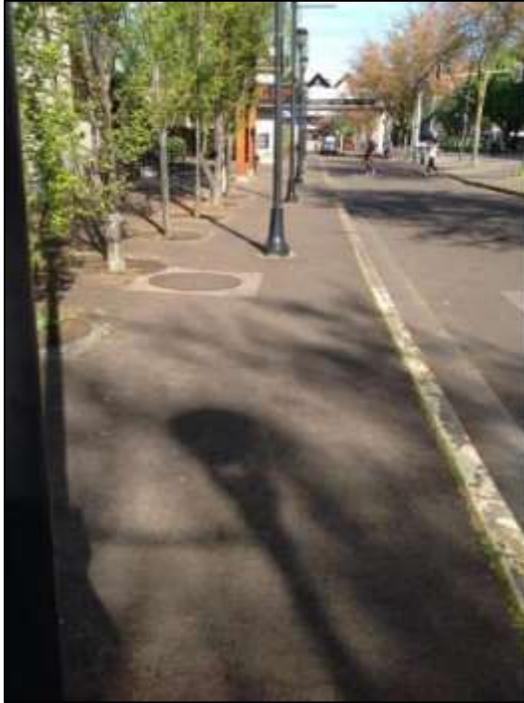
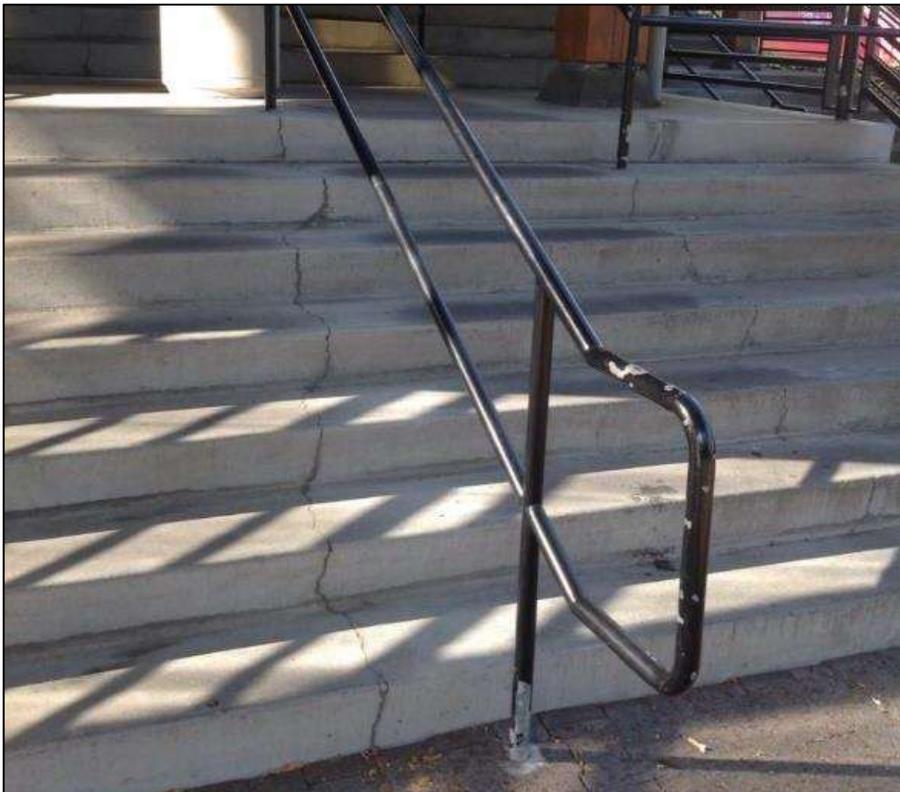
Property #47 Images continued.

Photo: top left: image shows damage to pipe on rear of building; top right: picture shows an example of sidewalk width; bottom: image shows cracks in steps

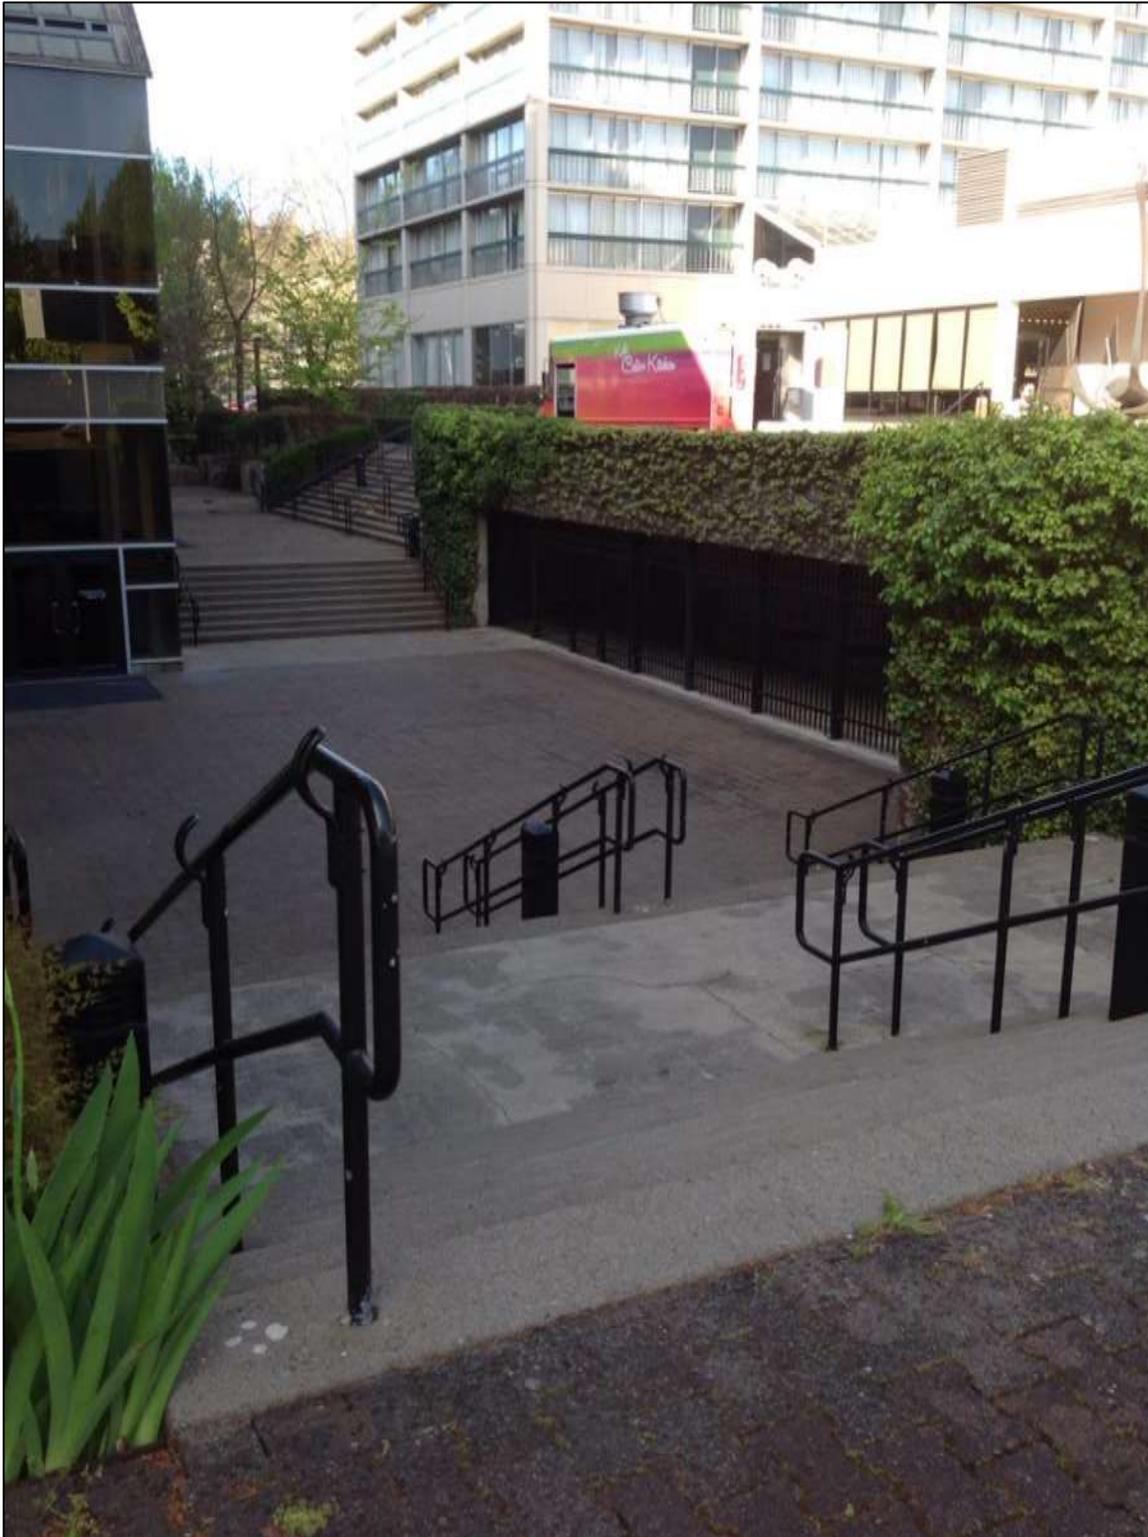
Property #47 Images continued

Photo: Image shows open space area, cracks in pavement in stairs landing, and bricks used to create pathways.

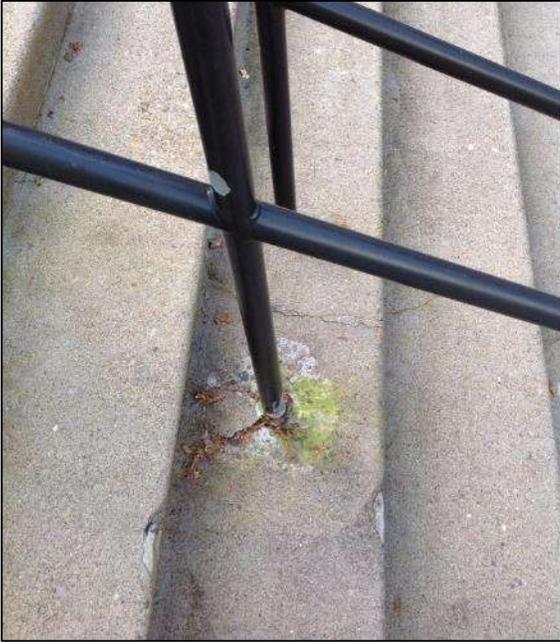
Property #47 images continued.

Photo: Top: image shows deterioration of steps; bottom: image shows cracks in cement of structure

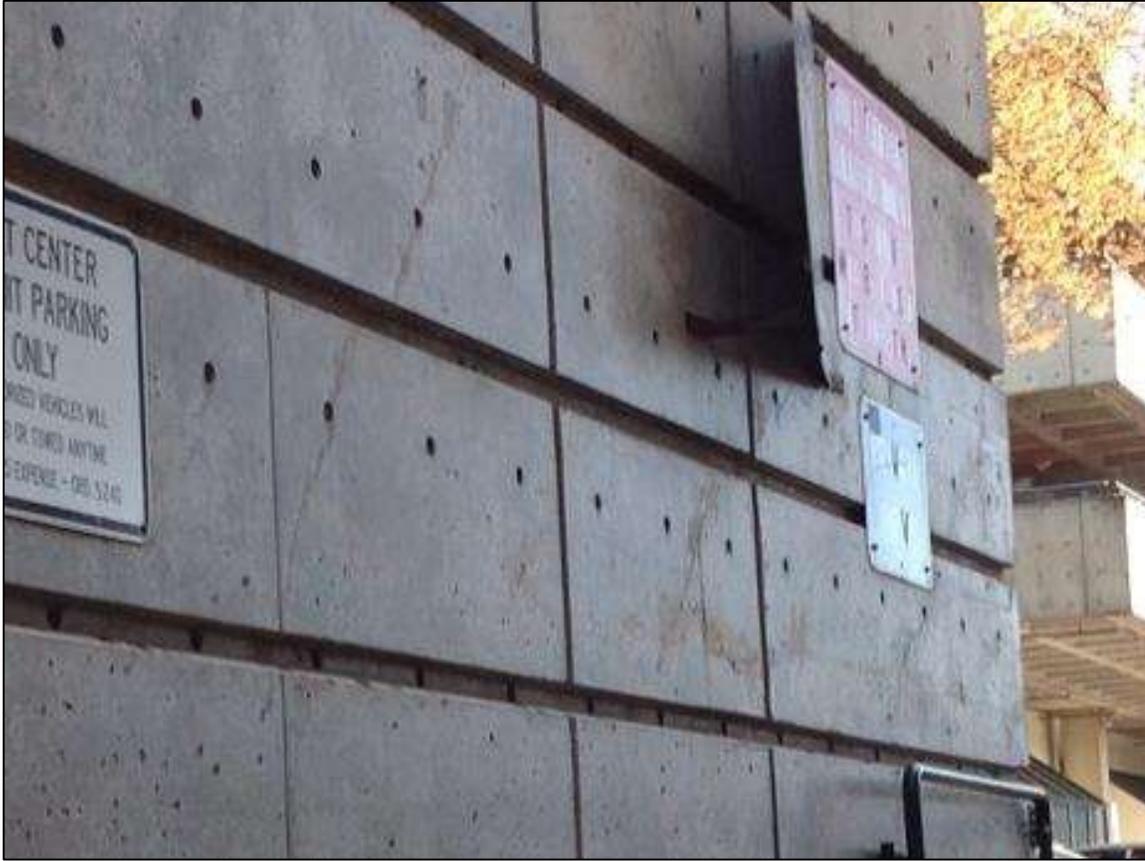
Property #47 images continued.

Photo: Image shows example of cracks along surface (diagonal lines).

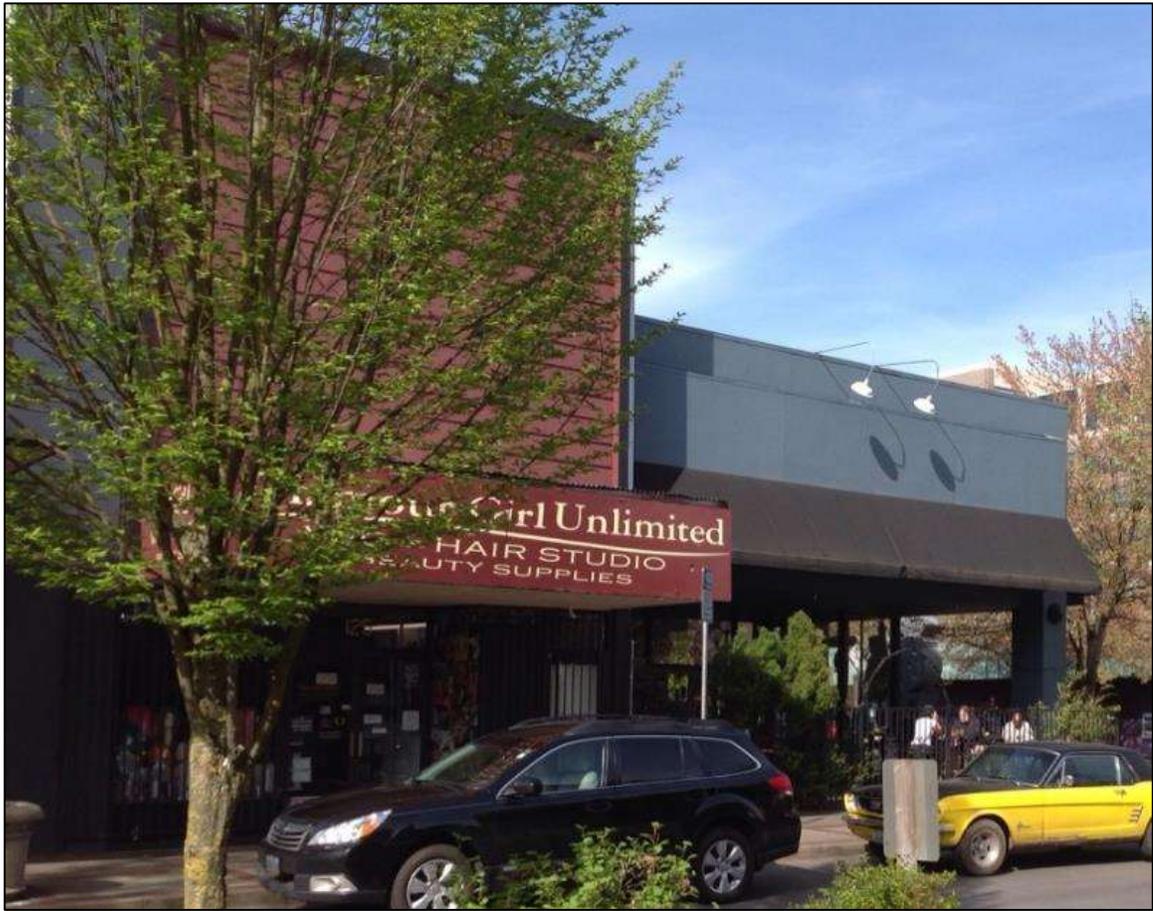
Photo: Top: view of property from Broadway; bottom: image shows damage to awning top.

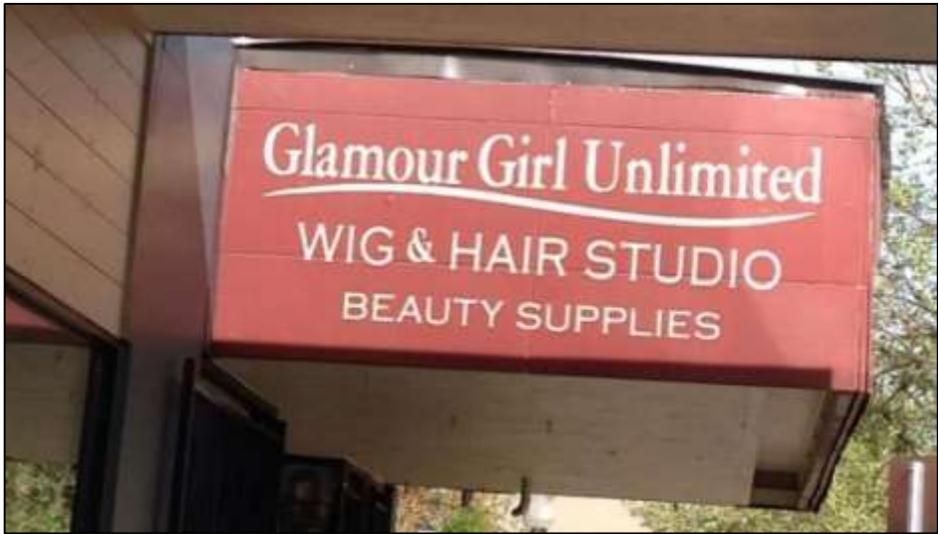
Property: 49	Name: Jamesons and Glamour Girls	Determination of Blight:	Yes
Taxlot(s): 1703311304800		Depreciation Ratio:	1.65
Property Notes:	Building appears in good shape. Awning on Glamour Girls has damage along top section. Determination of blight based on ORS 457.010 (1)(g) and (h)

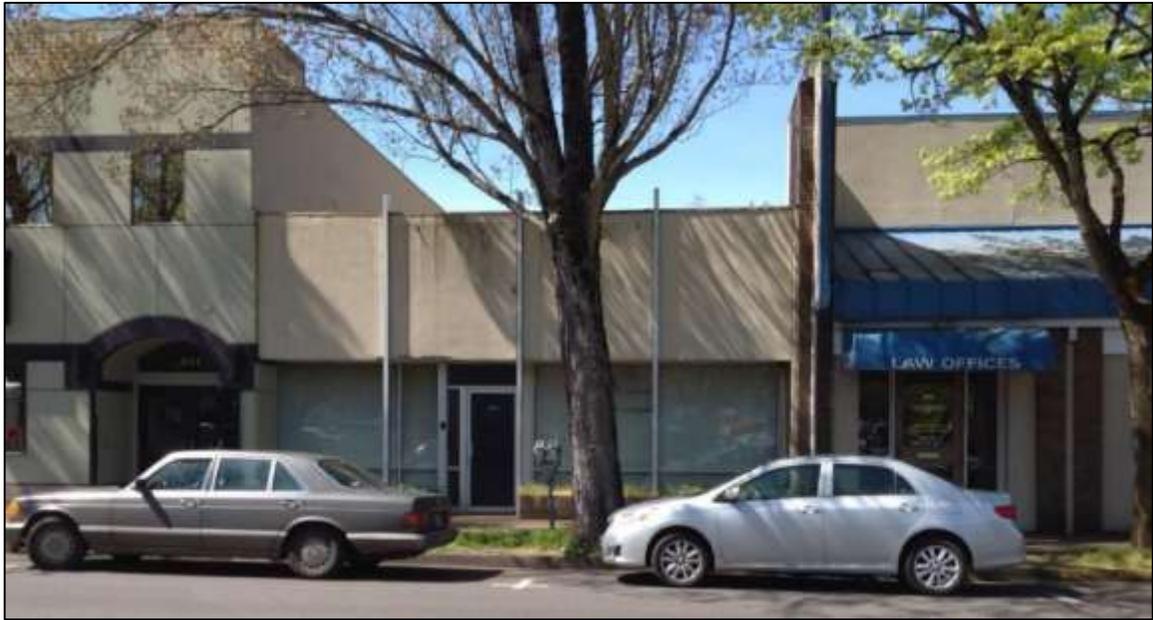
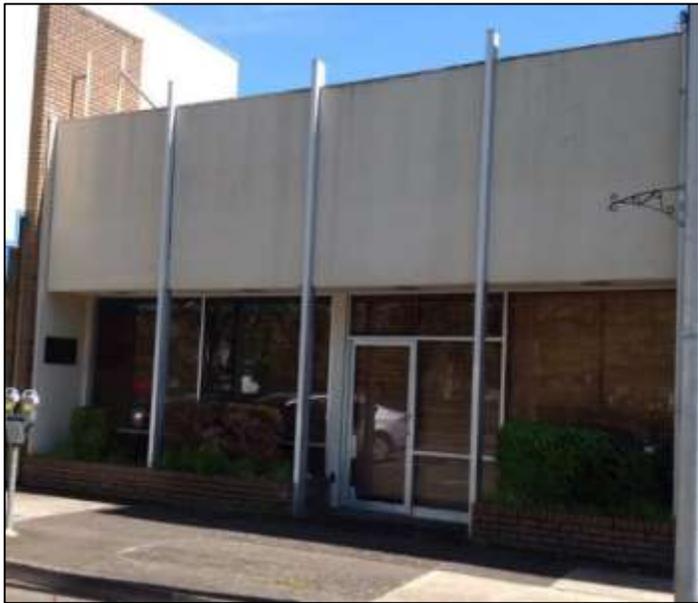
Taxlot(s):	1703311402400	Depreciation Ratio:	3.44
Property Notes:	Building is in poor condition. There is moss growing out of a crack in front, the raised beds made of brick in front and back have garbage, are overgrown, and are damaged. The building is has closed up windows on both. Determination of blight based on ORS 457.010 (1), (g), and (h).

Photo: Top and bottom images shows front and back of building

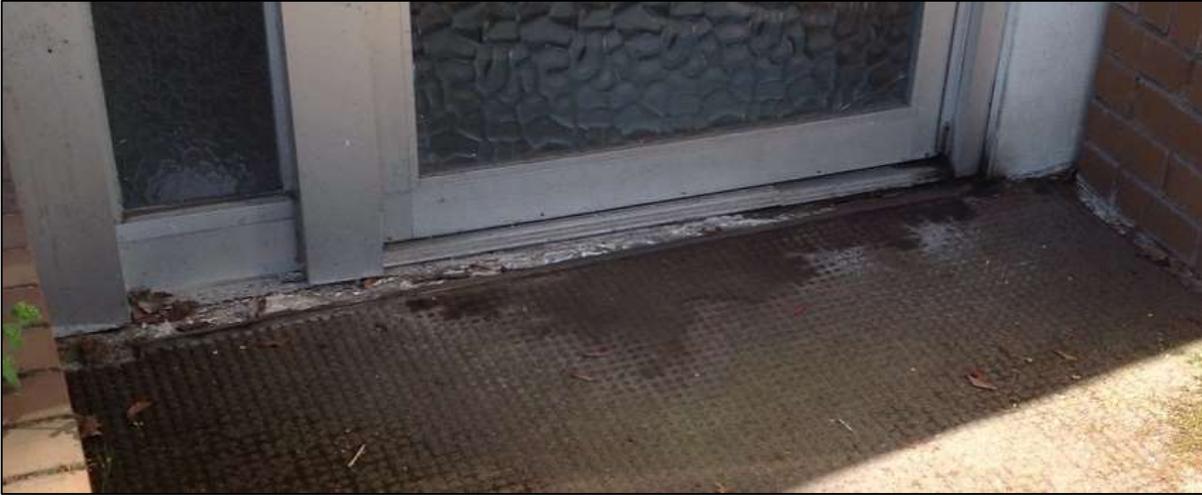
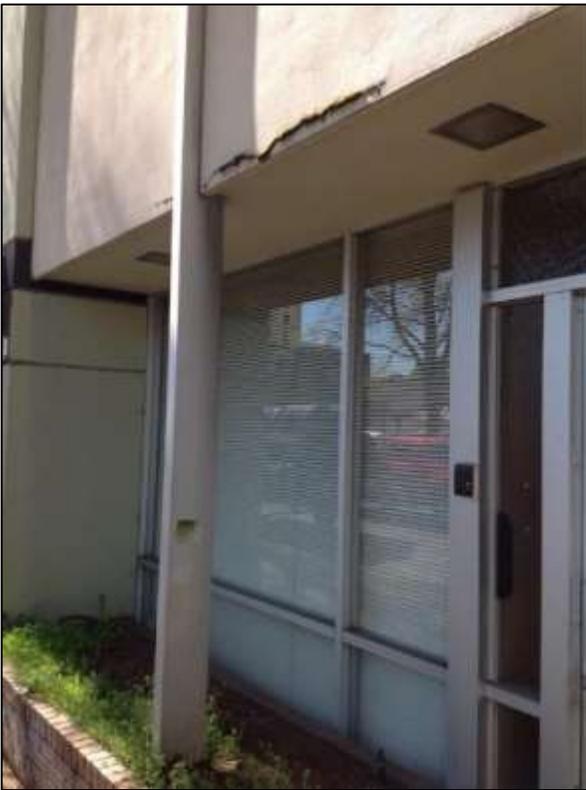
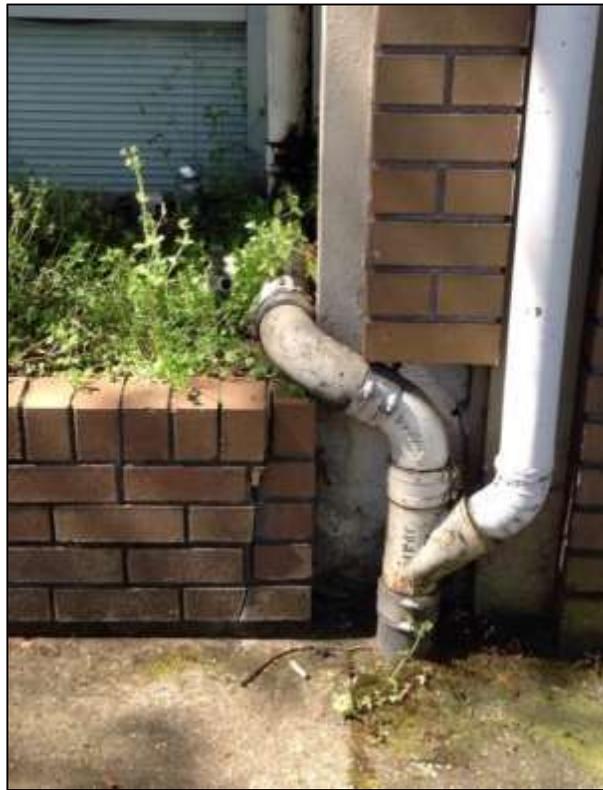
Property #50 images continued.

Photo: Top: damage at door base; bottom left: façade deterioration; bottom right: broken bricks, overgrown vegetation.

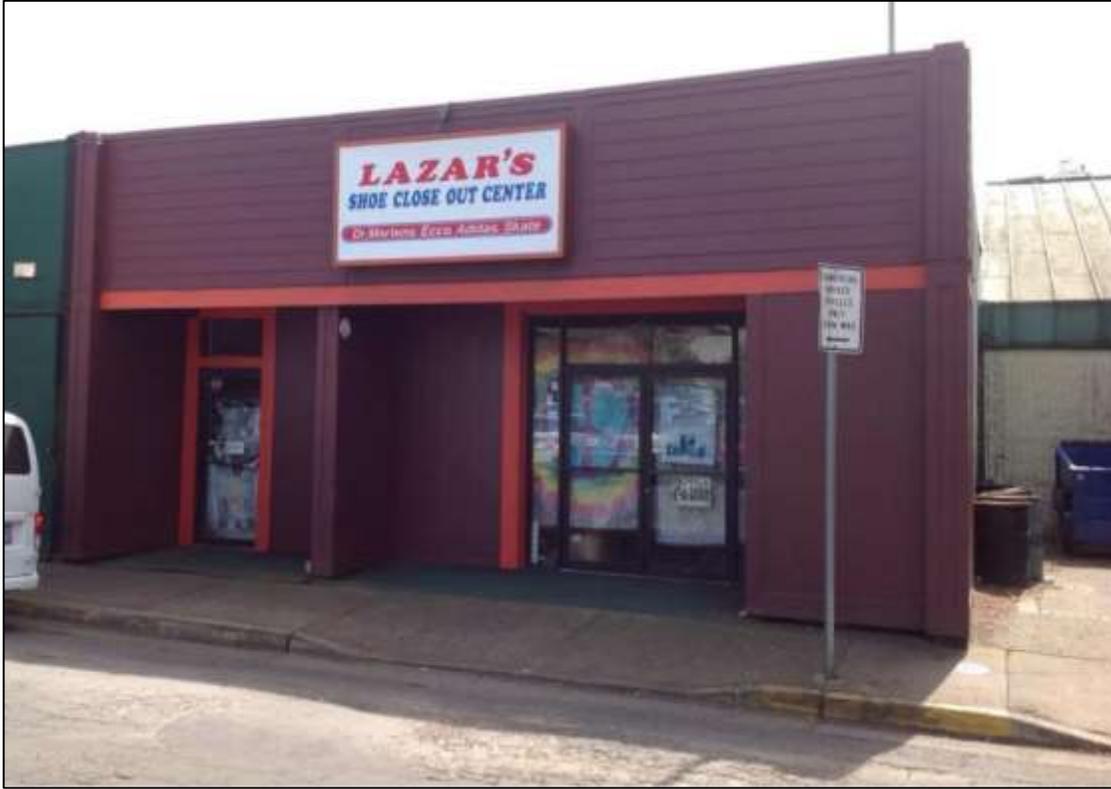
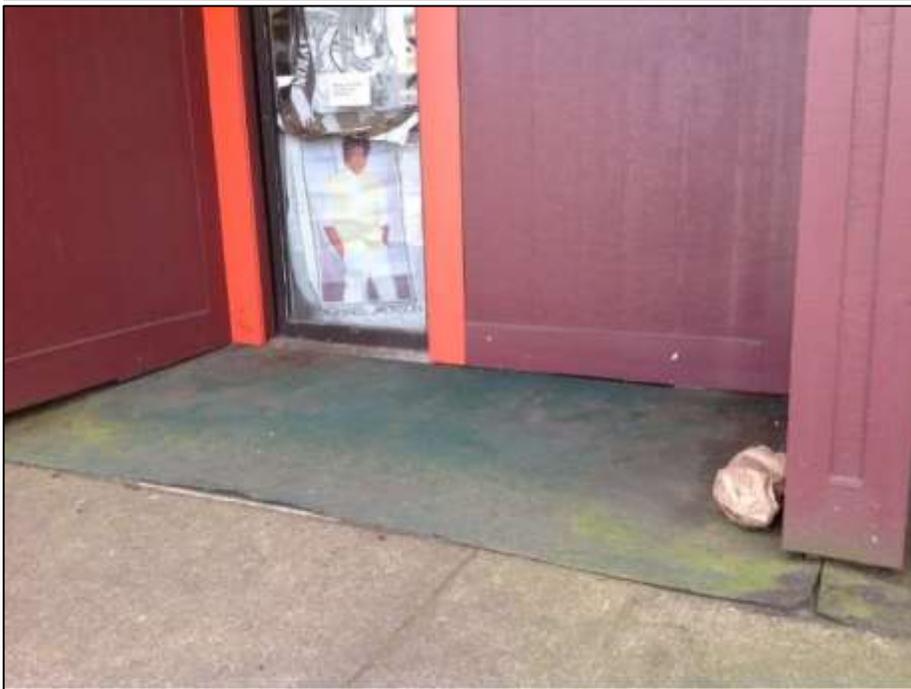
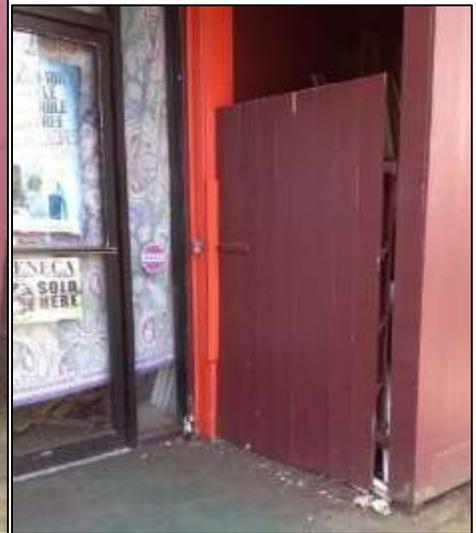
Property #56a images continued.

Property:	56a	Name:	Lazar's Bazaar (Shoe Closeout Center)	Determination of Blight:	Yes
Taxlot(s):	1703311303100			Depreciation Ratio:	2.13
Property Notes:	Building appears in good shape. The ground in front and back are worn. The rear entrance has torn up AstroTurf. Lot shape is very long and thin. Determination of blight based on ORS 457.010 (1)(c),(g), and (h).

Photo: Top image shows back entrance of property; bottom: image shows close-up view of back entrance ground level; bottom right: shows back entrance storage area.

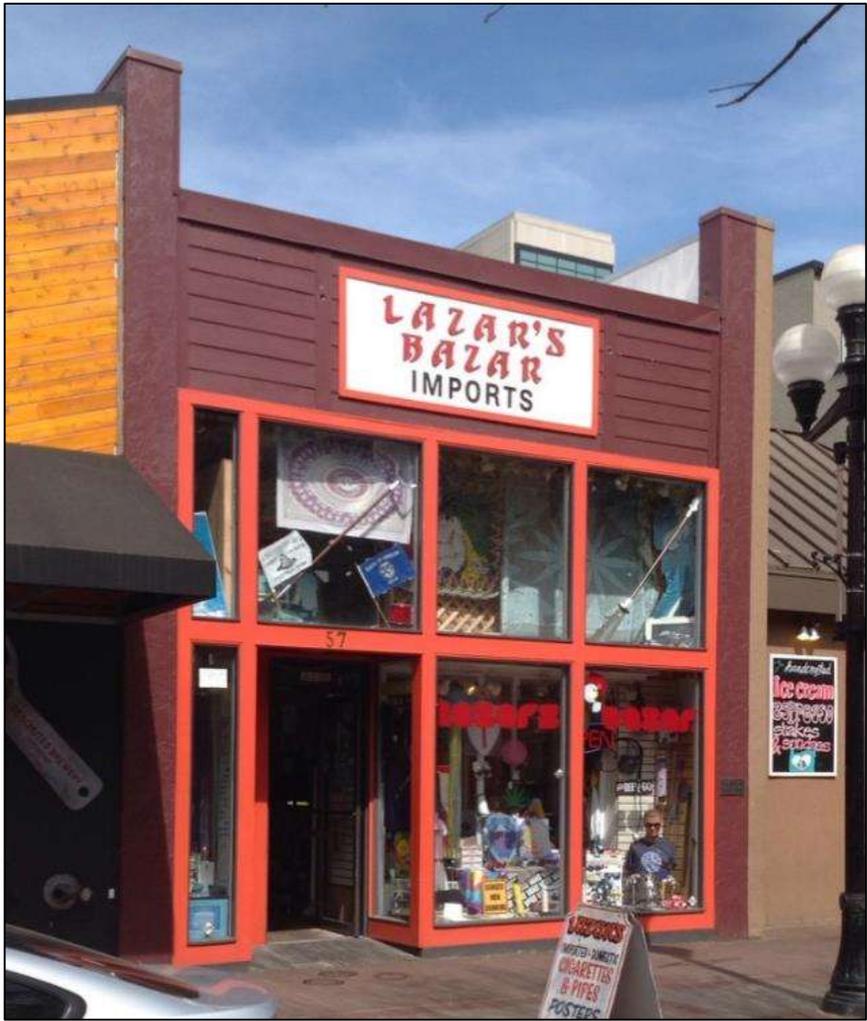
Photo: Top: front of building facing Broadway; bottom: front entrance wear.

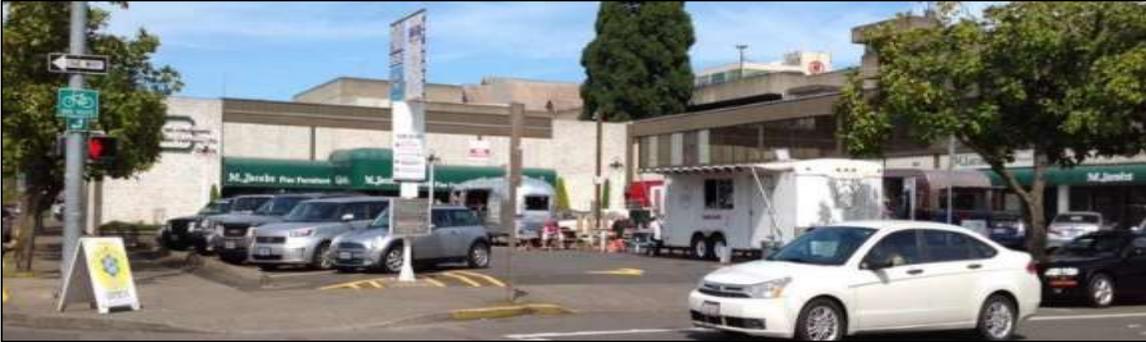
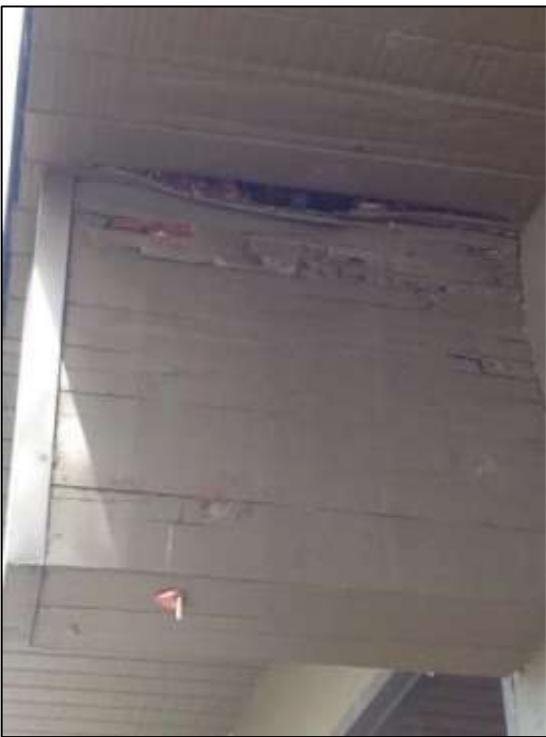
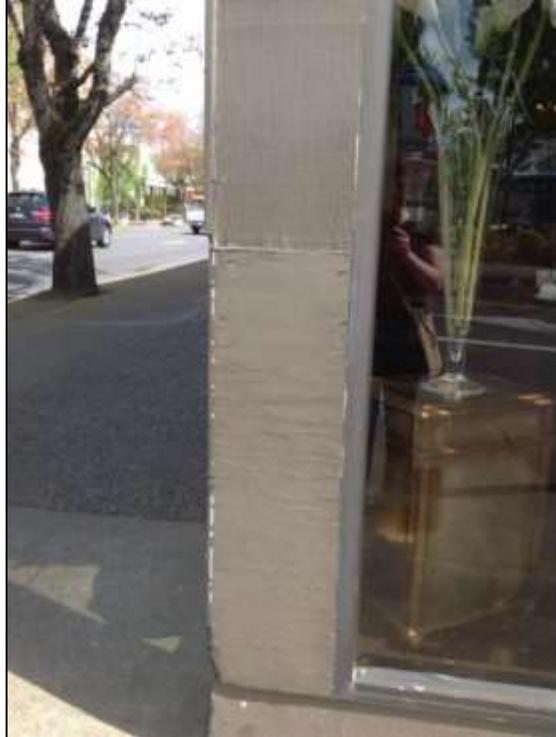
Property Notes: Property is in fair condition. Property consists of a large building and multiple parking lots. The building contains multiple businesses, the north parking lot is a paid parking lot, and the southern lot is general parking and has food carts. The building has fresh paint but shows signs of deterioration, including wood rot on exterior, and a concave sidewalk. Building deterioration also includes the outdoor walkway ceiling panels that are broken and falling out in places, a light with electrical wires showing, and a broken drainpipe on alley. The parking lot is made up of multiple lots with irregular shapes. Lot is used for food carts, sometimes, or is vacant and represents 1/4 block underutilized space. Determination of blight based on ORS 457.010 (1)(a)(A), (c),(g), and (h).

Photo: Top: View of property from East 8th Avenue and Olive Street; bottom images show damaged wood on structure.

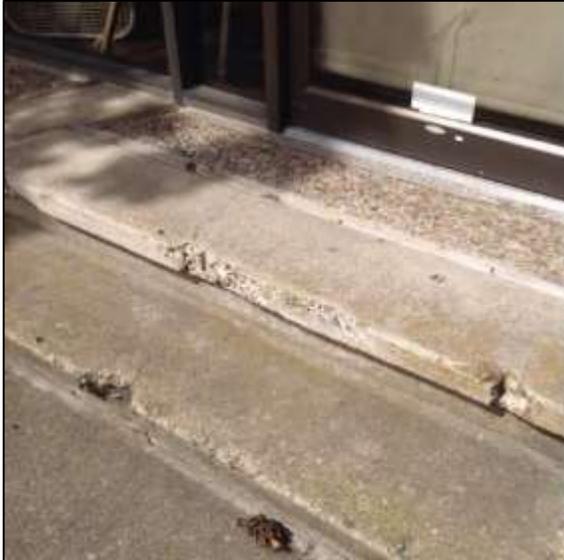
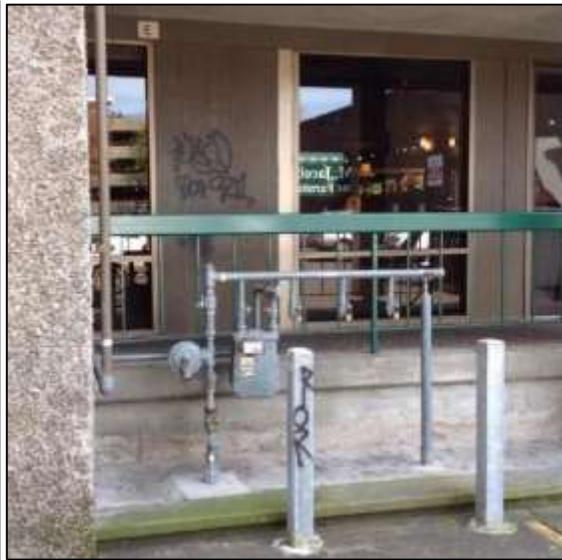
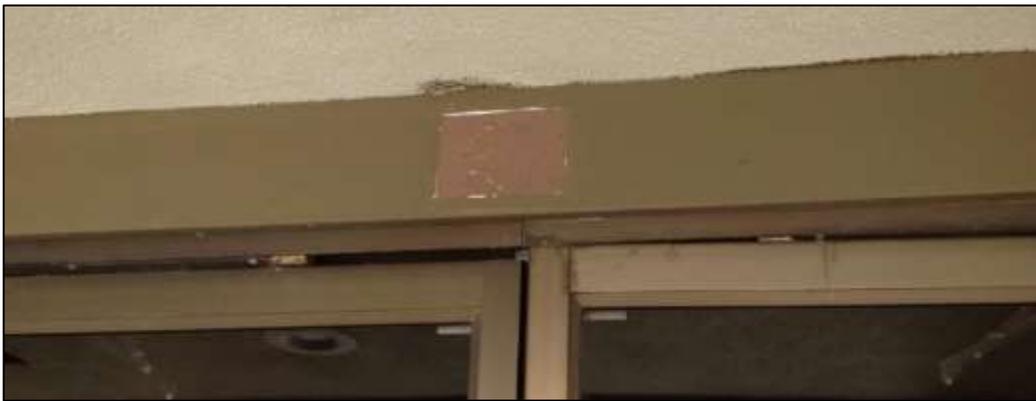
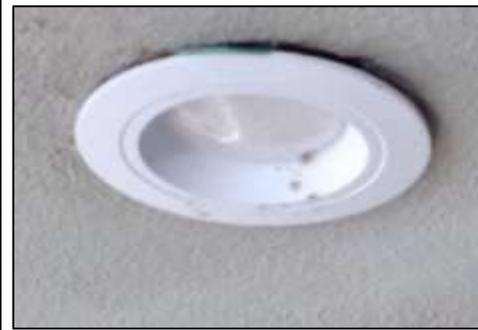
Property #60 images continued.

Photo: Top left: example of deteriorated cement; top right: property damage; middle: top of exterior door that is mis-aligned with structure; bottom left: entrance with concave entryway; bottom right: outside light fixture with wires exposed.

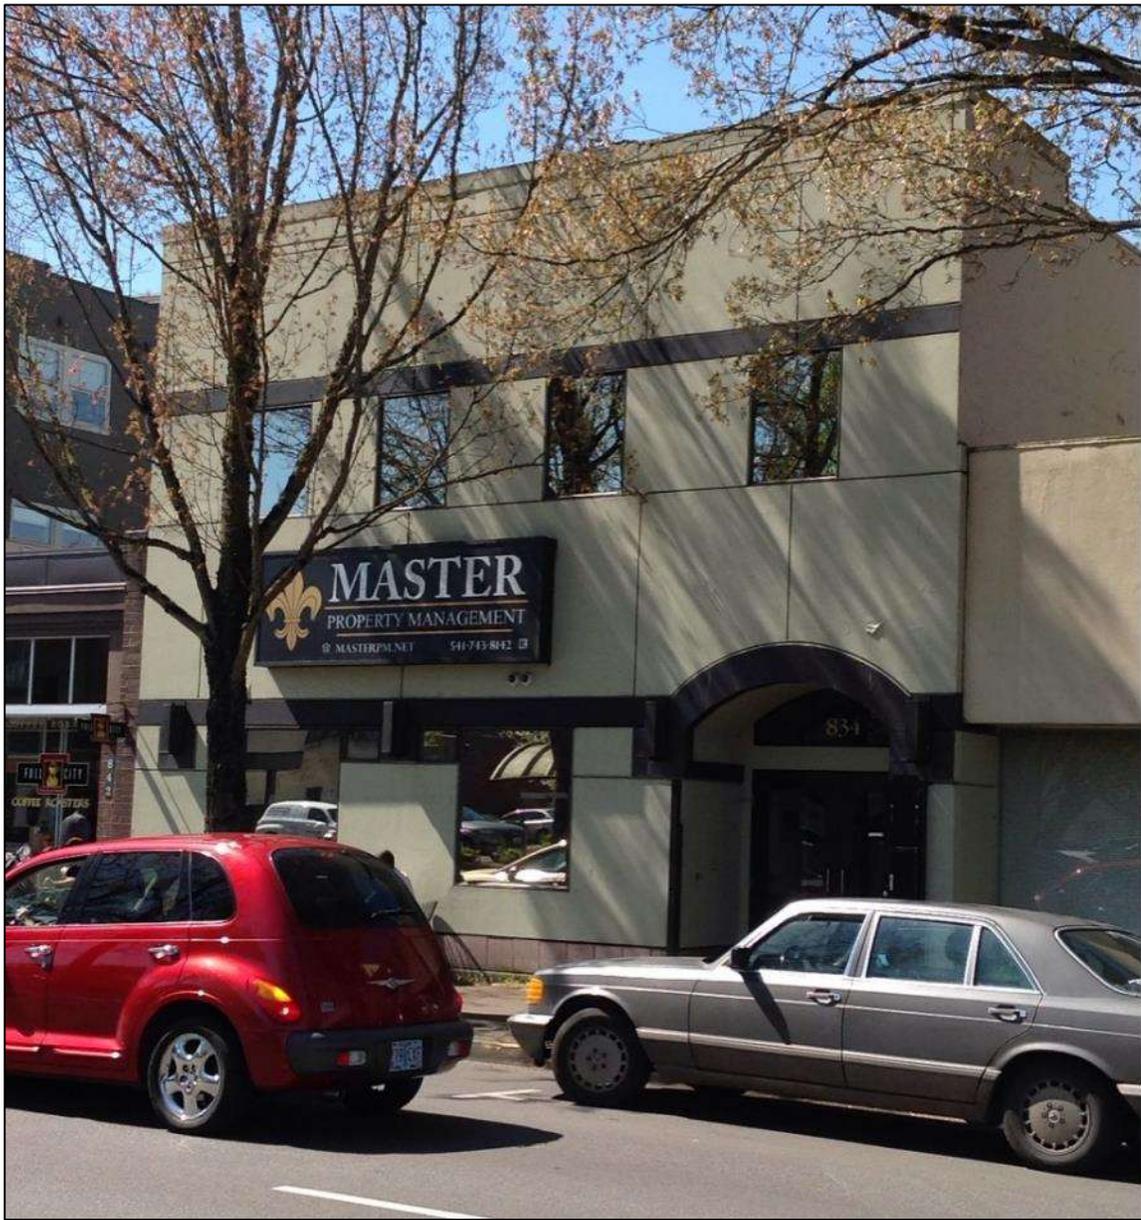
Property: 61	Name: Masters Development	Determination of Blight: No
--------------	---------------------------	-----------------------------

Taxlot(s): 1703311402500	Depreciation Ratio: 6.15
Property Notes: Building appears in good condition.

Photo: View of property from Pearl Street.

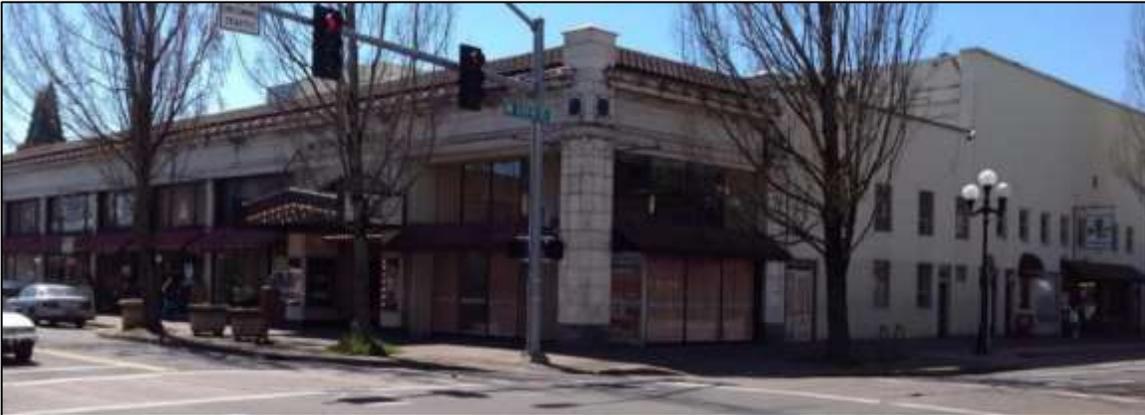
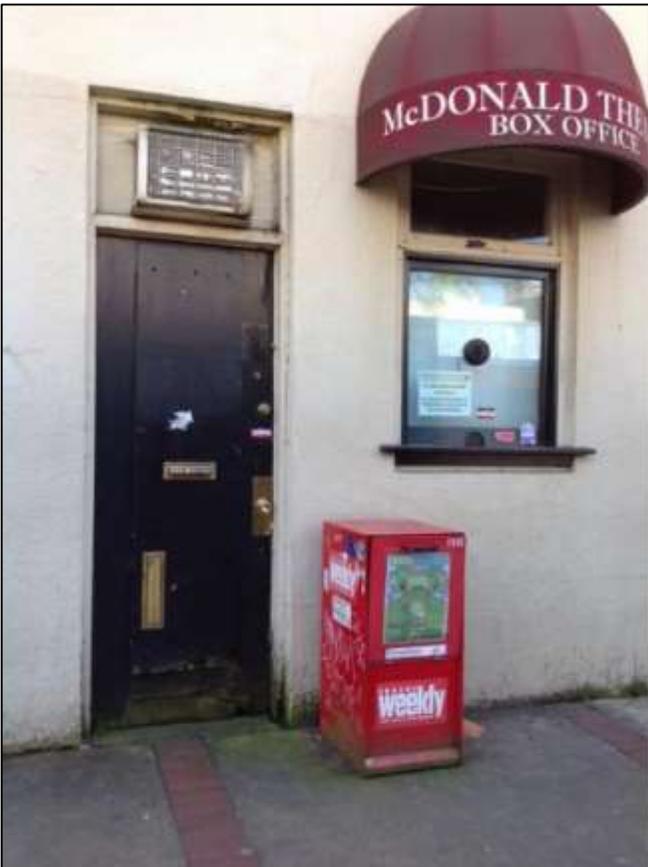
Property: 62	Name: McDonald Theater building	Determination of Blight: Yes
Taxlot(s): 1703311301900		Depreciation Ratio: 1.34
Property Notes:	Property is in fair condition. Property contains a large building that holds not only the Theater, but also a restaurant and several shops, there are also some vacant storefronts with windows covered. The building has cracks along surface on West 10th Avenue. This section also has rot visible in a door, is of poor quality, and mildew/moss is on building edge and a drainage pipe has no connection to drain. Determination of blight based on ORS 457.010 (1)(a)(E) and (g).

Photo: Top: View of property from West 10th Avenue and Willamette Street; bottom: shows example of damage on building, especially where the door meets the sidewalk

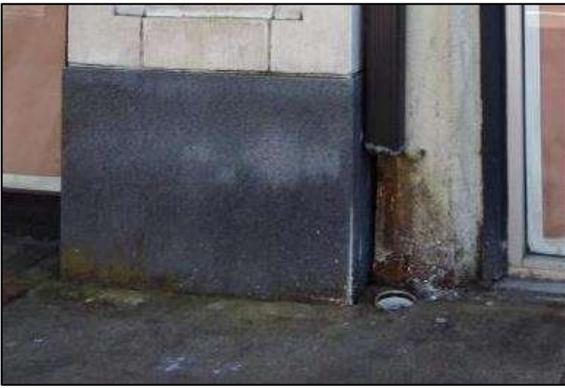
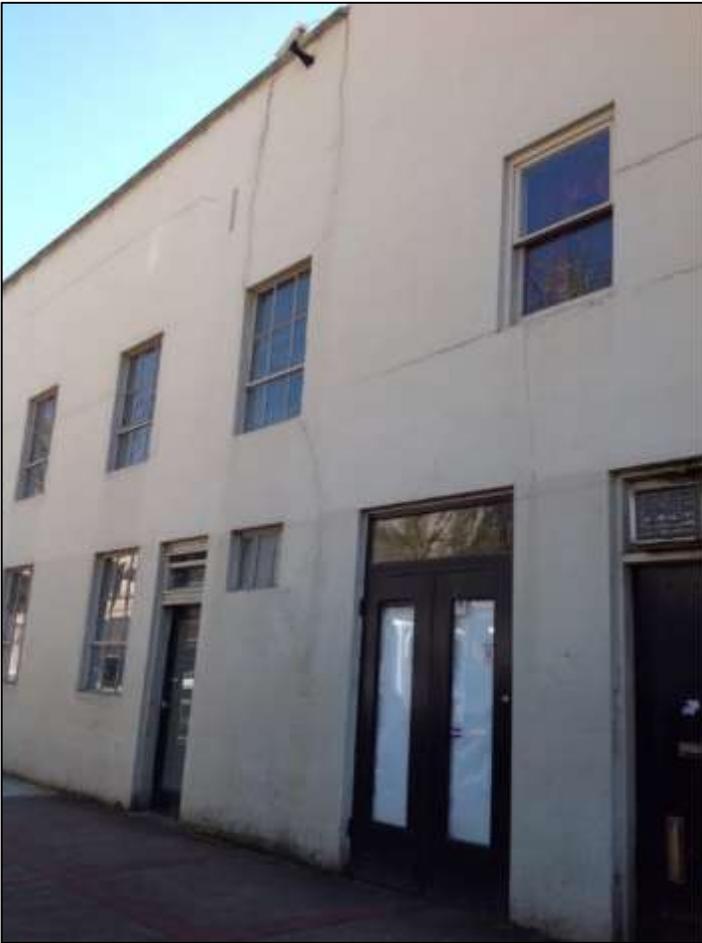
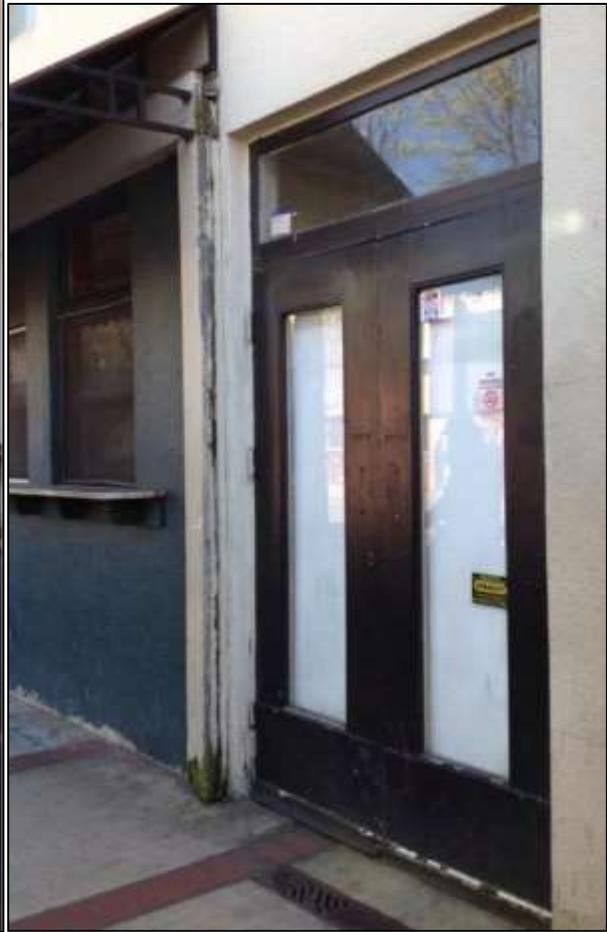
Property #62 images continued.

Photo: Top: image shows where drainpipe does not meet drainage; bottom left: shows cracks in building surface; bottom right: shows damage and deterioration in building.

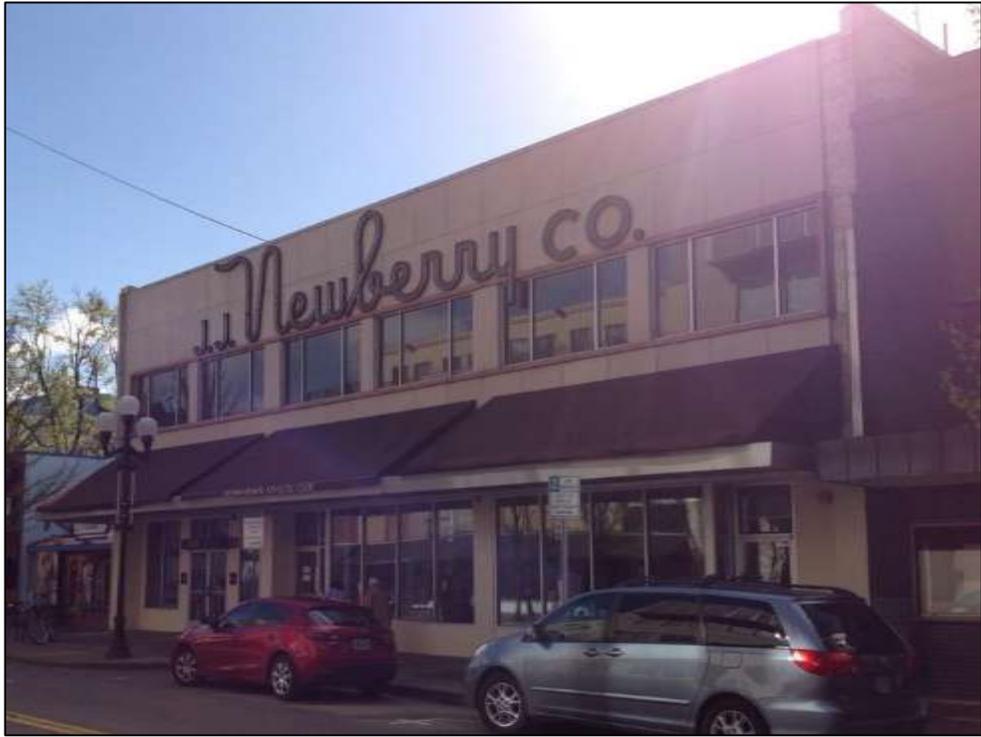
Property: 63	Name: Newberry's	Determination of Blight:	Yes
Taxlot(s): 1703311301700		Depreciation Ratio:	2.25
Property Notes:	Building appears in good condition. Building is in good shape at ground floor, and upper levels seem to have more wear around windows. Determination of blight based on ORS 457.010 (1)(g).

Photo: View of property from Willamette Street.

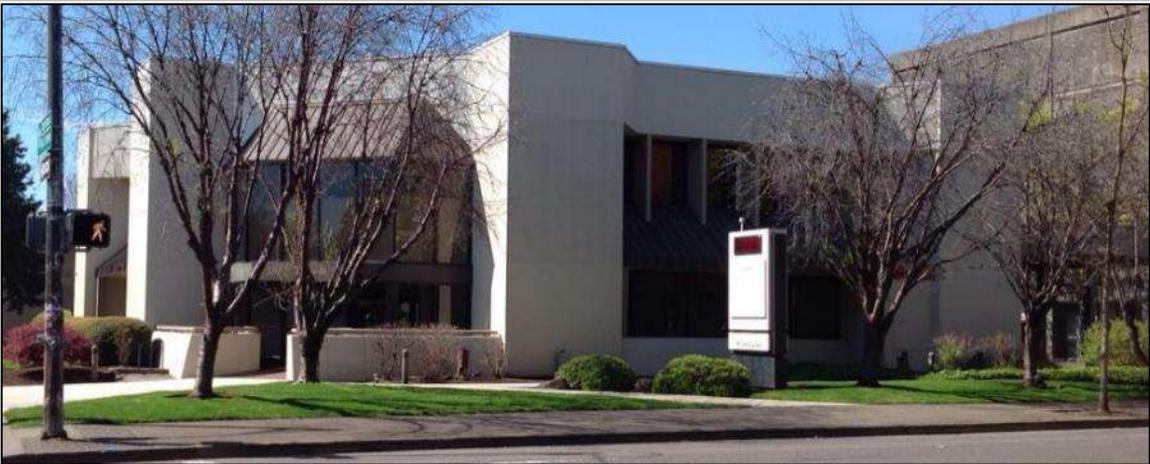
Property: 64	Name: Office Building (Vacant)	Determination of Blight:	Yes
Taxlot(s): 1703311412100		Depreciation Ratio:	1.06
Property Notes:	Building is in good condition. The building is currently vacant. The property is mostly parking. Parking is reserved during the day in parking lot. Determination of blight based on ORS 457.010 (1)(g) and (h).

Photo: View of property from East 11th Avenue and Oak Street.

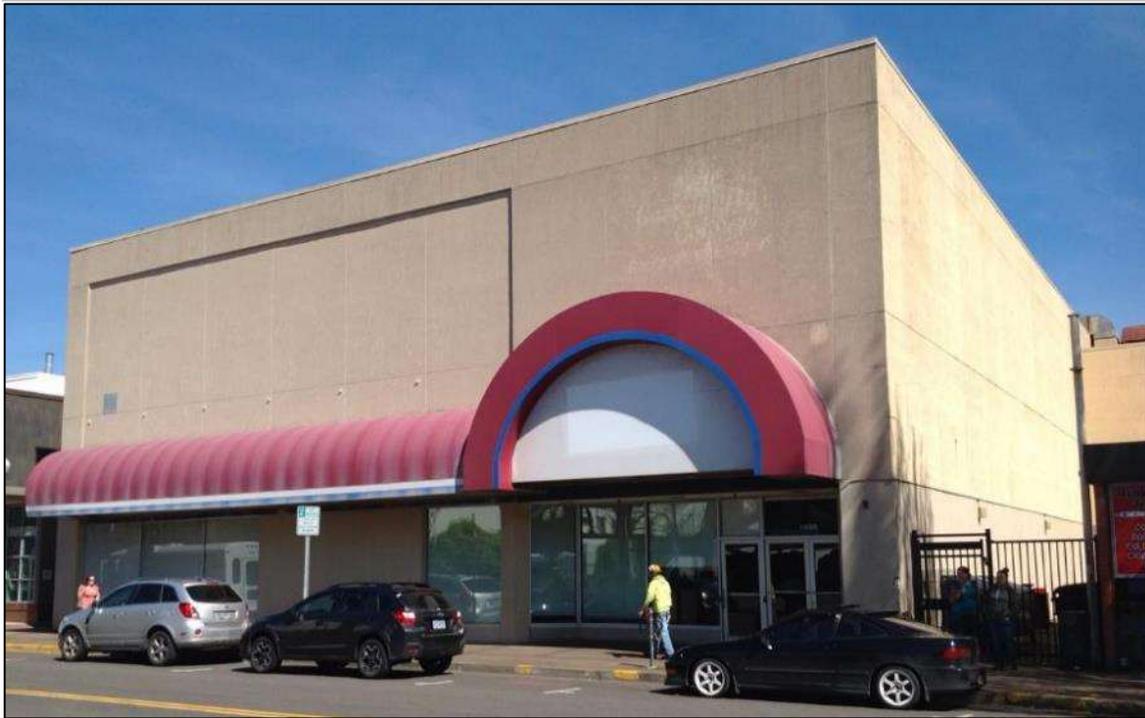
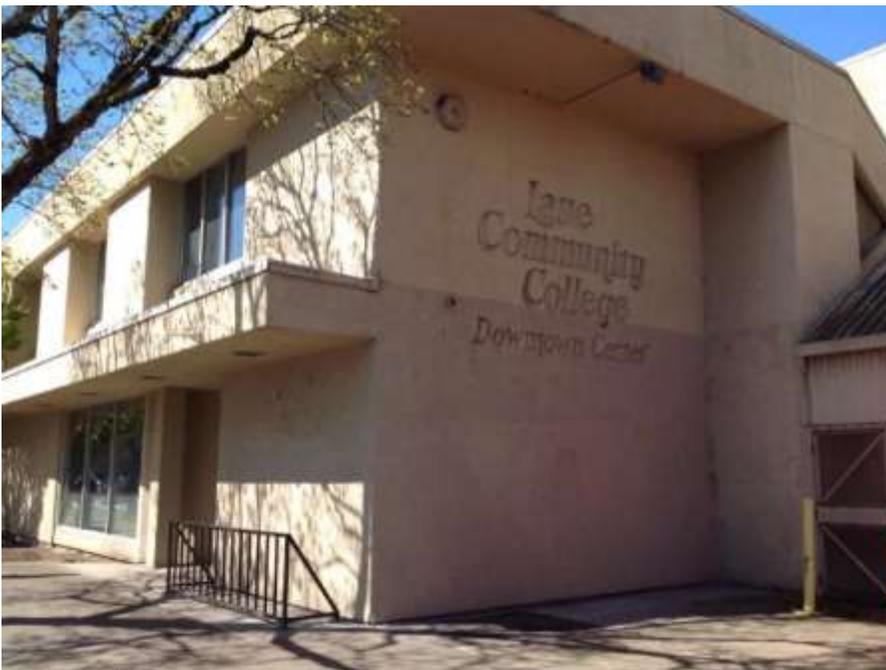
Taxlot(s):	1703311412800	Depreciation Ratio:	6.54
Property Notes:	Property is in fair condition. Property consists mainly of the building, which is large, vacant, and lacks windows.. Determination of blight based on ORS 457.010 (1)(a)(E), (b), (h), and (i).

Photo: Top: view of property from Willamette Street; bottom: view of property from East 11th Avenue.
