DOWNTOWN URBAN RENEWAL DISTRICT REPORT

REPORT ON THE DOWNTOWN URBAN RENEWAL DISTRICT PLAN

Map to Accompany Downtown Urban Renewal Slums and Blight Report 2016

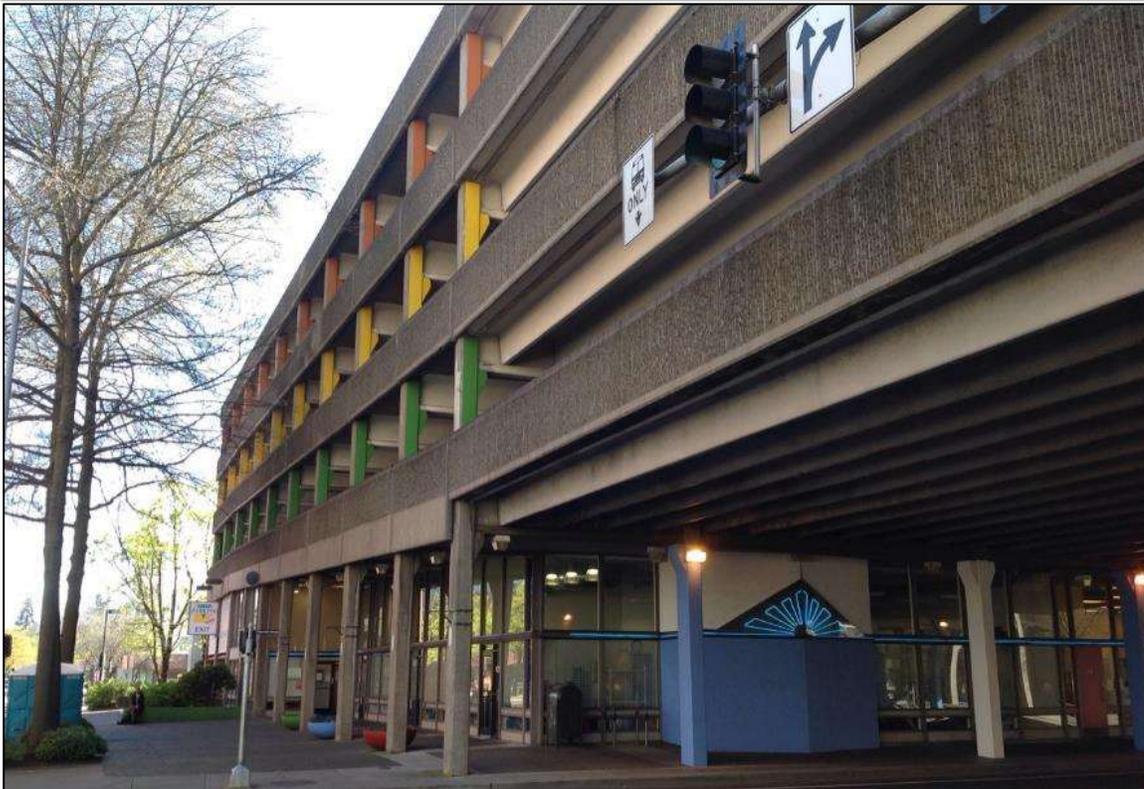
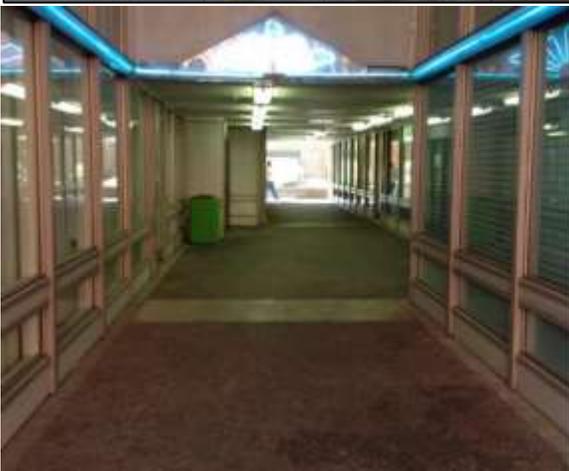
Property Notes: Property is in good condition. This is a cement parking garage with ground floor commercial, including a dance studio and gym. Property contain oversized pedestrian walkways that are underutilized space. Determination of blight based on ORS 457.010 (1)(h).

Photo: Top: View of property from East 10th Avenue; bottom: example of oversize pedestrian walkways and underutilization of space.

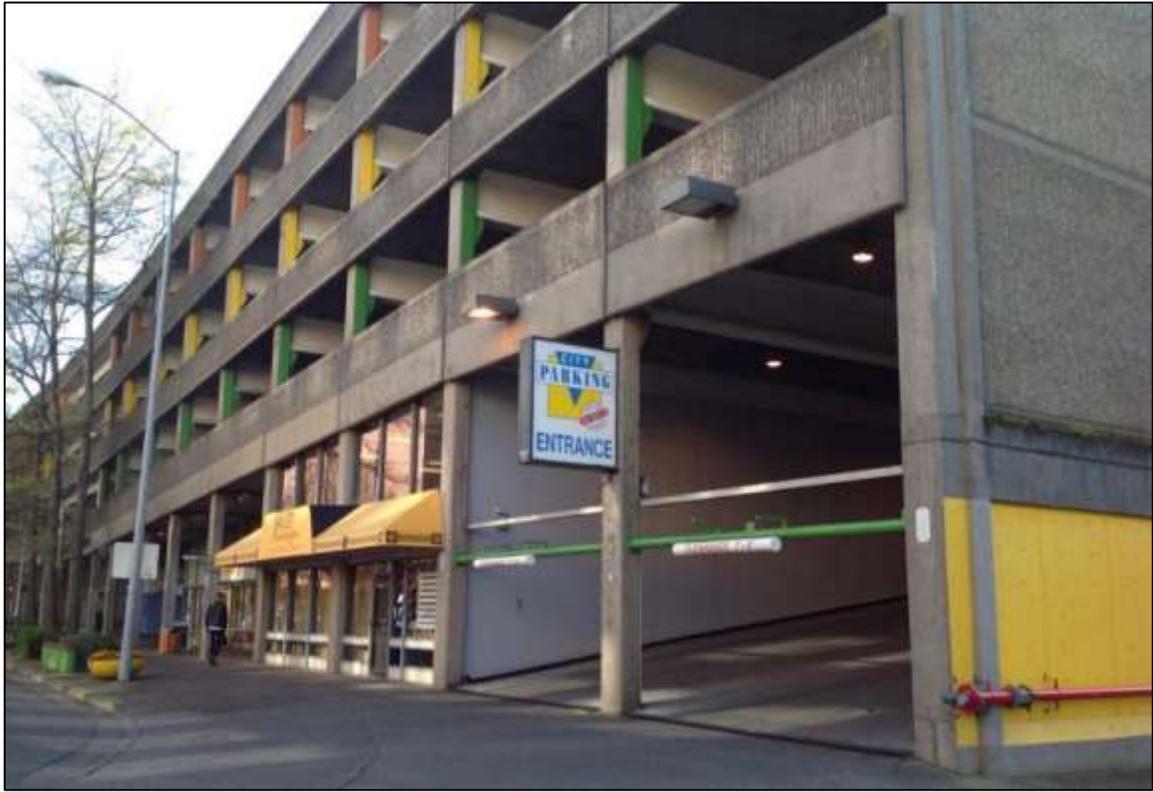
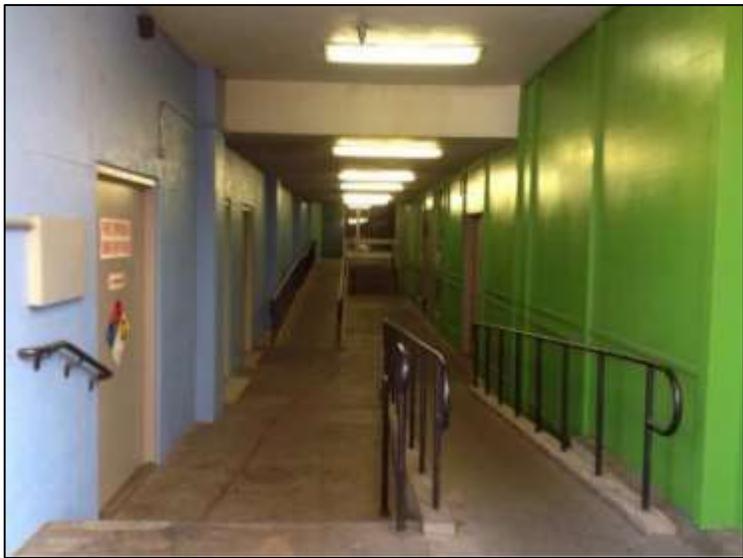
Property: 67	Name: Overpark Garage North	Determination of Blight:	Yes
Taxlot(s): 1703311405800		Depreciation Ratio:	4.42
Property Notes:	The property is in good shape. Property is a cement parking garage that extends over East 10 th Avenue, connecting with Property 66. This property has ground floor commercial. The building has underutilized and poorly designed spaces that were formerly public restrooms and open space in pedestrian pathways. Determination of blight based on ORS 457.010 (1)(a)(E), (b), (h) and (i).

Photo: Top: view of property from Oak Street; bottom: area with closed restrooms and example pedestrian walkways.

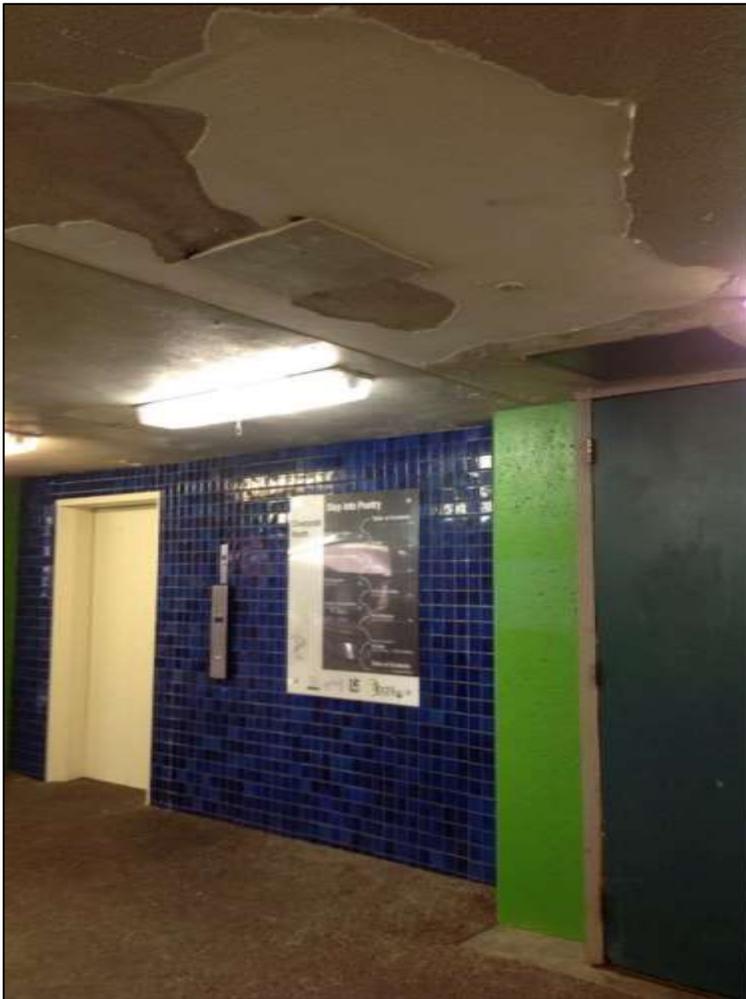
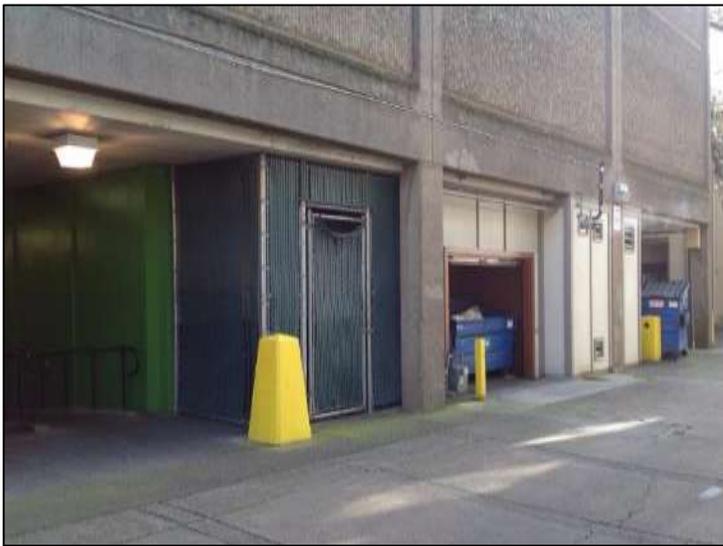
Property #62 images continued.

Photo: Top: example of building condition in interior pathways; bottom: view of alley and area of access to pedestrian walkway to restroom.

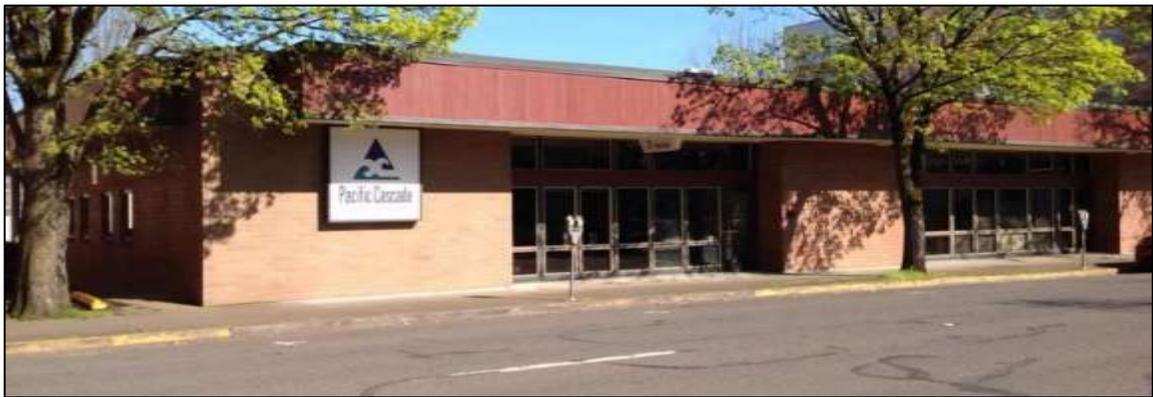
Property Notes:	Property is in good condition. The building is single story with large area of parking. Determination of blight based on ORS 457.010 (1)(g), and (h).
------------------------	---

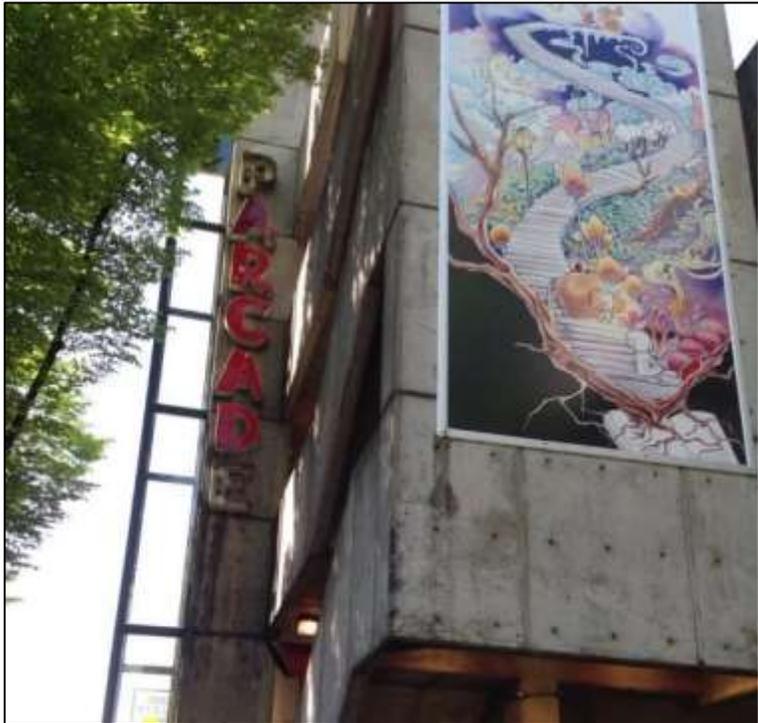
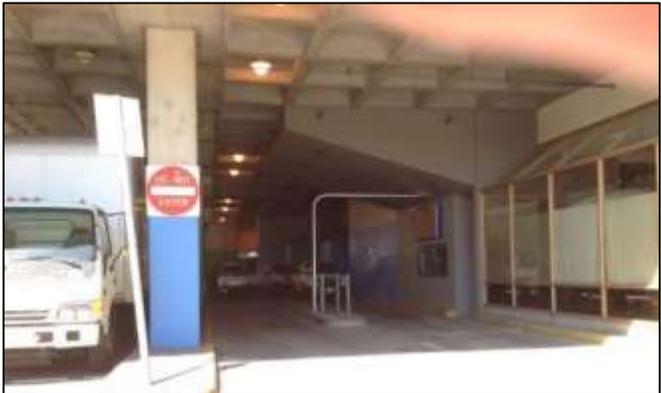
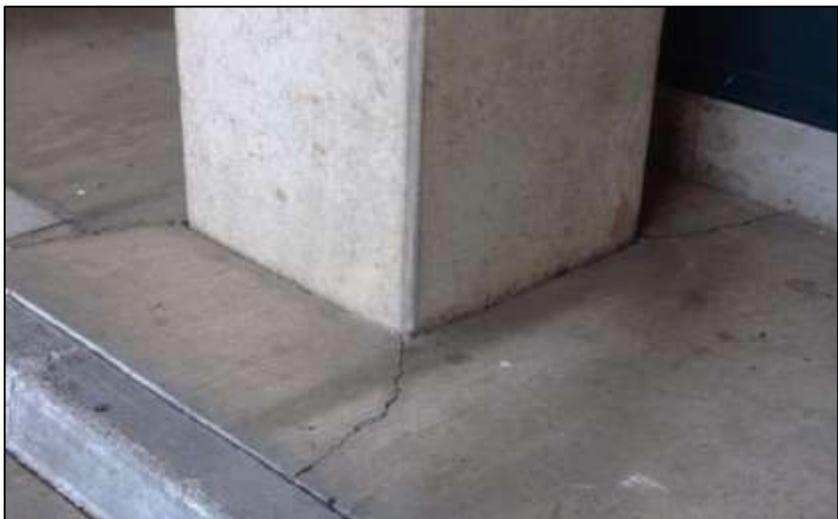
Property: 70	Name: Parcade	Determination of Blight:	Yes
Taxlot(s): 1703311216801		Depreciation Ratio:	2.58
Property Notes:	Property is in fair condition. Property is a large, older parking garage with ground floor commercial. The garage building appears deteriorated with broken signs, wood areas at street level are broken and look damaged, there are large cracks at the base of the large cement pillars, and the garage surface has areas with deterioration and wear. The sidewalk space near the bars small. The property has a large interior open space that is underutilized. Determination of blight based on ORS 457.010 (1)(a)(A) and (g).

Photo: Top left: image shows broken sign; top right: large open space; bottom: image shows cracks at base of pillar.

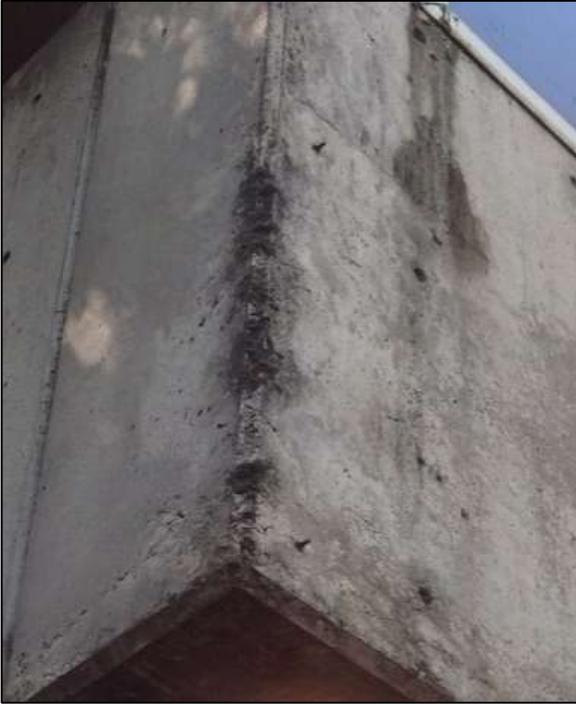
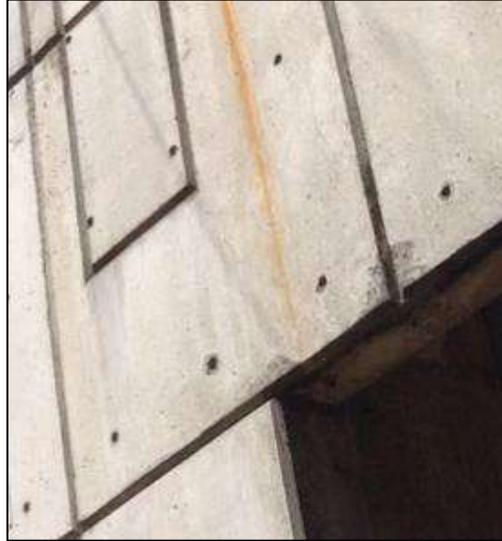
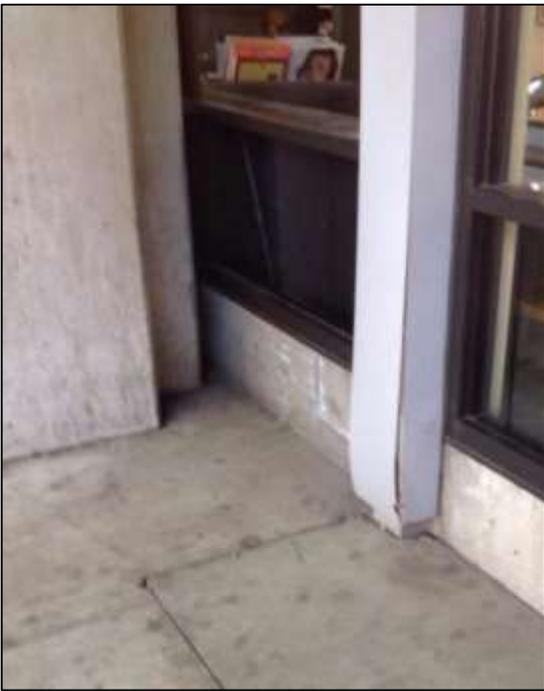
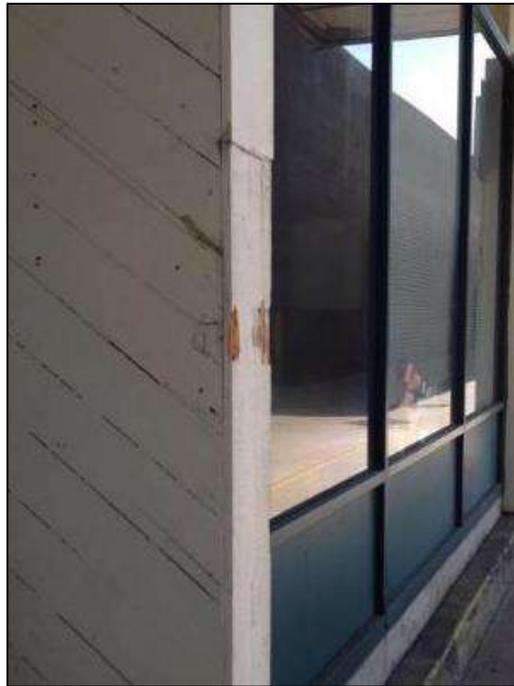
Property #70 images continued.

Photo: Top: examples of damage on exterior of structure; bottom: images showing examples of façade damage.

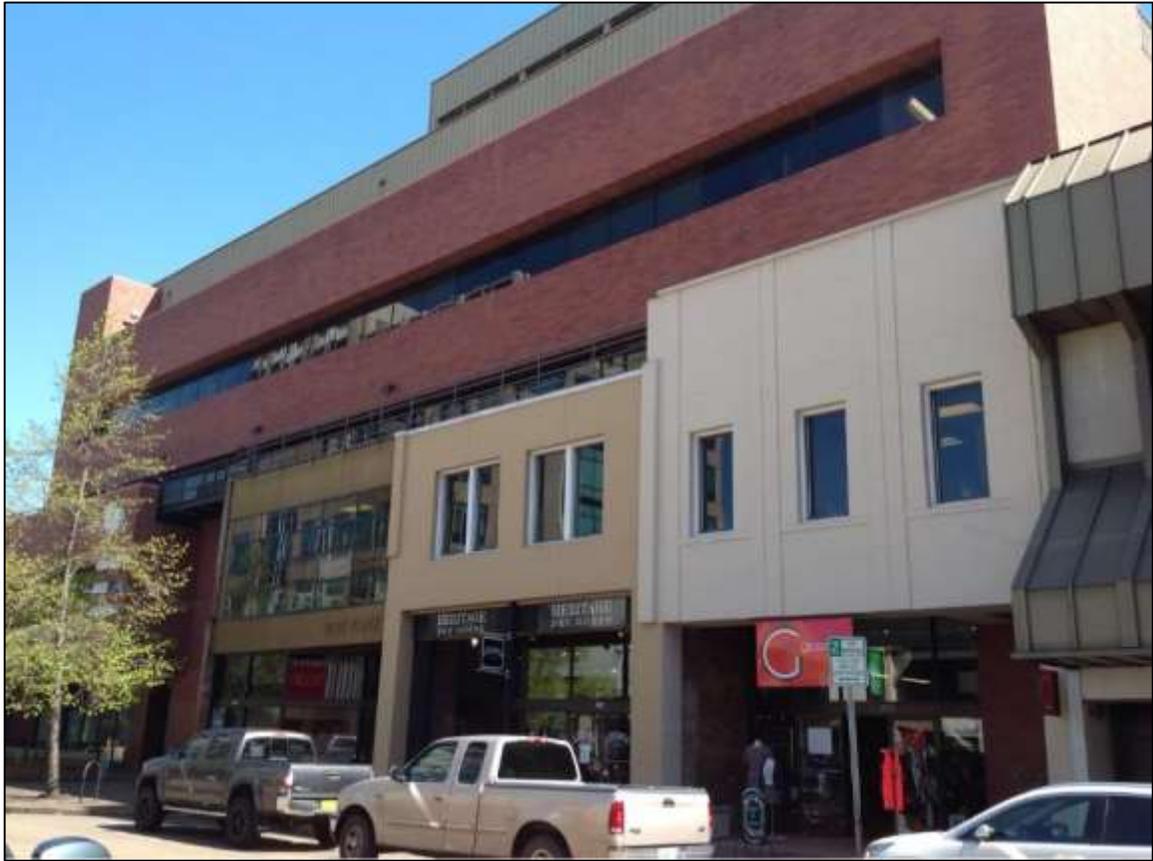
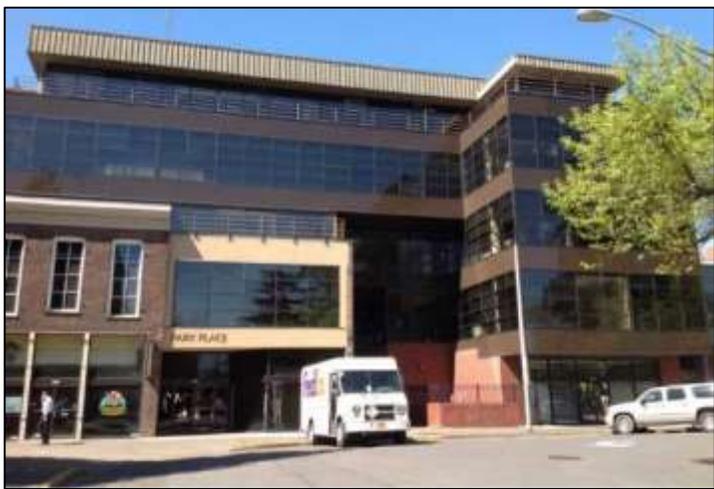
Property: 71	Name: Park Place	Determination of Blight:	No
Taxlot(s): 1703311404400		Depreciation Ratio:	11.88
Property Notes:	Property is in good condition. The building has ground floor commercial on west side with one vacant space. East side has vacant space and not much street level activity. East side of building has section with evidence of building that is gone, there is a west side entry with damage along bottom of entry, and there are former fluorescent light fixtures on front of building.

Photo: Top: view of property from Willamette Street; bottom: view of property from West Park Street.

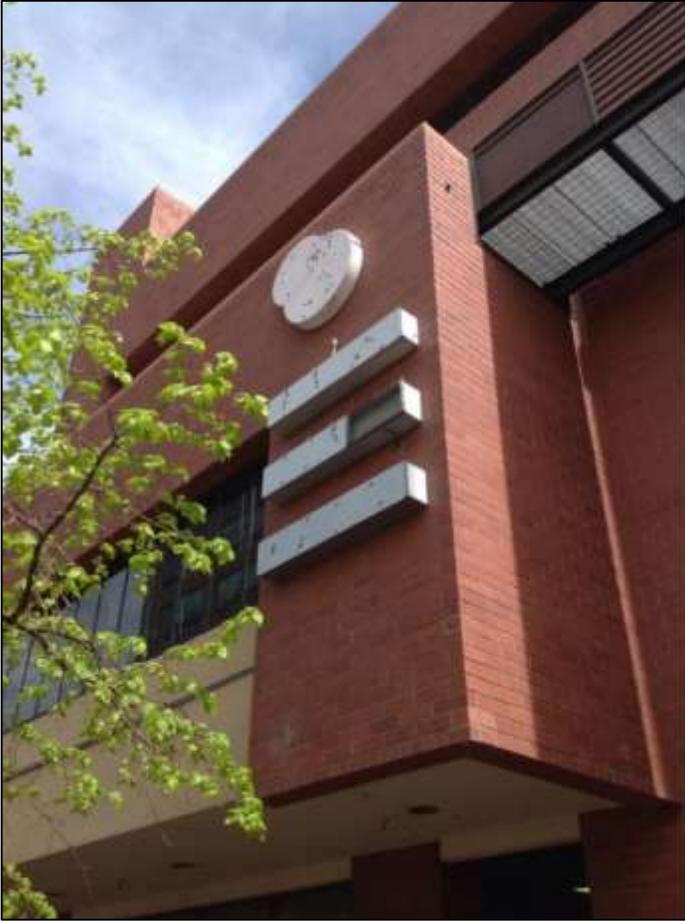
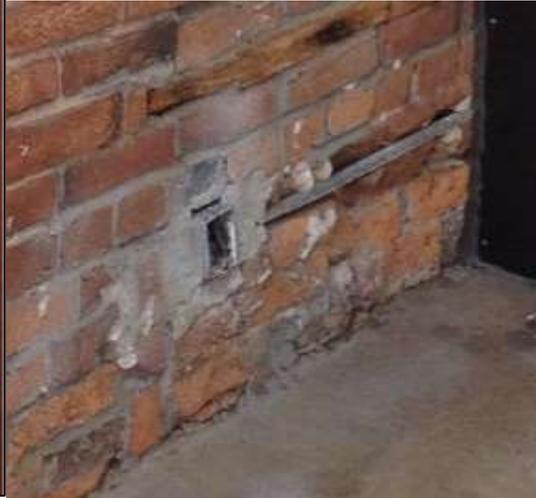
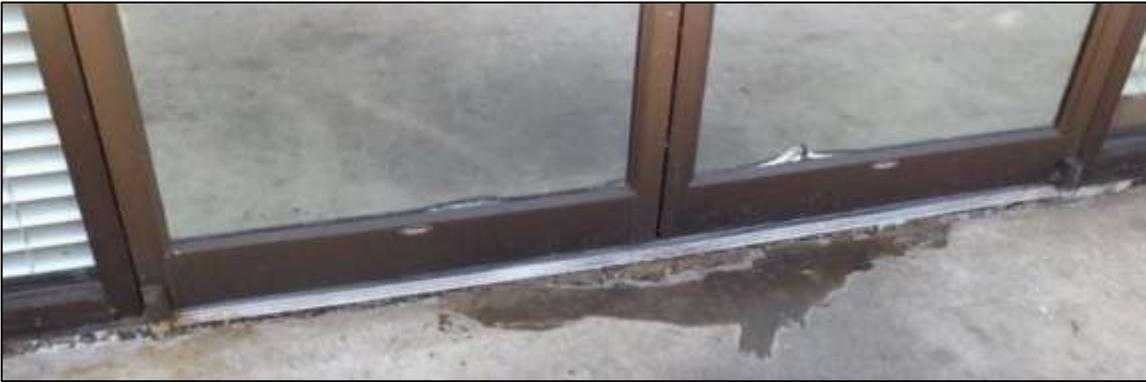
Property #62 images continued.

Photo: Top left shows where sign was partially removed; top right: damaged exterior brick work; bottom: damaged entryway.

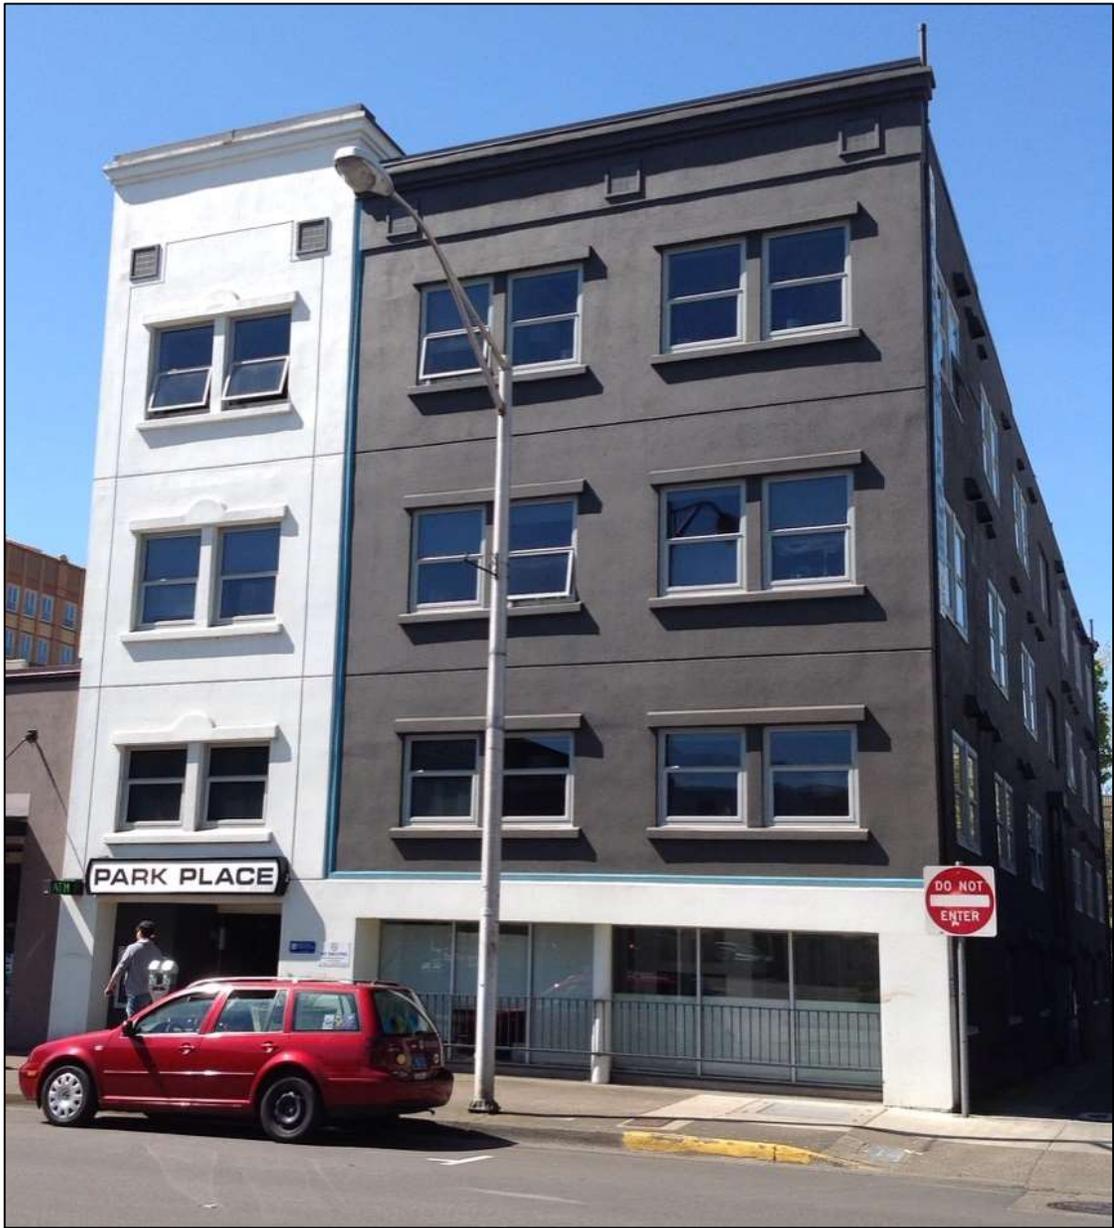
Property: 72	Name: Park Place Apts	Determination of Blight: No
Taxlot(s): 1703311402700		Depreciation Ratio: 14.98
Property Notes:	Building is in good condition and recently renovated.

Photo: View of property from Pearl Street.

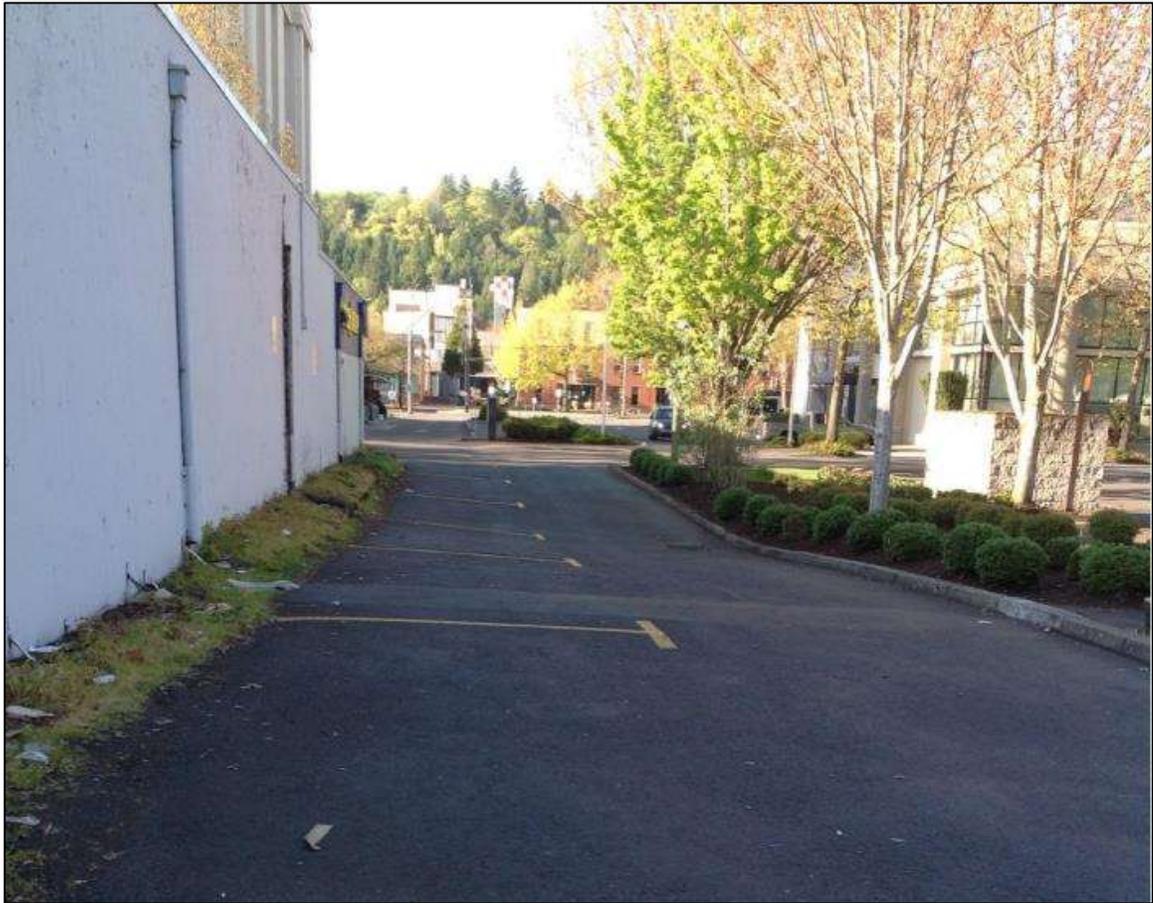
Property: 73	Name: Parking	Determination of Blight:	Yes
Taxlot(s): 1703311215200		Depreciation Ratio:	0.07
Property Notes:	Property in fair condition and is adjacent to another property that is not in good condition. Determination of blight based on ORS 457.010 (1) (g) and (h).

Photo: View of property looking towards West 7th Avenue.

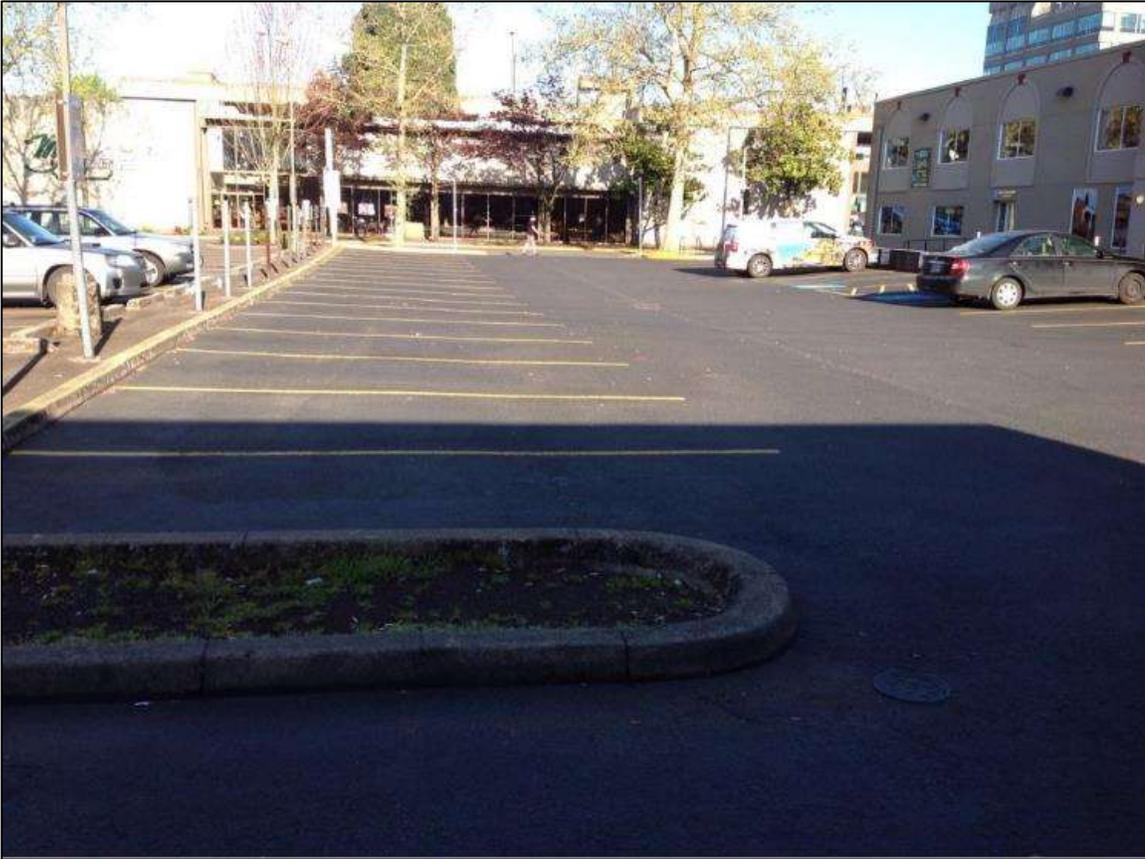
Property: 74	Name: Parking	Determination of Blight:	Yes
Taxlot(s): 1703311215200		Depreciation Ratio:	0.07
Property Notes:	Good condition. Determination of blight based on ORS 457.010 (1)(g) and (h).

Photo: View of property looking towards Olive Street.

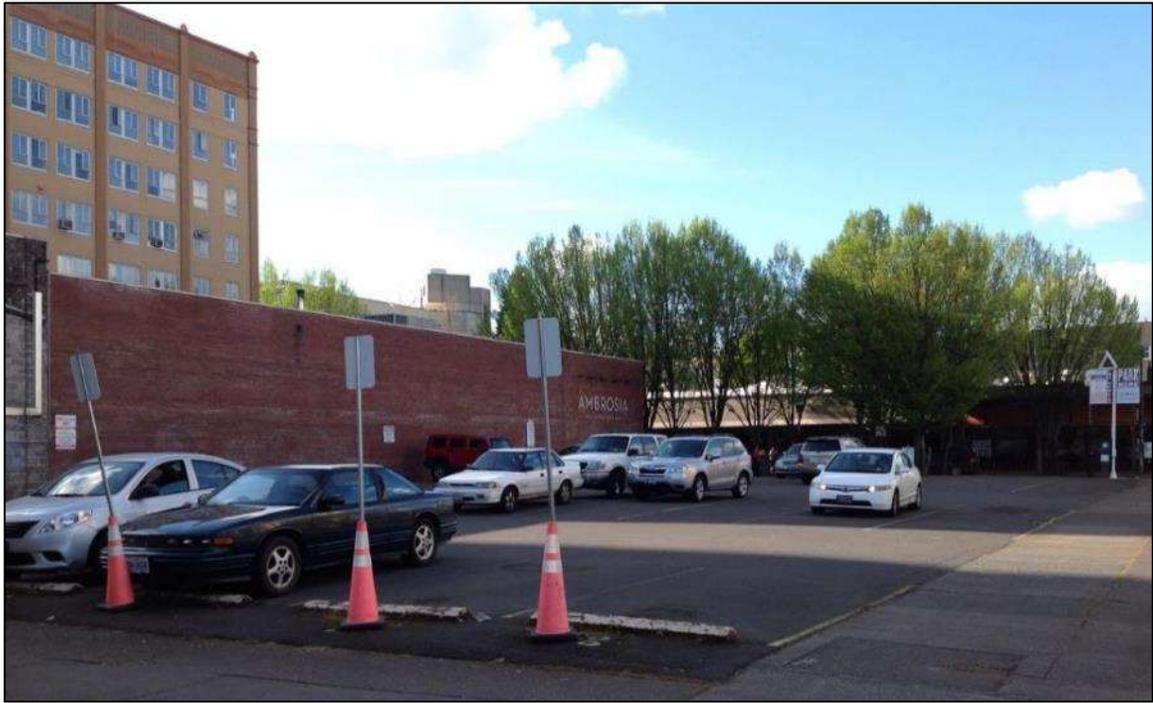
Property: 75	Name: Parking - Ambrosia	Determination of Blight:	Yes
Taxlot(s): 1703311407700	1703311407600	Depreciation Ratio:	0.03
Property Notes:	This property is a quarter block of surface parking. Determination of blight based on ORS 457.010 (1) (g) and (h).

Photo: View of property from East Broadway Alley along Pearl Street.

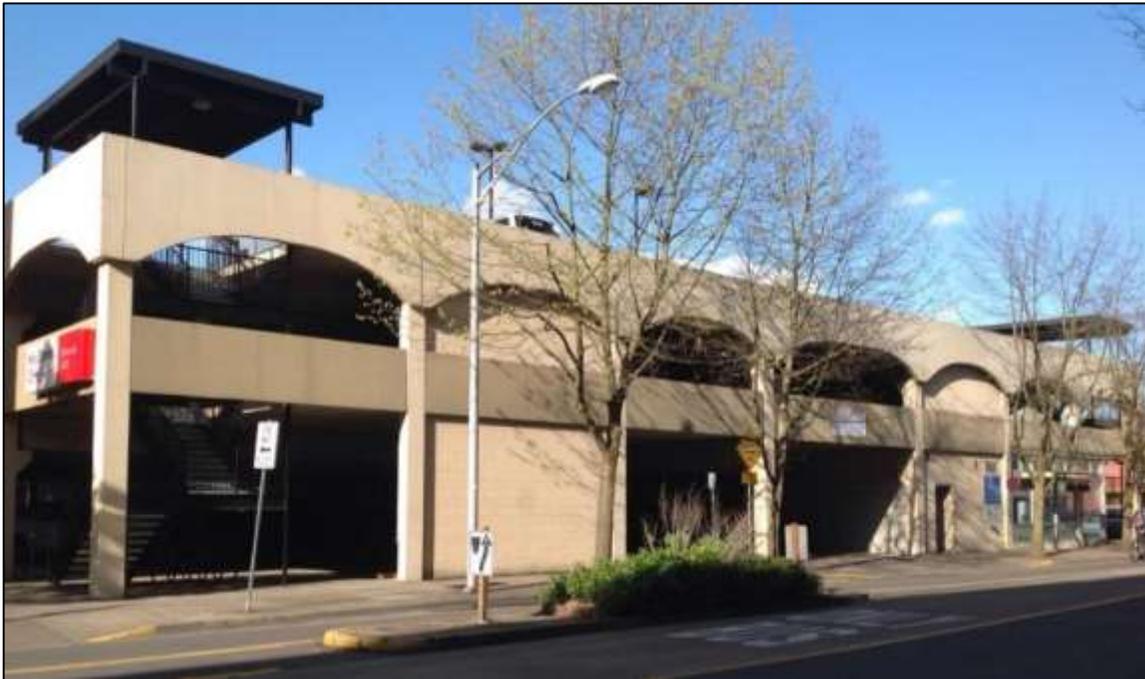
Photo: Top: view of property from Pearl Street; bottom photo shows ramp with questionable angle for accessibility.

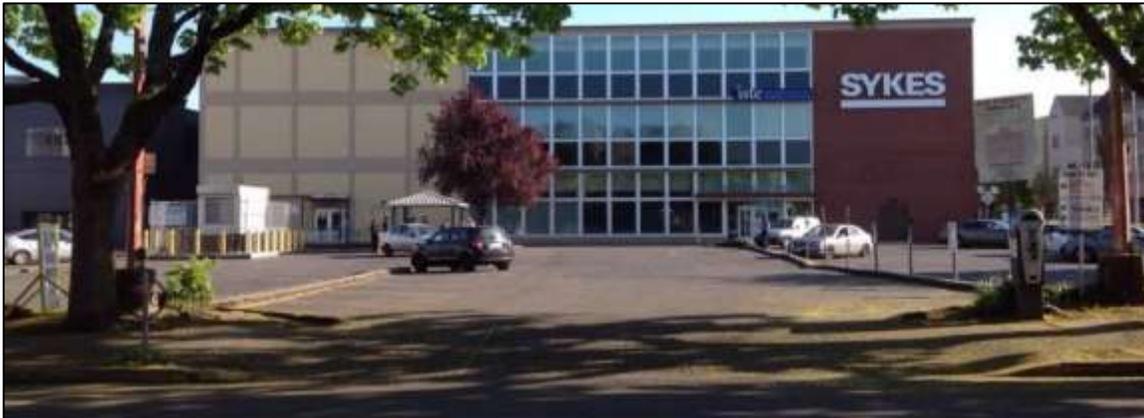
Property: 77	Name: Parking - Surface	Determination of Blight:	Yes
Taxlot(s): 1703311306900		Depreciation Ratio:	0.03
Property Notes:	Property is in fair shape and is a surface parking that is a ¼ block in size. Determination of blight based on ORS 457.010 (1)(g) and (h).

Photo: View of property from West 8th Avenue.

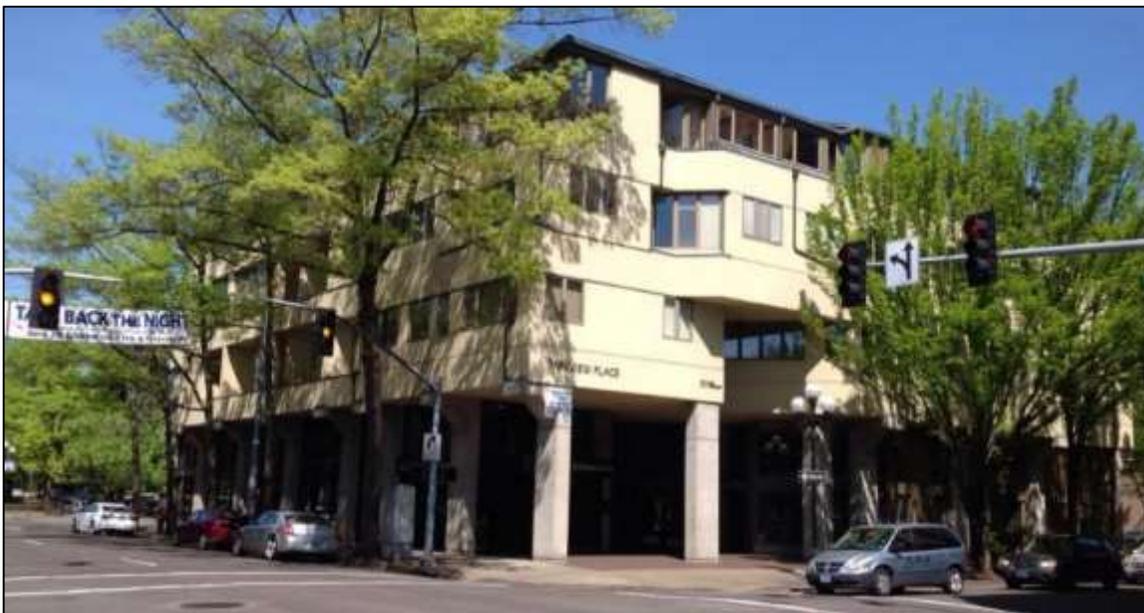
Property: 78	Name: Parkview Place	Determination of Blight:	No
Taxlot(s): 1703311402900		Depreciation Ratio:	7.98
Property Notes:	Property appears in good condition. The building is older and has a few spots where cement looks worn. The Building also has wood which appears buckled under one window.

Photo: View of property from East Broadway and Oak Street.

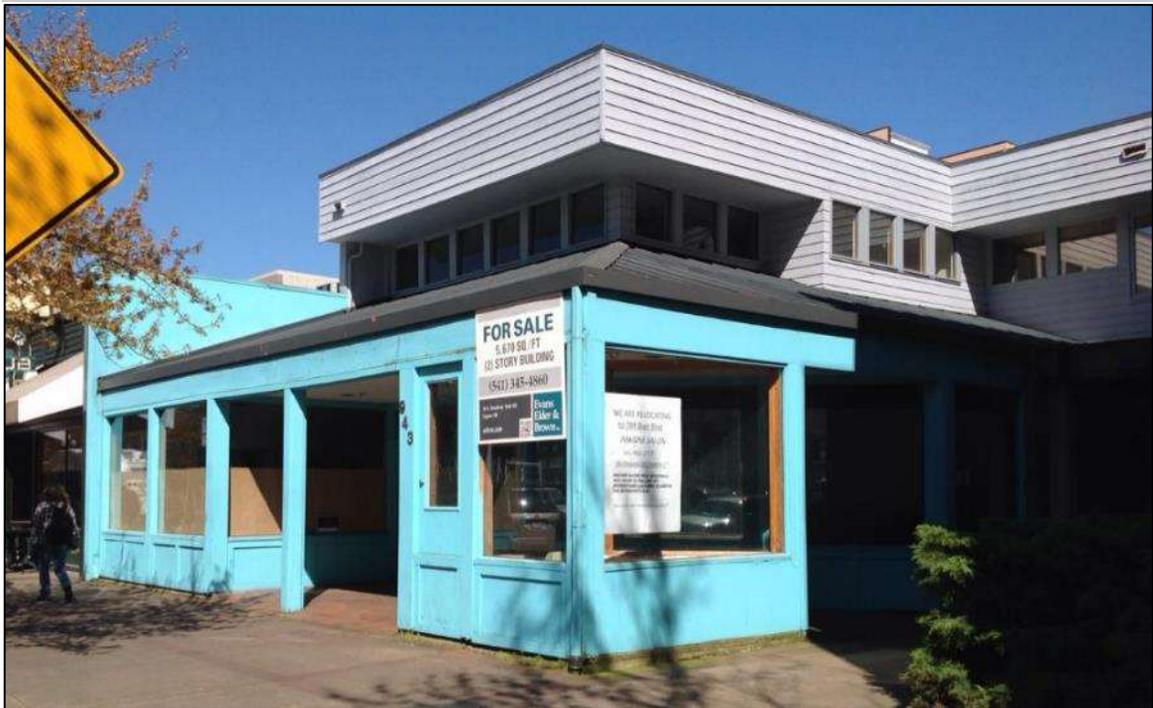
Photo: Top: view of property west side from Olive Street; middle left: photo is east side of building from service court; middle right: detail photo of entryway off Olive Street; bottom: example of wood damage on exterior.

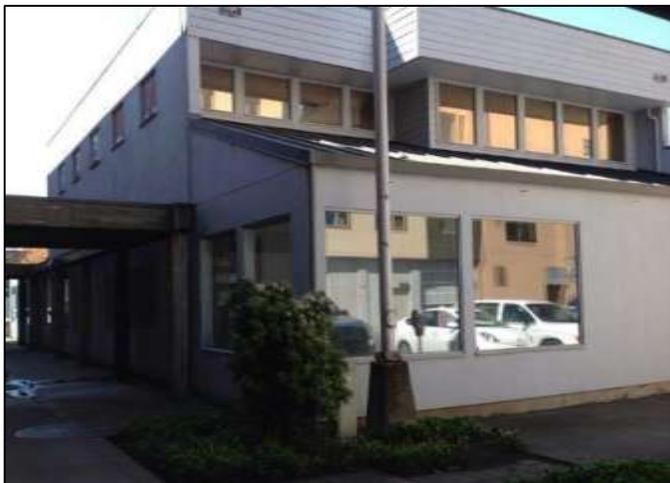
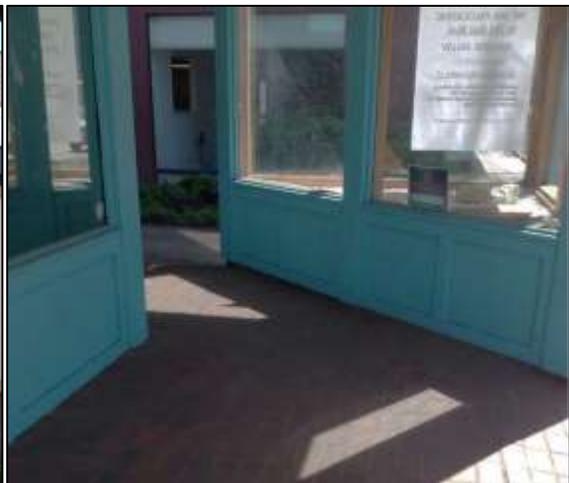
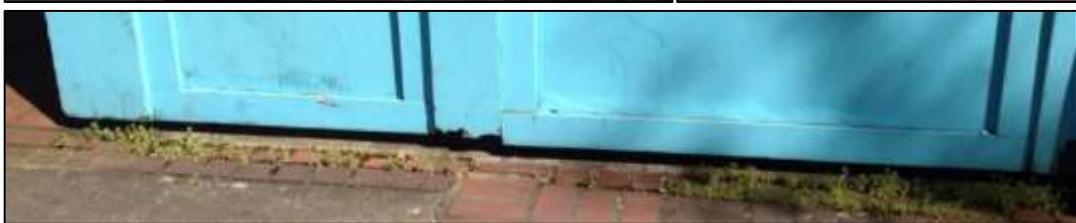
Property: 79	Name: Partially Vacant - former hair salon	Determination of Blight:	Yes
Taxlot(s): 1703311302700		Depreciation Ratio:	2.83
Property Notes:	Property is in poor condition. There is rotting wood visible in structure on the west side and the storefront is vacant. The east side of the building appears to be office. Condition on the side is good. Blight determination based on ORS 457.010(a)(E), (g), and (h).

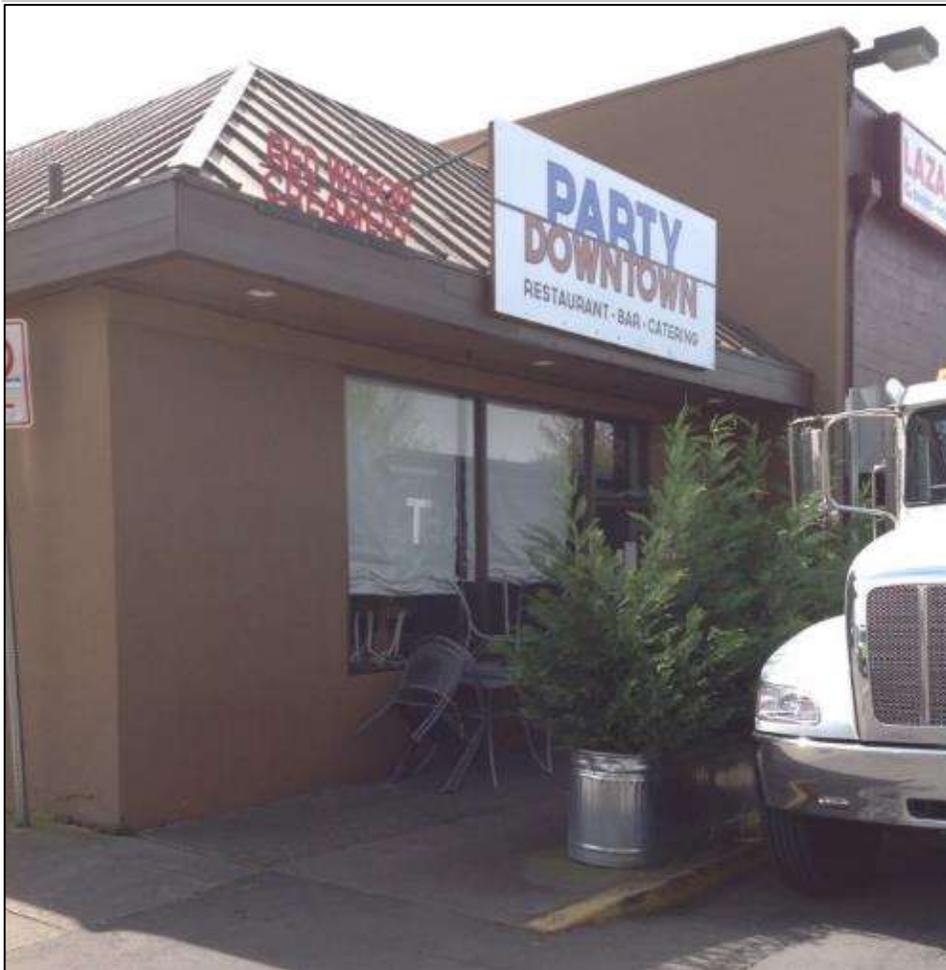
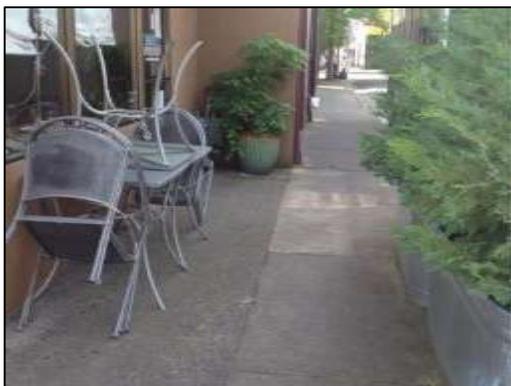
Property:	80	Name:	Party Downtown & Red Wagon Creamery	Determination of Blight:	Yes
Taxlot(s):	1703311303400			Depreciation Ratio:	3.80
Property Notes:	Building appears in good condition. Lot shape is long and thin. Back sidewalk seating area is narrow and accessibility questioned. Blight determination based on ORS 457.010 (1)(c), (g), and (h).

Photo: Top: View of property from West 8th Avenue Alley; bottom: image shows seating area width on alley.

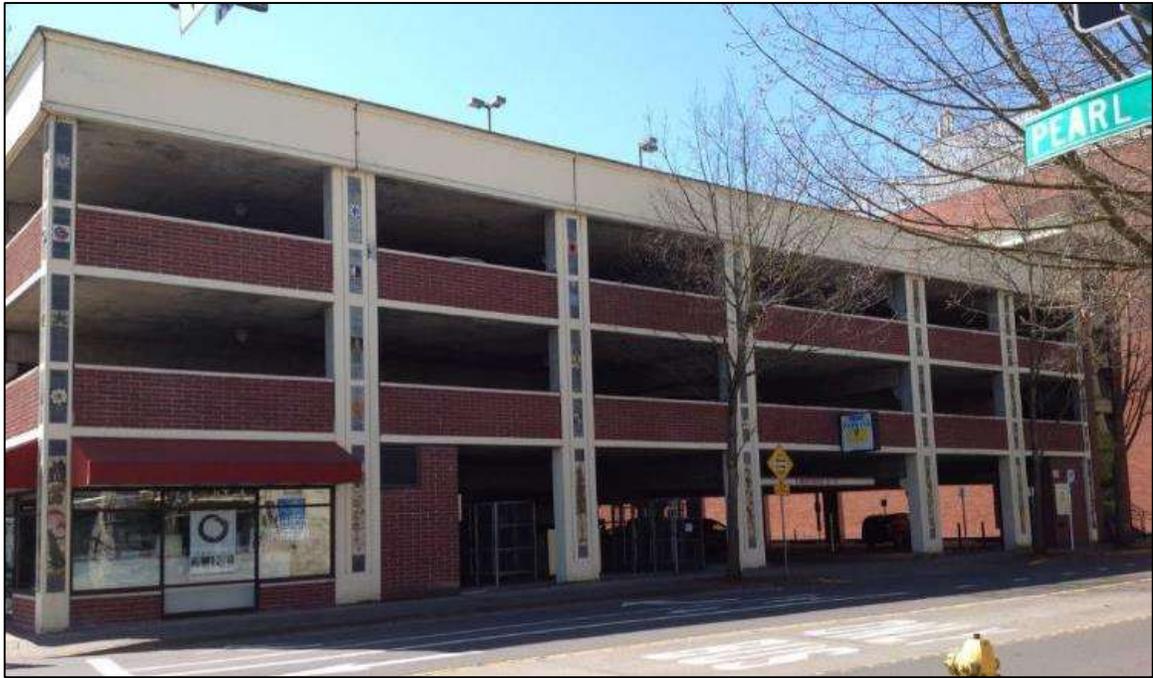
Photo: Top: view of property on East 10th Avenue; bottom left: example of surface damage on buiding; bottom right: example of rust on stairs.

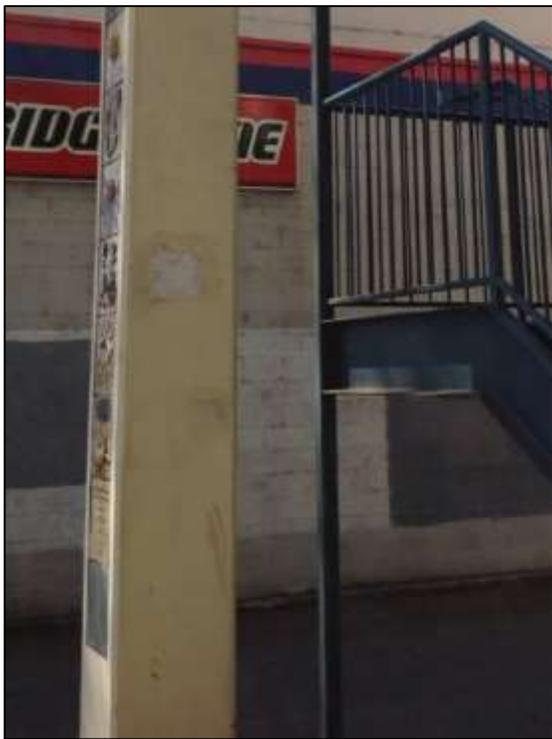
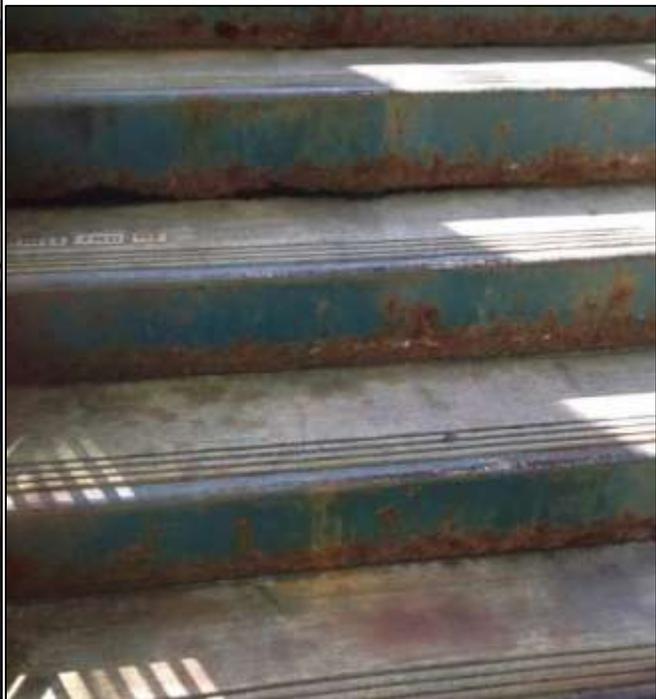
Taxlot(s):	1703311303400	Depreciation Ratio:	5.44
Property Notes:	Property appears in good condition. This property has ground floor commercial. The stairs show rust damage and some damage visible to surface of structure.

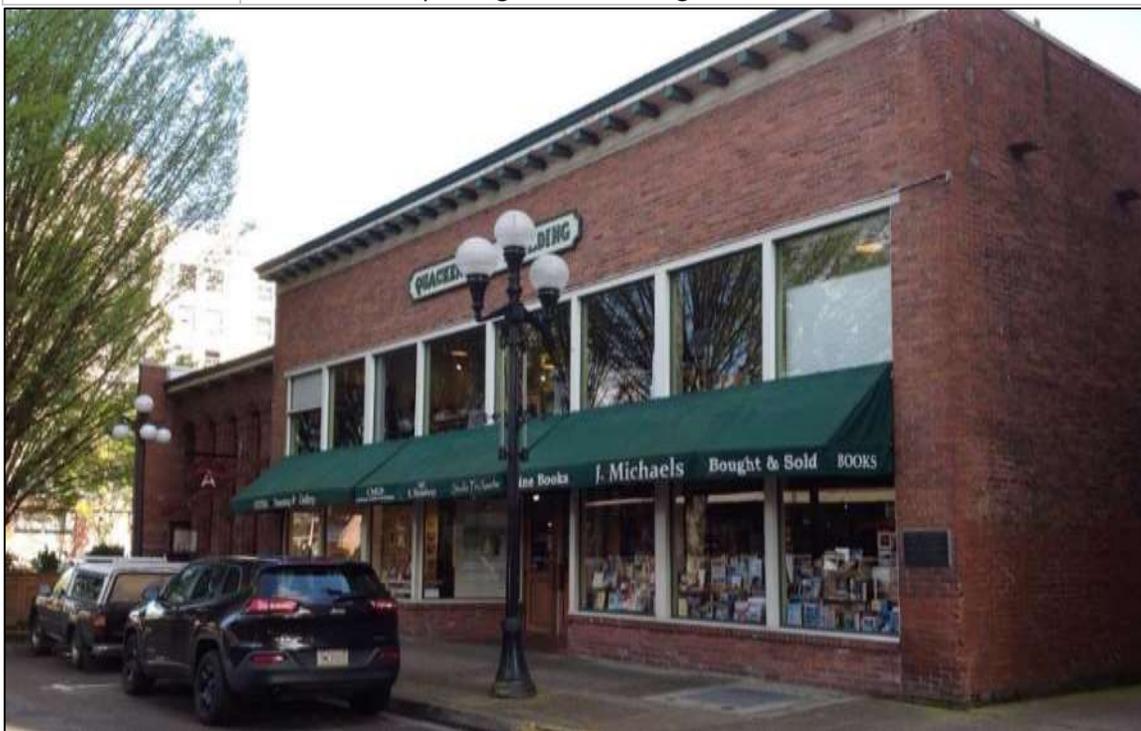
Photo: Top: front of building on East Broadway; bottom left: example of boarded up window along alley; bottom right: view of rear section of building with old cinderblock looking construction.
