DOWNTOWN URBAN RENEWAL DISTRICT REPORT

REPORT ON THE DOWNTOWN URBAN RENEWAL DISTRICT PLAN

Map to Accompany Downtown Urban Renewal Slums and Blight Report 2016

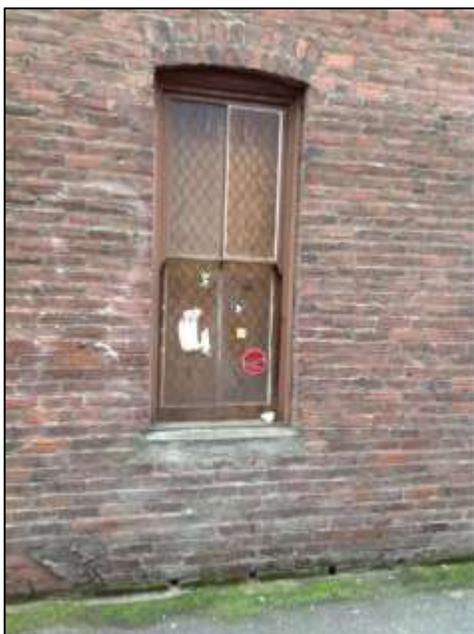
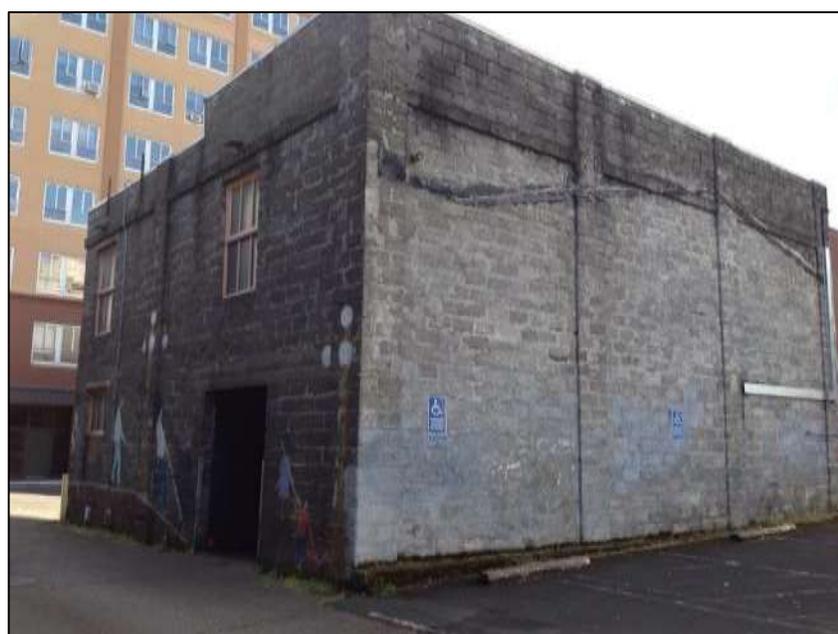
Property Notes: Building appears in good condition even though very old. Questionable section in rear of building with old and visibly patched cinder block construction. Old windows are boarded up alongside of building.

Photo: Top: front of building on East Broadway; bottom left: example of boarded up window along alley; bottom right: view of rear section of building with old cinderblock looking construction.

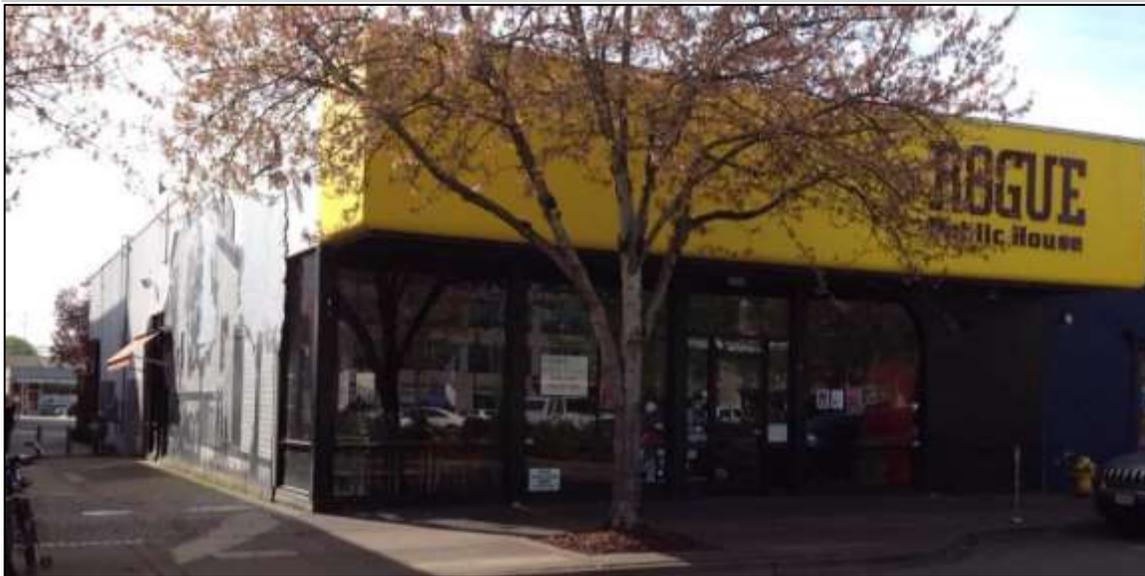
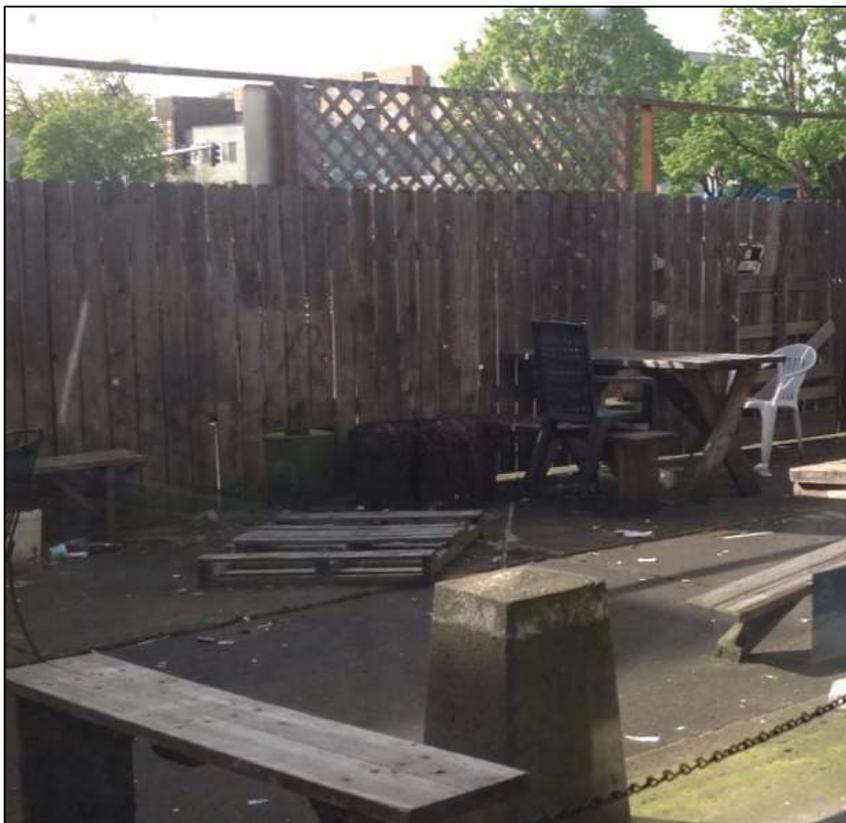
Property: 88	Name: Rogue	Determination of Blight:	Yes
Taxlot(s): 1703311304400		Depreciation Ratio:	3.38
Property Notes:	Building appears in relatively good condition. Outside seating area in back looks vandalized and in poor shape. Building shows evidence of graffiti. Property is vacant, underutilized, and the extended vacancy creates safety concerns. Blight determination by ORS 457.010 (1)(b),(g), and (h).

Photo: Top: view of property from Olive Street; bottom: view of back patio damage.

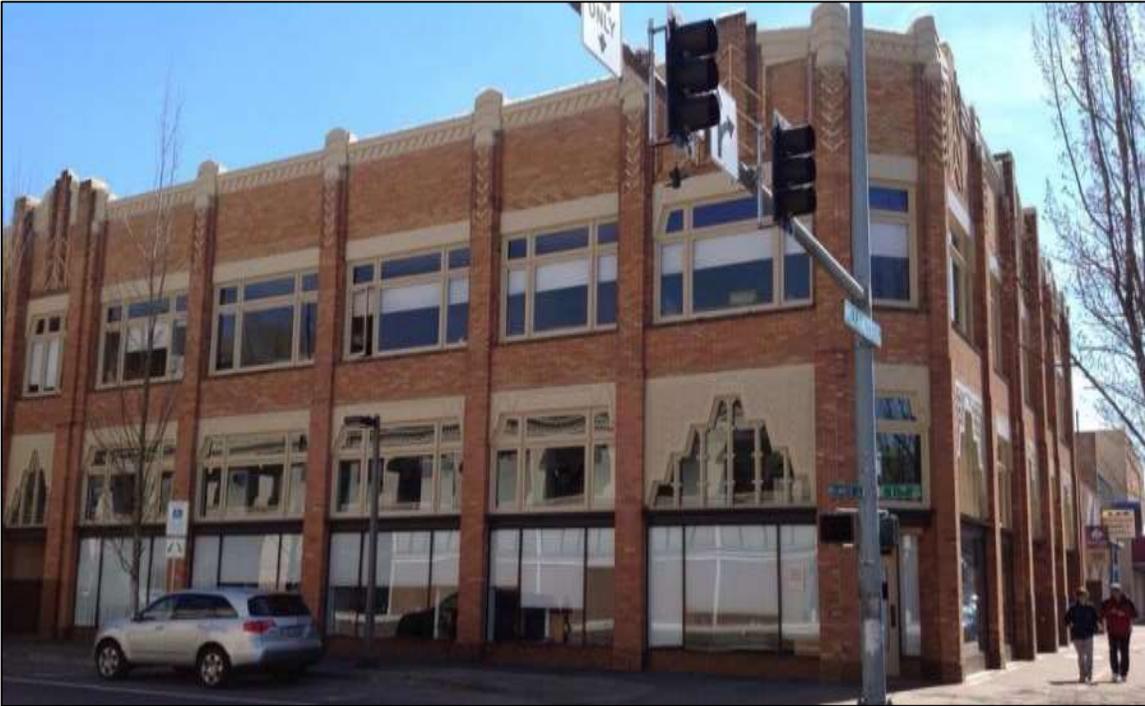
Photo: Top: view of property from East 10th Avenue and Willamette Street; bottom: image shows damage at base of building.

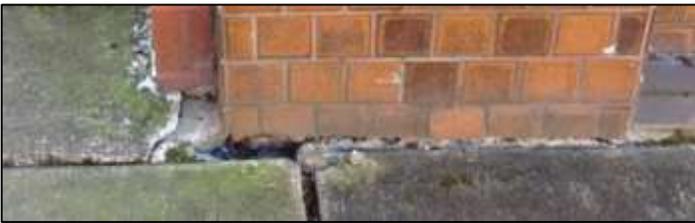
Property: 90	Name: Schaefer building	Determination of Blight:	No
Taxlot(s): 1703311412500		Depreciation Ratio:	7.19
Property Notes:	Property appears in good shape. There is a section with damage on NE corner.

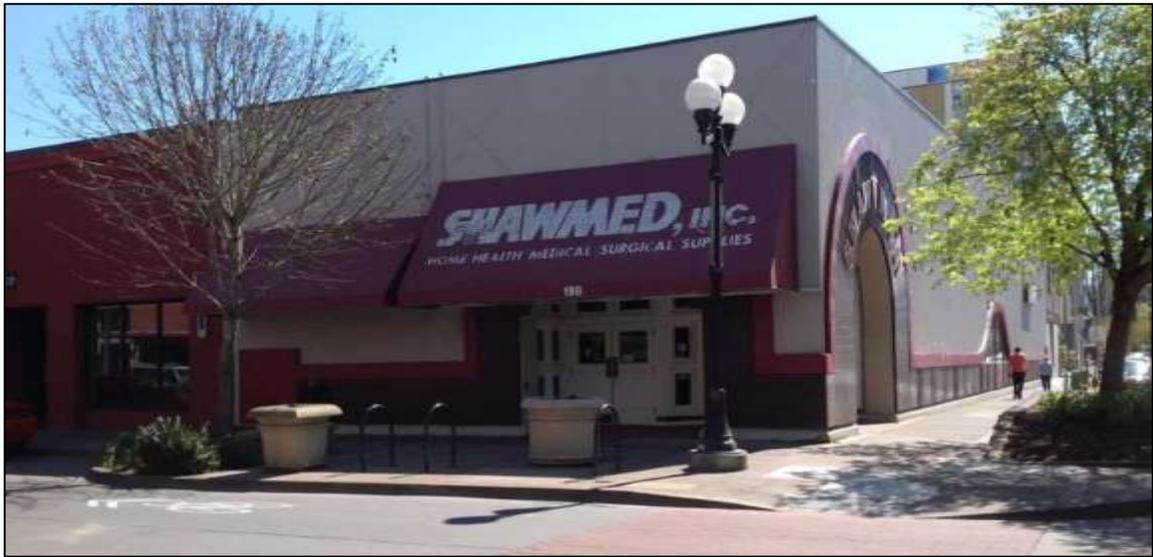
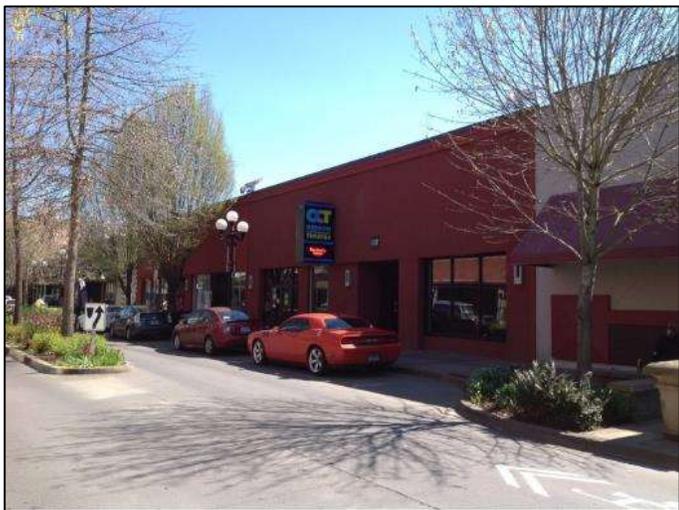
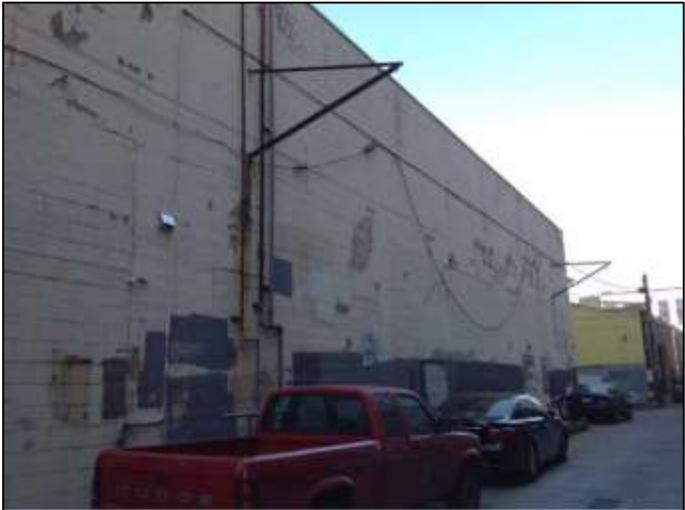
Property: 92	Name: Shawmed	Determination of Blight:	Yes
Taxlot(s): 1703311306700		Depreciation Ratio:	1.74
Property Notes:	Property appears in good condition. There are several businesses in one building that is a ¼ block n size. The Shawmed section has few windows. This is a single level building, connected to Oregon Contemporary Theater (OCT). The OCT property is painted in good condition in front but back of OCT in less than good condition with graffiti, peeling paint, but no structural damage. Blight determination by ORS 457.010(1)(g) and (h).

Photo: Top: View of Shawmed section of building from Braodway; bottom left: view of Oregon Contemporary Theater section from Broadway; bottom right: back section of OCT portion of building.

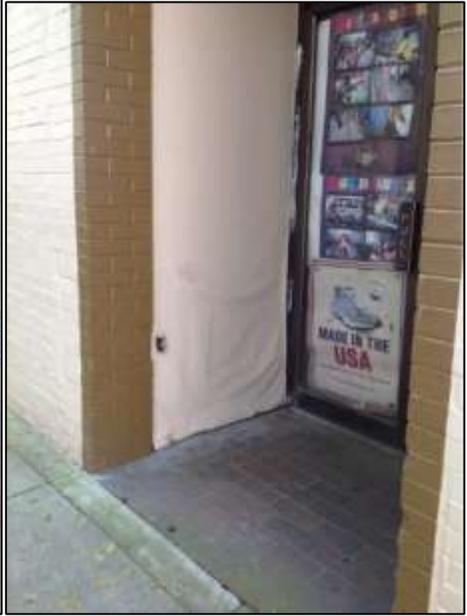
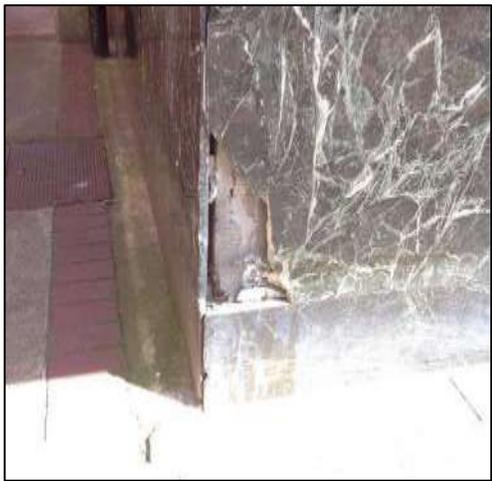
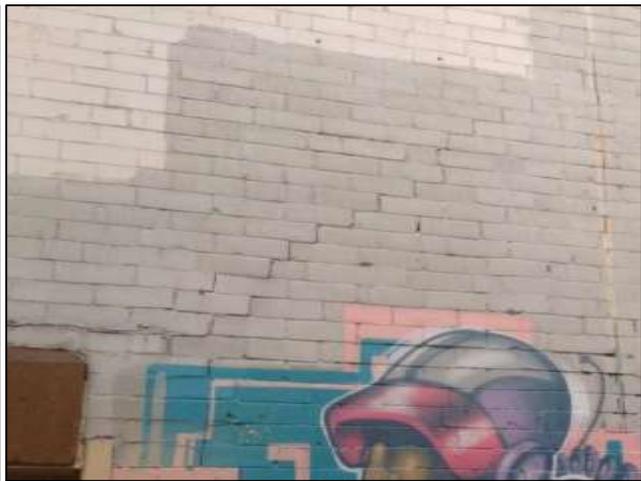
Property:	93	Name:	Shoe-a-Holic	Determination of Blight:	Yes
Taxlot(s):	1703311405500			Depreciation Ratio:	1.62
Property Notes:	Building appears in good condition. This is an older building and there are a few areas with damage and wear, these include the brick on the side of the building, the façade on the front, and the rear door. Blight determination by ORS 457.010(1)(g).

Photo: Top left: view of property from Willamette Street; top right: damage by rear door; bottom left: damage to front façade; bottom right: worn brick area.

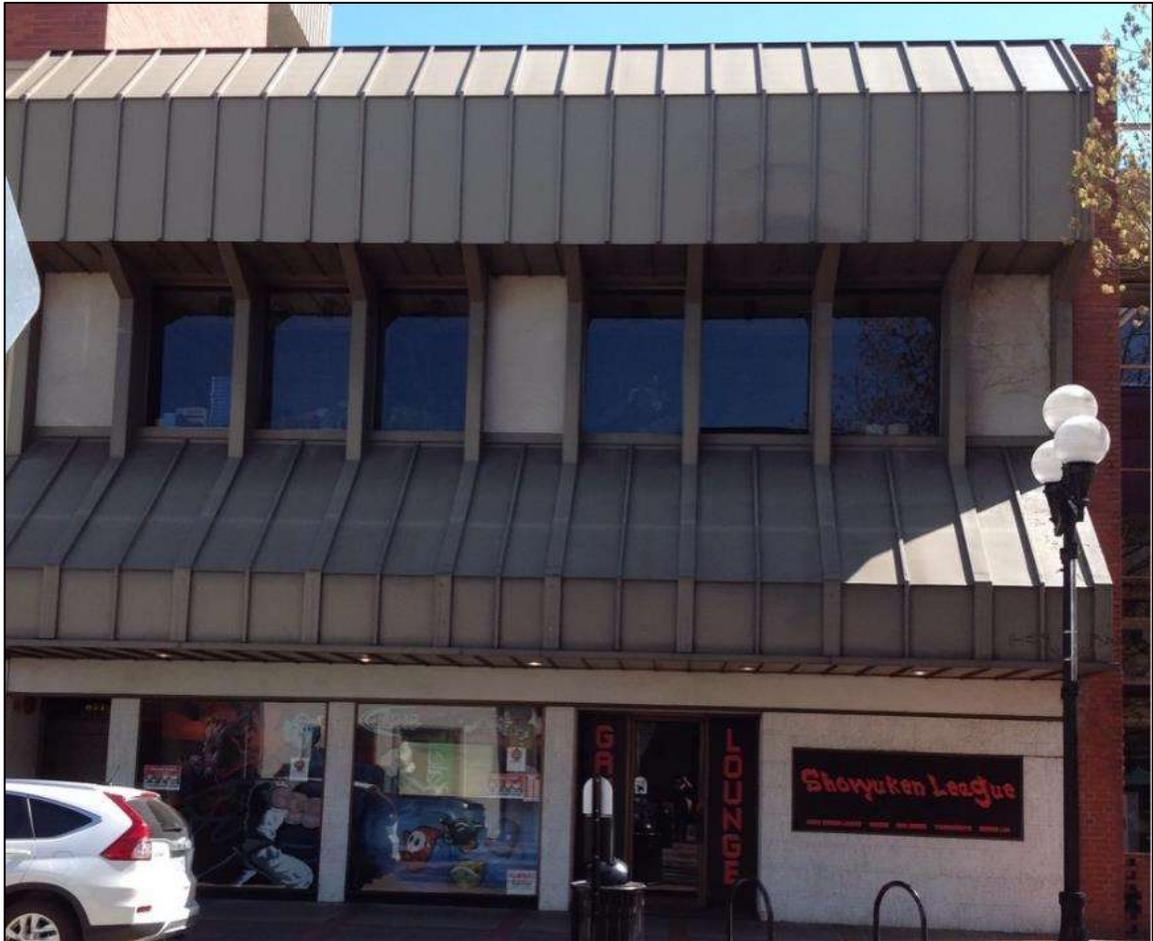
Photo: Top: View of property from Willamette Street; bottom: Damage and deterioration on front of building.

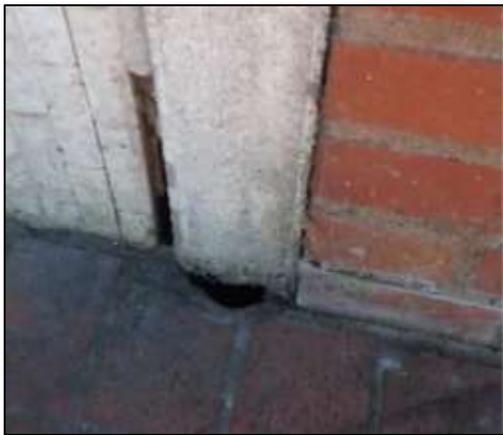
Taxlot(s):	1703311404000	Depreciation Ratio:	3.10
Property Notes:	Property appears in good condition. East side and second floor appear to be law offices and west 1st floor is a bar and game lounge. The west side of the building has marble looking tiles, a few are gone, and the bottom of building edge has hole. Blight determination by ORS 457.010(1)(g).

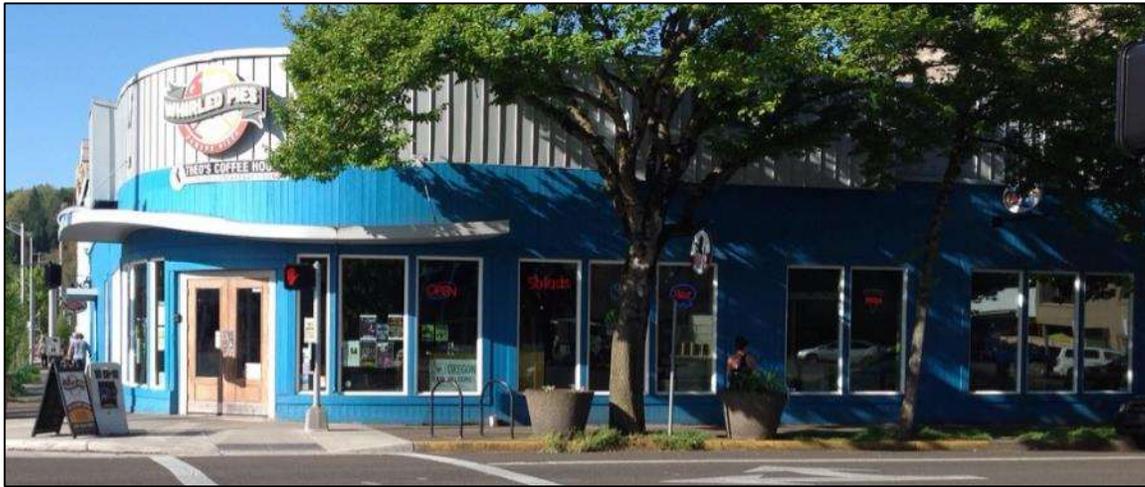
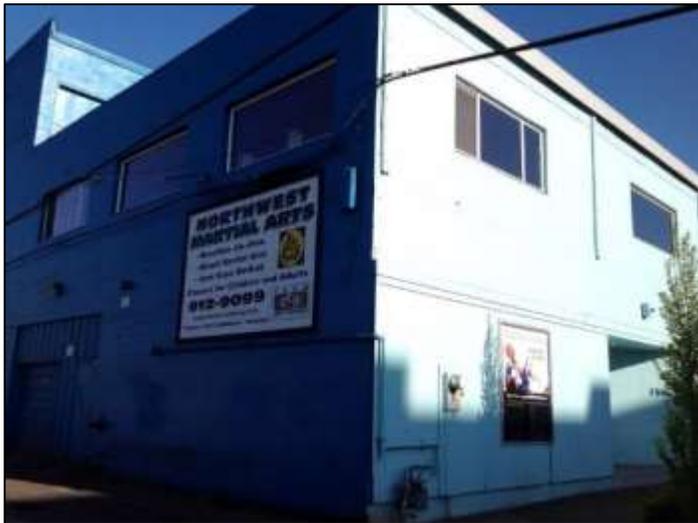
Property: 100	Name: Theos, Whirled Pies	Determination of Blight:	Yes
Taxlot(s): 1703311306800		Depreciation Ratio:	3.32
Property Notes:	Building appears in fairly good condition. A few locations show wood deterioration on exterior. Blight determination based on ORS 457.010 (1)(g).

Photo: Top: view of property from West 8th Avenue and Charnelton Street; bottom left: north side of building, bottom right: example of damage on exterior

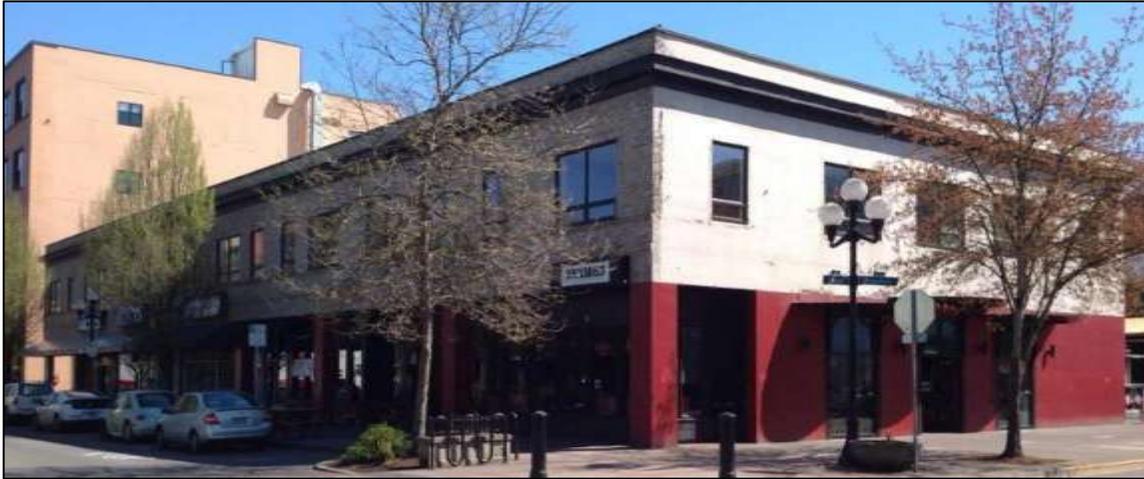
Taxlot(s):	1703311302900	Depreciation Ratio:	3.96
Property Notes:	Building in fair condition. There are upper level offices and bottom floor commercial. The building has some peeling paint. Blight determination based on ORS 457.010 (1)(g).

Photo: View of property from Broadway and Olive Street.

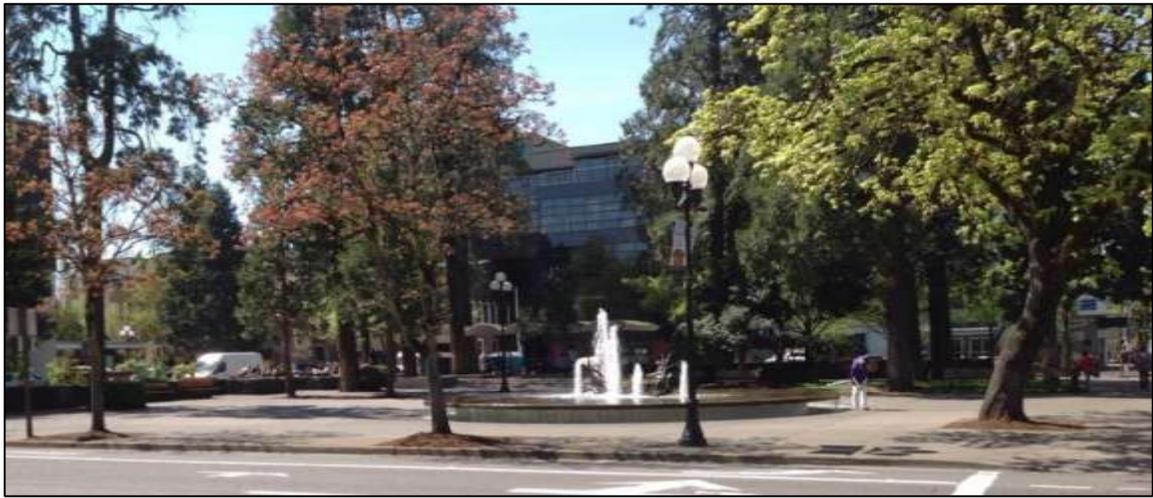
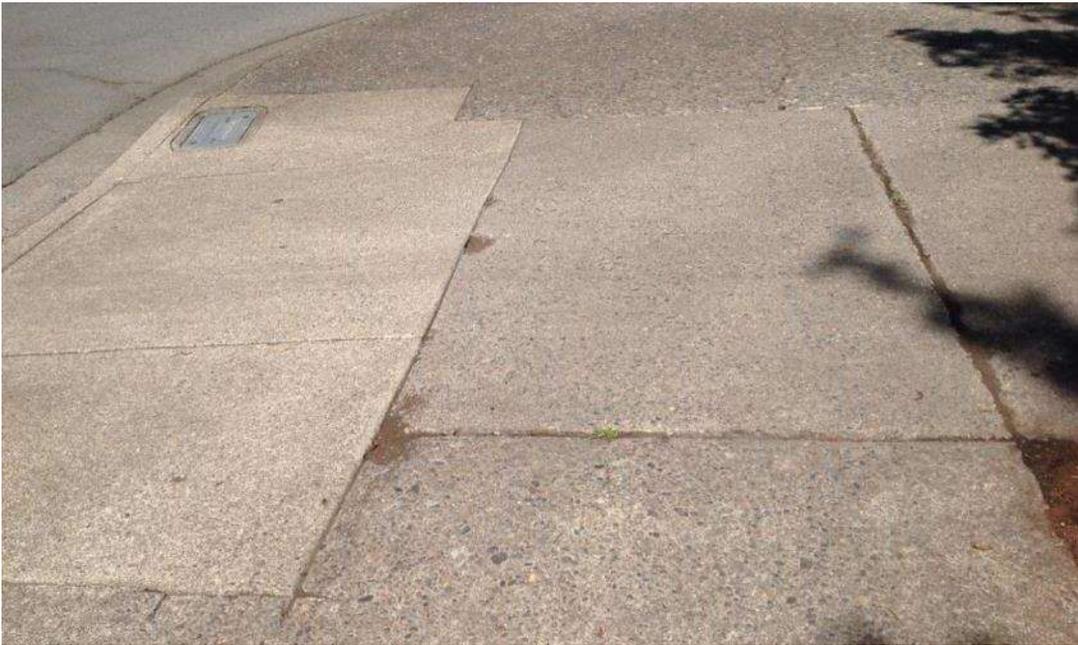
Property: 107	Name: West Park Block	Determination of Blight:	Yes
Taxlot(s): 1703311404700		Depreciation Ratio:	0.05
Property Notes:	Property is in poor conditions. Damage includes broken sidewalks that uneven and have holes, benches are rusty with peeling paint and some are crooked; and there is a broken utility box with wires exposed. Property does not look maintained with garbage lying around and portable restrooms with graffiti add to perceptions of blight. Accessibility is questionable, the ramp is not flush with the sidewalk and it has holes. Determination of blight based on ORS 457.010 (1) (b), (e),(g),(h), and (i).

Photo: Top: view of property from Oak Street; bottom: image shows holes and cracks in pavement leading up to ramp

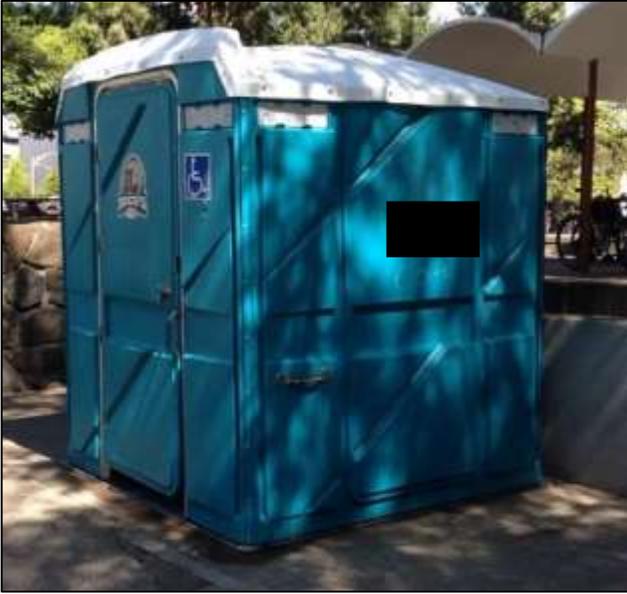
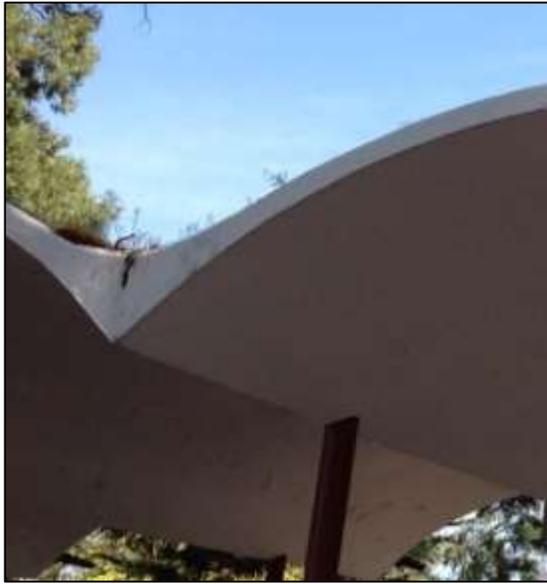
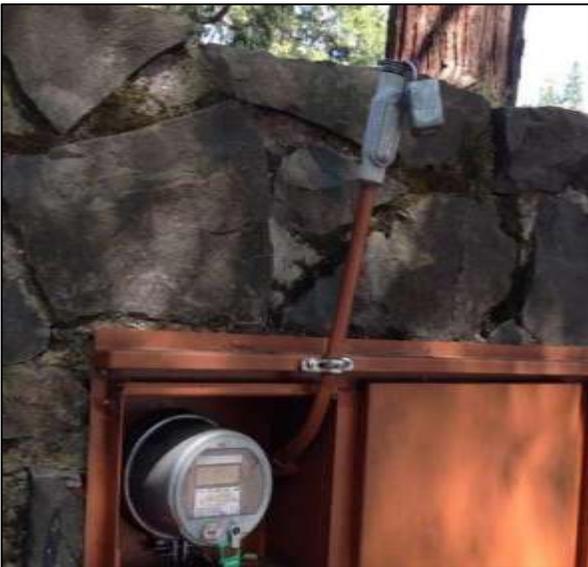
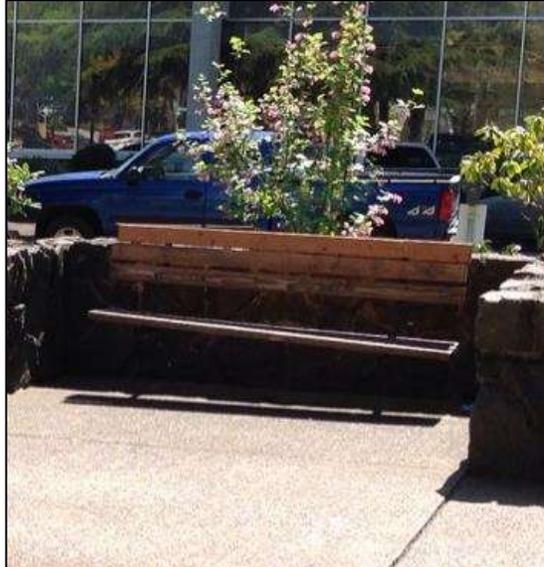
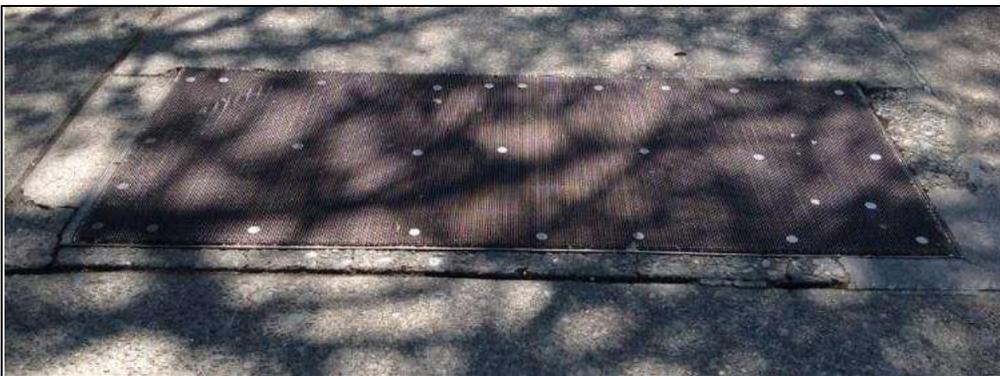
Photo: Top left: portable restroom on property, graffiti is covered by black box; top right: image shows plants growing on shelter; middle left: broken utility box; middle right: example of crooked bench; bottom: metal grate in damaged sidewalk

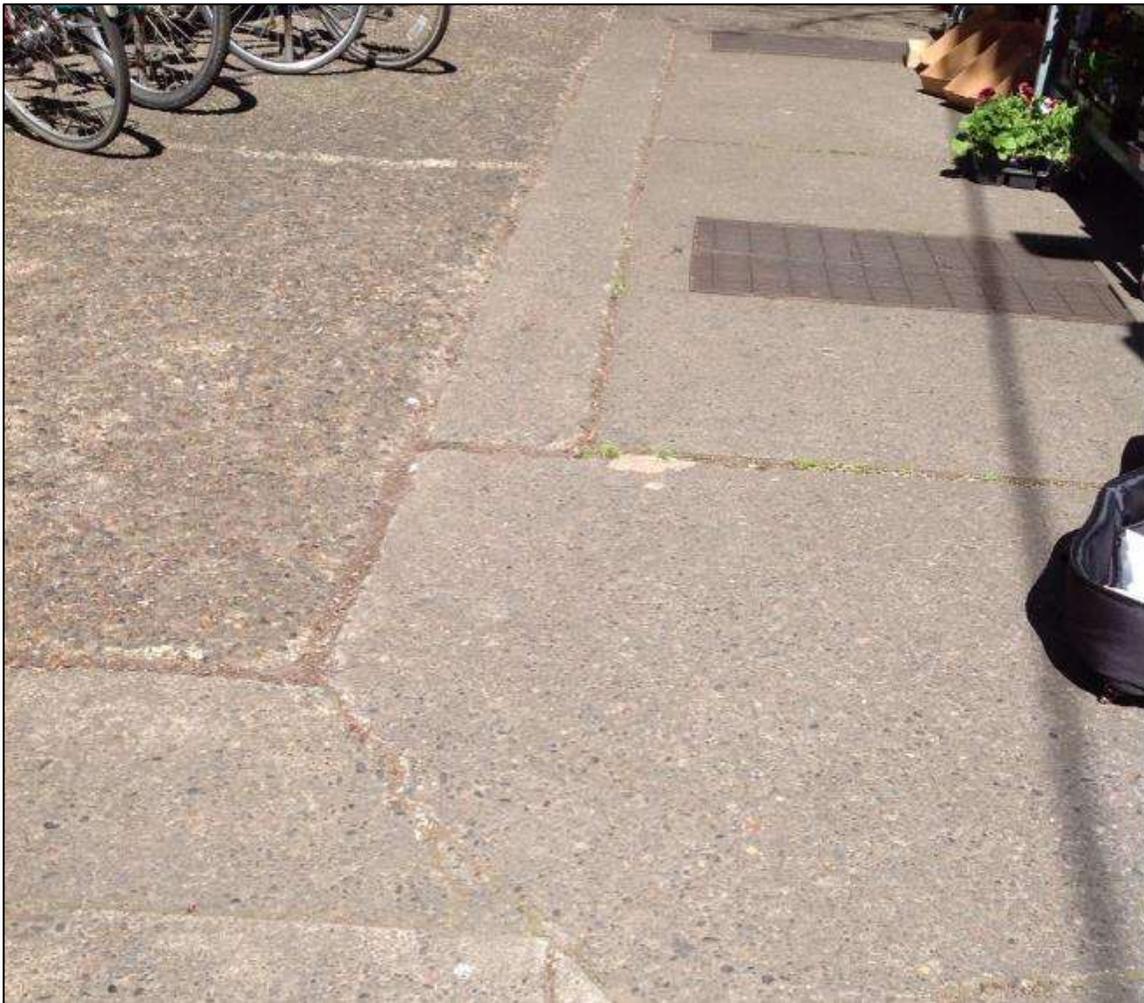
Area:	110	Name:	Sidewalk	Determination of Blight:	Yes
Notes:	Sidewalk has a large hole in pavement and vegetation is not maintained. Determination of blight based on ORS 457.010 (1)(e).

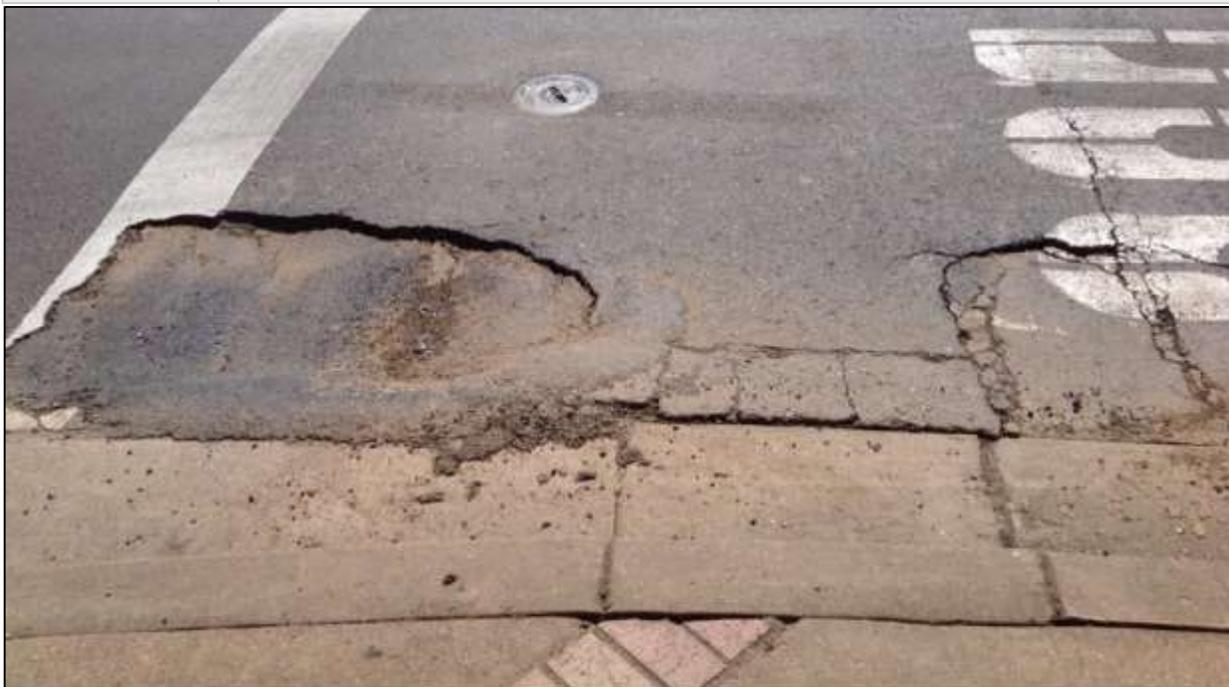
Area:	112	Name:	Sidewalk	Determination of Blight:	Yes
--------------	-----	--------------	----------	---------------------------------	-----

Pedestrian crossing at 10th and Willamette. The crossings most notably on 10th Avenue are broken, pitted, and have large holes increasing concerns for accessibility. Determination of blight based on ORS 457.010 (1)(e).

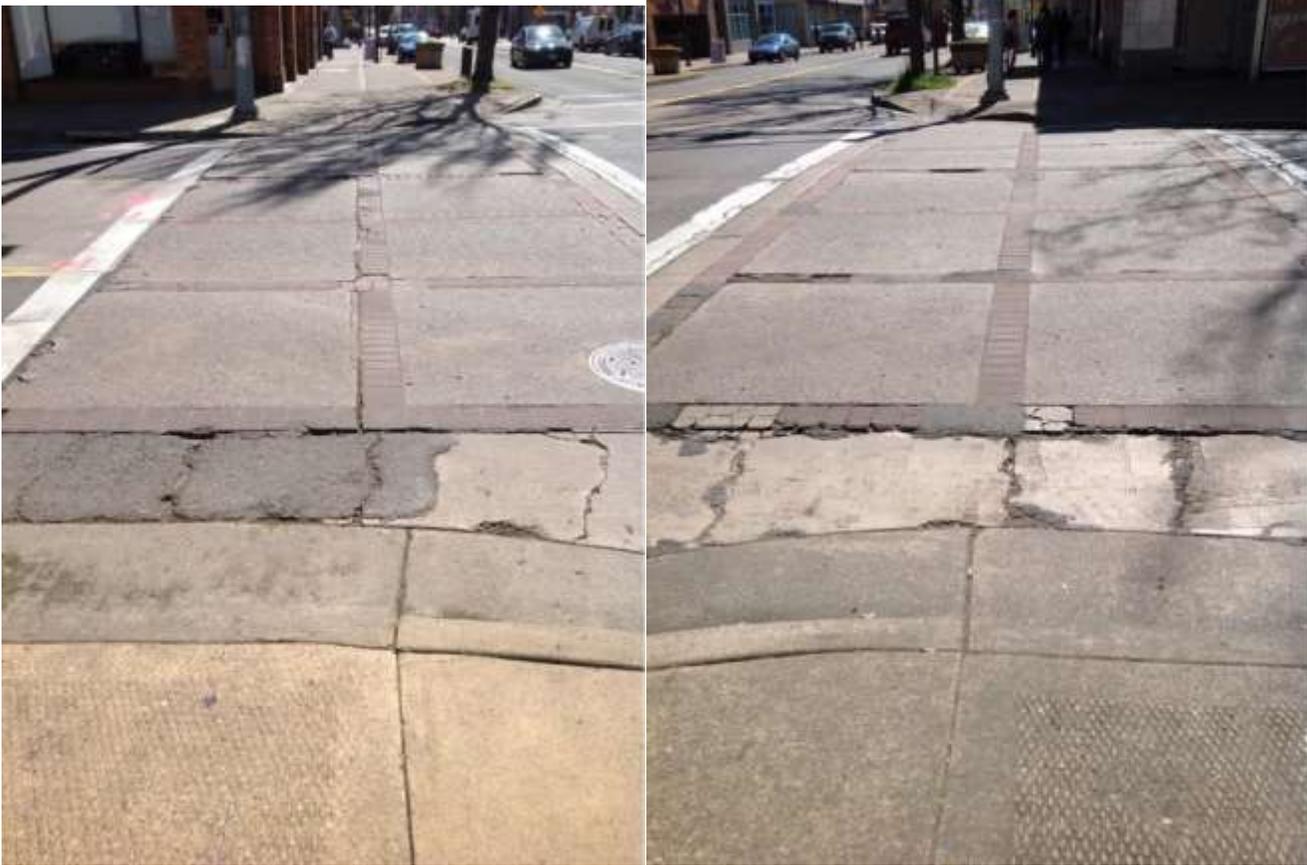
Photo: left: east crossing on 10th, right: west crossing on 10th

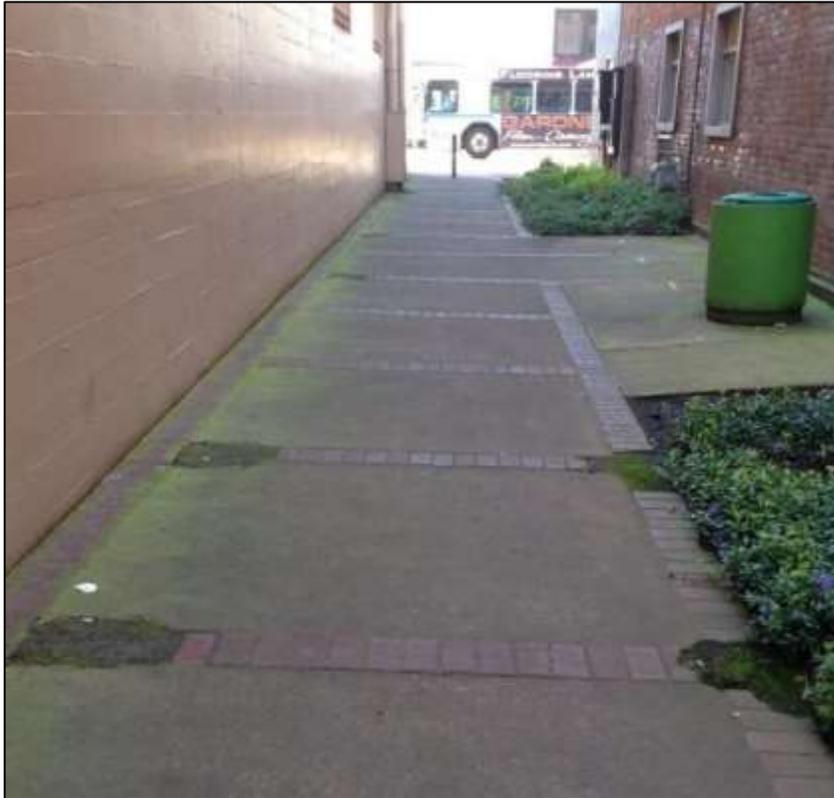
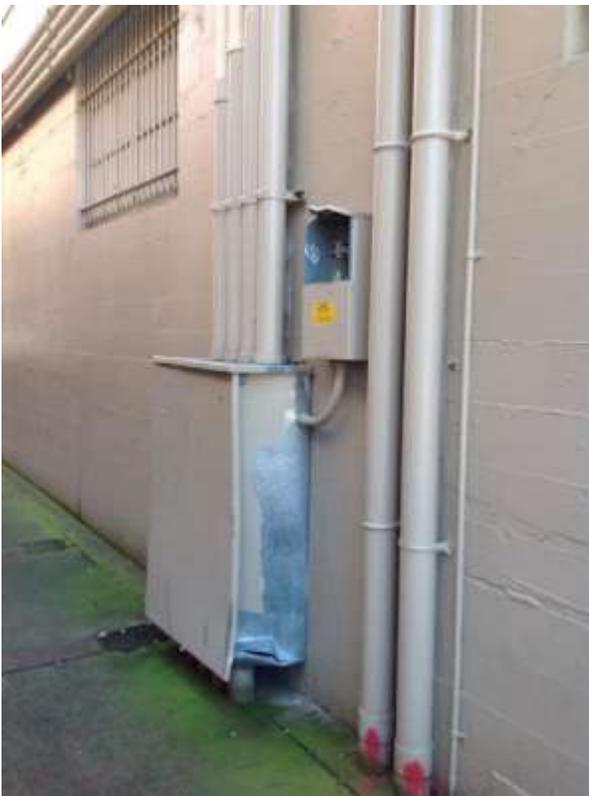
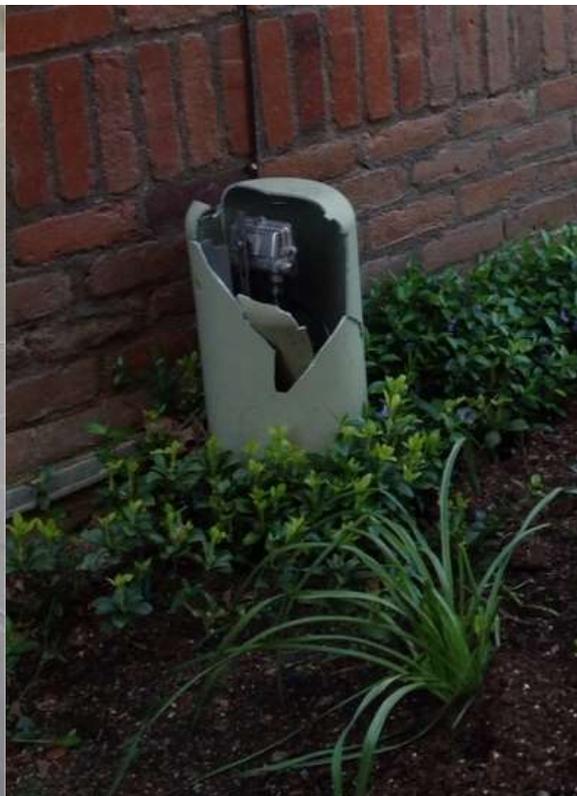
Area:	113	Name:	Sidewalk	Determination of Blight:	Yes
Notes:	Pedestrian walkway has damaged and patched sections and there are damaged utility boxes along walkway. Determination of blight based on ORS 457.010 (1)(e).

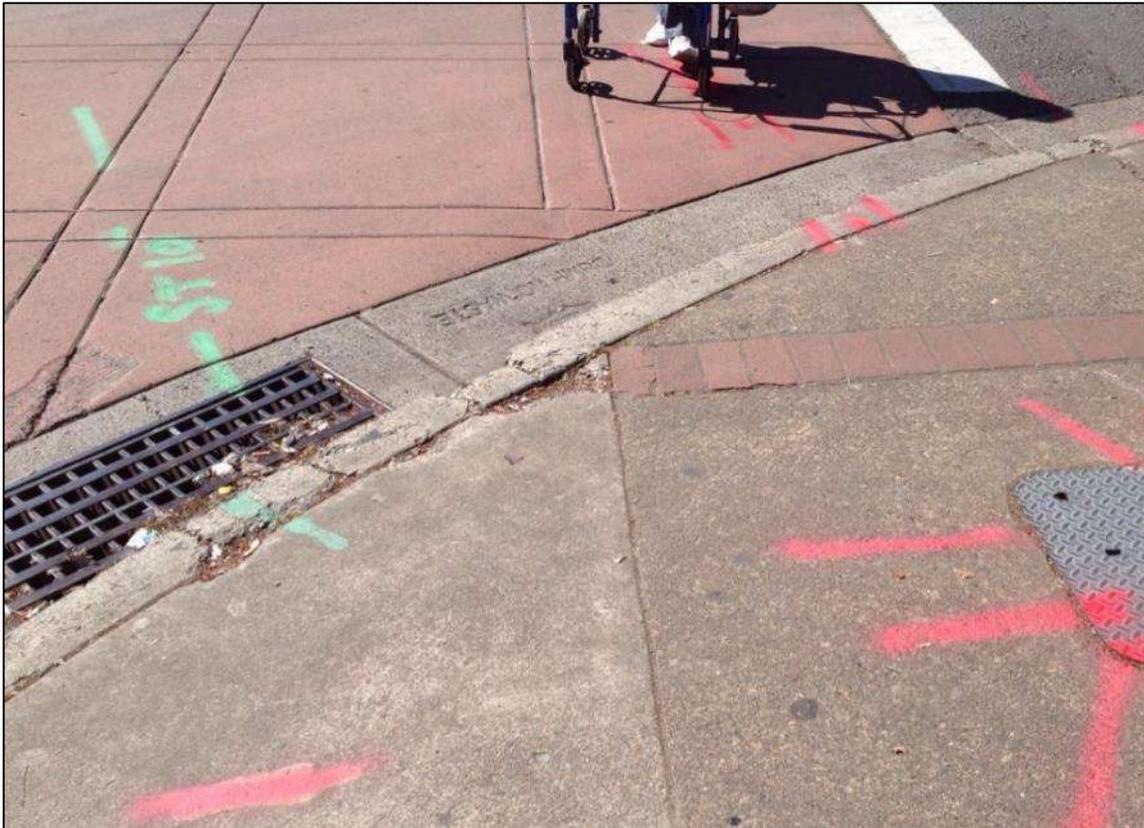
Area:	114	Name:	Sidewalk	Determination of Blight:	Yes
--------------	-----	--------------	----------	---------------------------------	-----

The sidewalk and ramp are uneven with holes. The ramp not very accessible due to pavement, ramp and grate. Determination of blight based on ORS 457.010 (1)(e).

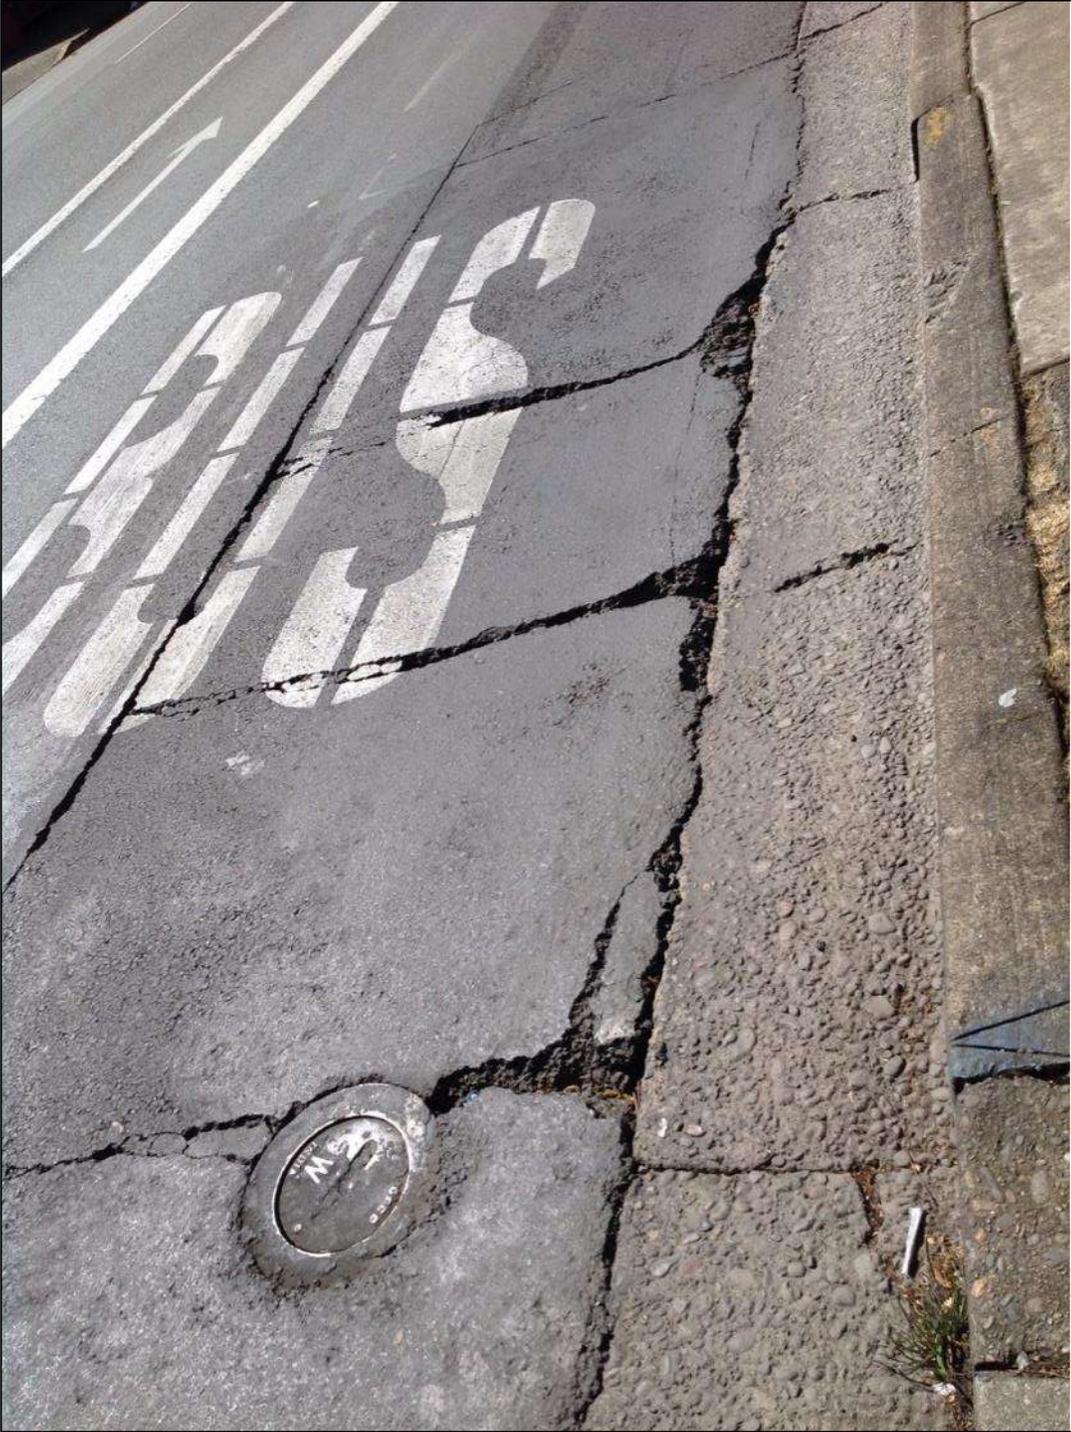
Area: 115 Name: Road Determination of Blight: Yes

Notes: There are several large holes in street. Determination of blight based on ORS 457.010 (1)(e).

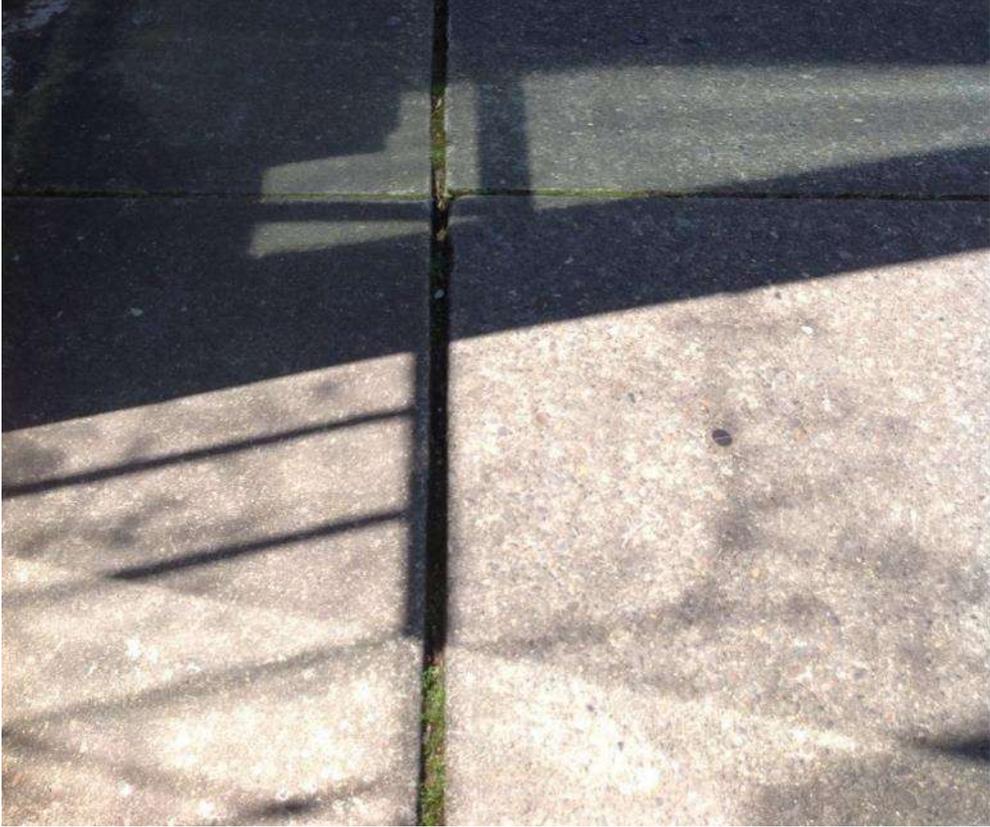
Area:	118	Name:	Sidewalk	Determination of Blight:	Yes
--------------	-----	--------------	----------	---------------------------------	-----

Notes: Sidewalk has large gap. Determination of blight based on ORS 457.010 (1)(e).

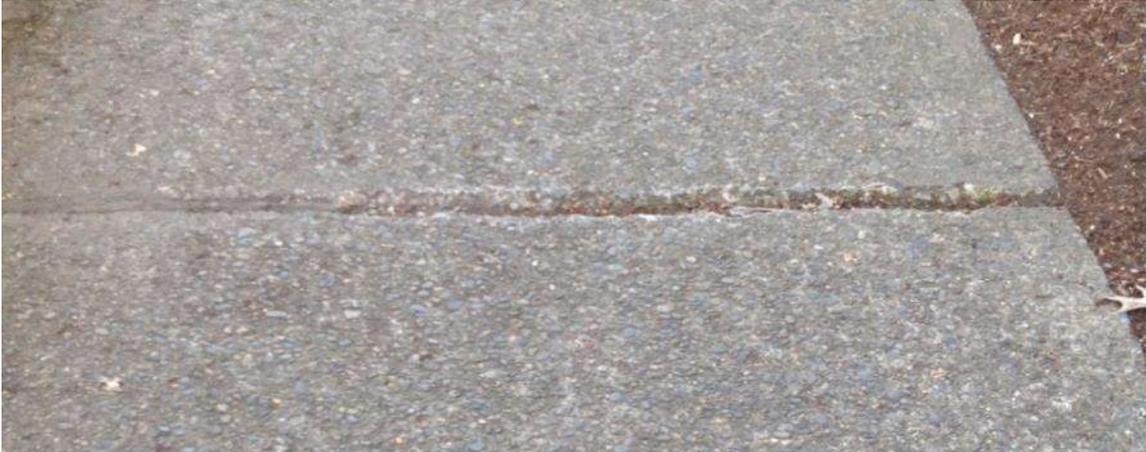
Area: 119 **Name:** Sidewalk **Determination of Blight:** Yes

Notes: The sidewalk is uneven and has a large space between tiles. Determination of blight based on ORS 457.010 (1)(e).

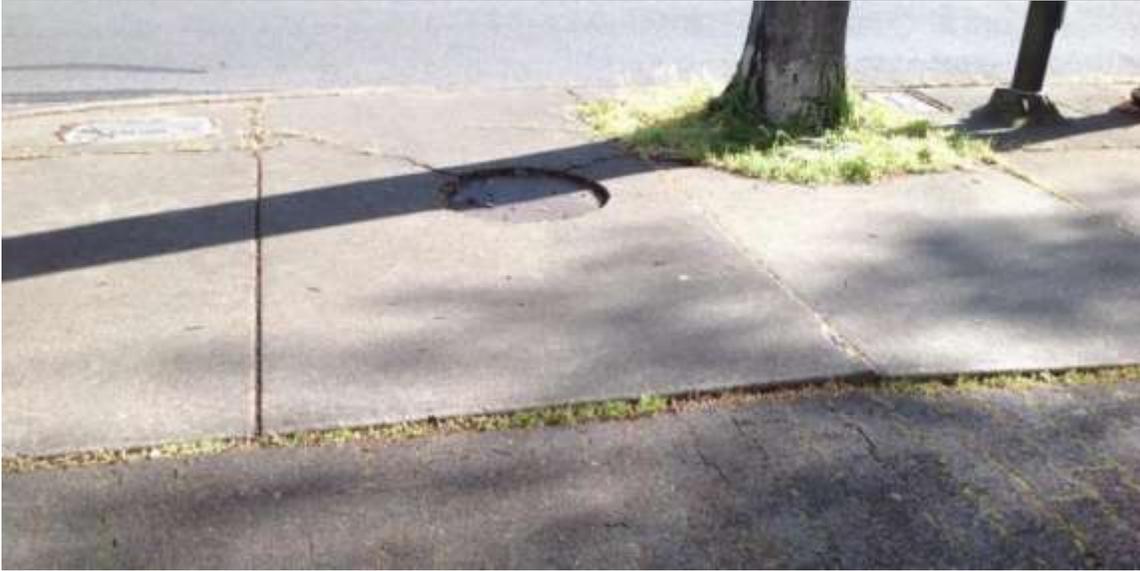
Area:	120	Name:	Sidewalk	Determination of Blight:	Yes
Notes:	The sidewalk is uneven and broken, raising concerns for accessibility. Determination of blight based on ORS 457.010 (1)(e).

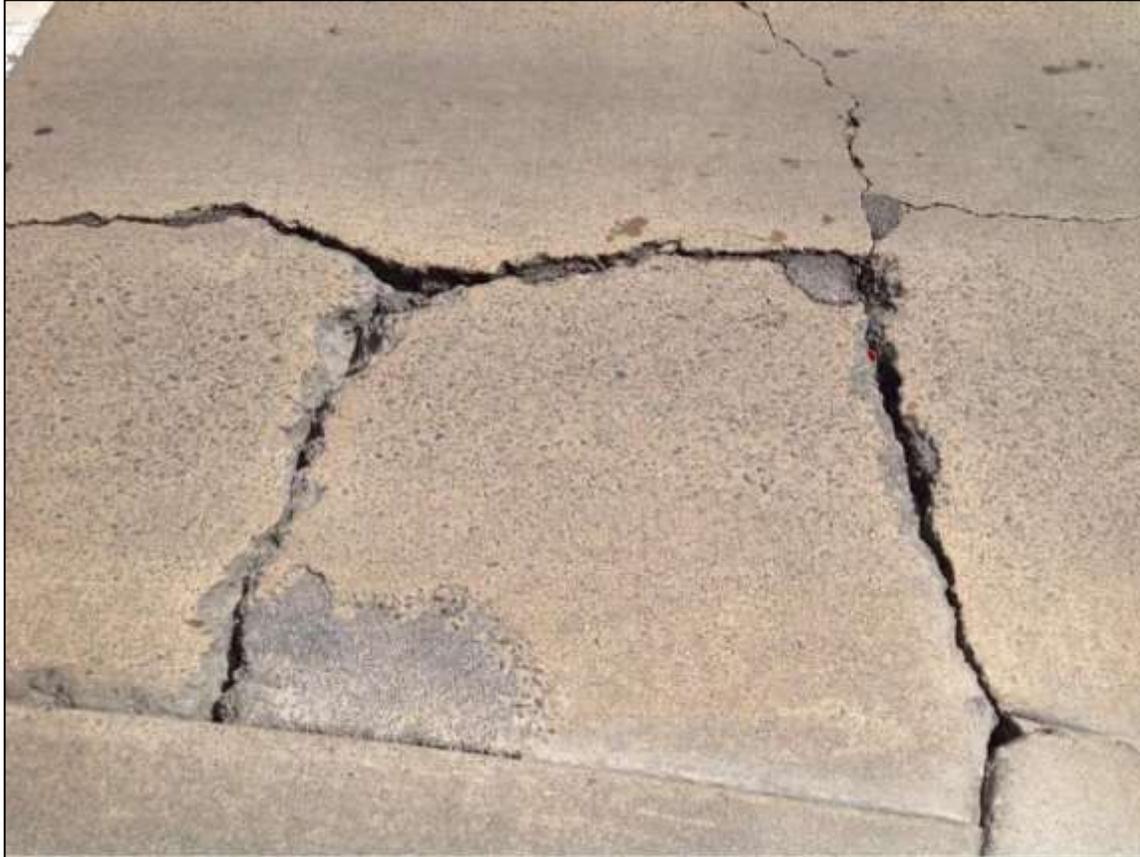
Area:	122	Name:	Pedestrian Walkway	Determination of Blight:	Yes
Notes:	Walkway has holes. Determination of blight based on ORS 457.010 (1)(e).
