DOWNTOWN URBAN RENEWAL DISTRICT REPORT

REPORT ON THE DOWNTOWN URBAN RENEWAL DISTRICT PLAN

Map to Accompany Downtown Urban Renewal Slums and Blight Report 2016

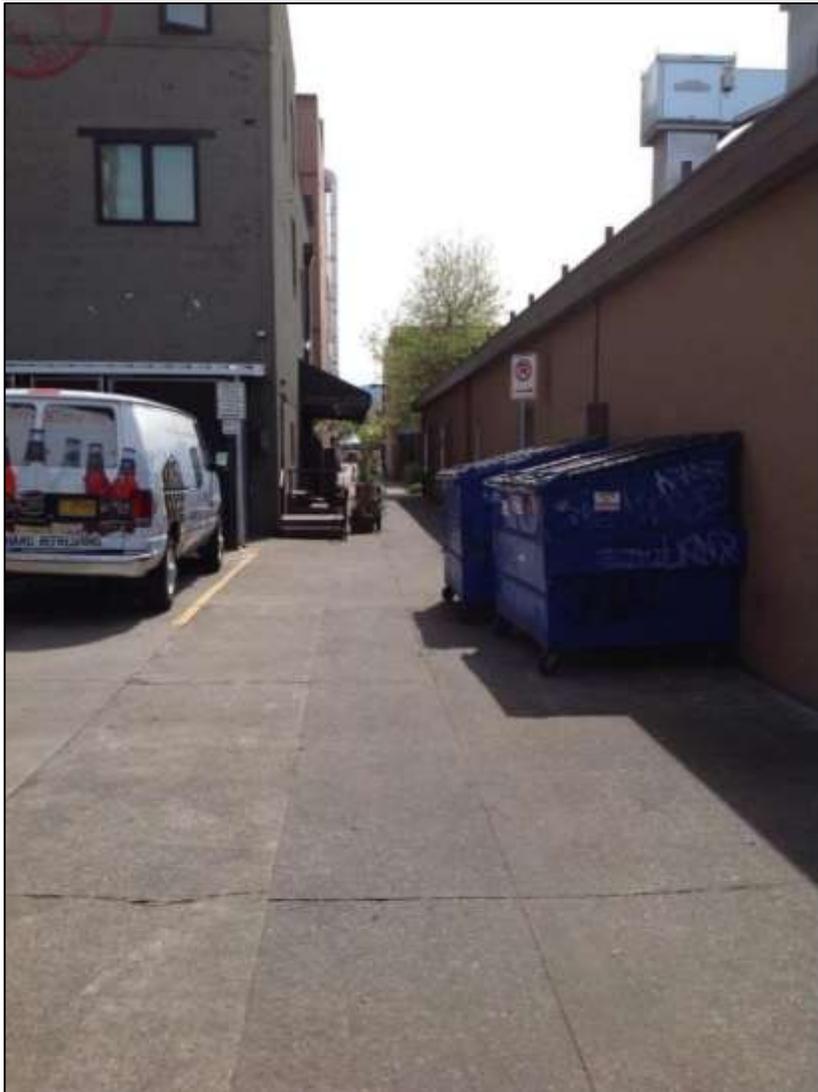
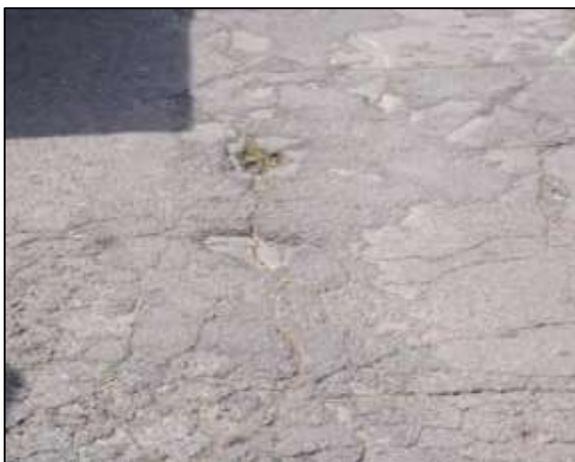
Area:	123	Name:	Alley and service court	Determination of Blight:	Yes
Notes:	In walkway and service court, the pavement is uneven with large holes. The pedestrian walkway leads people to service court with garbage containers. Determination of blight based on ORS 457.010 (1)(e).

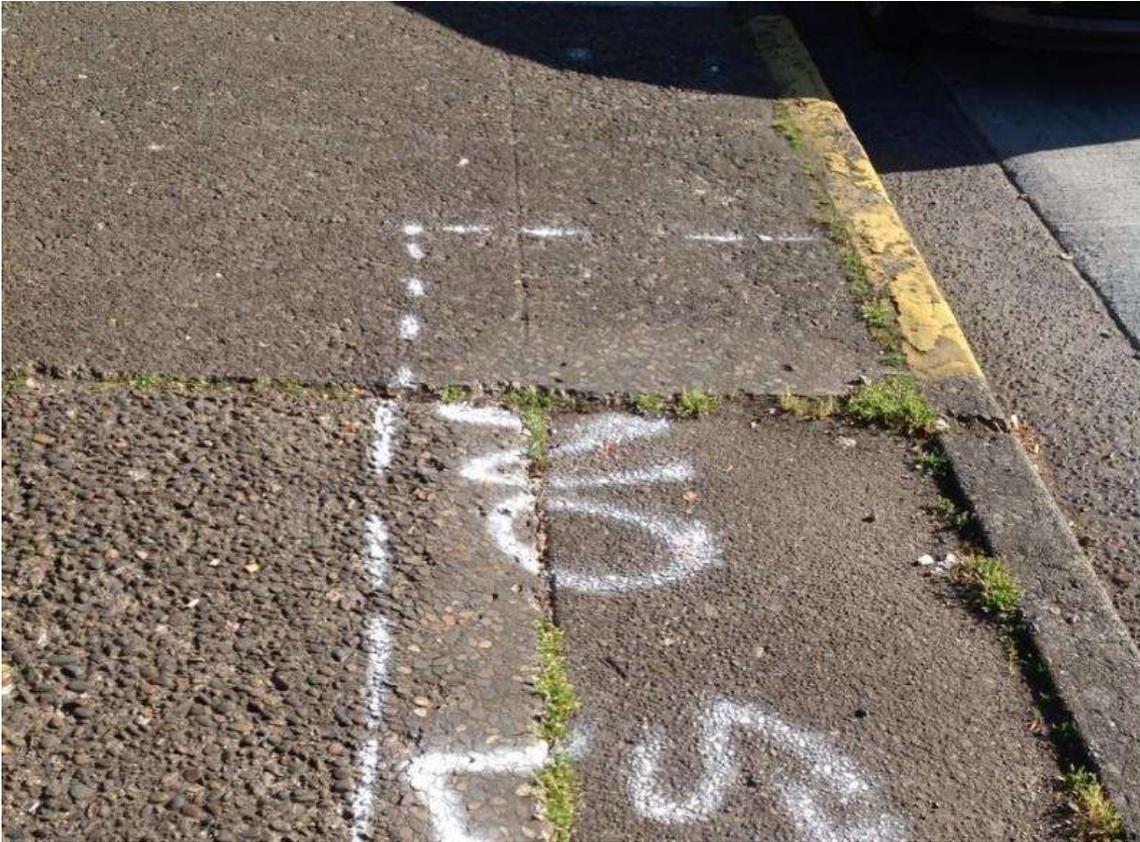
Area:	125	Name:	Sidewalk	Determination of Blight:	Yes
Notes:	Sidewalk is uneven and broken with overgrown vegetation. Determination of blight based on ORS 457.010 (1)(e).

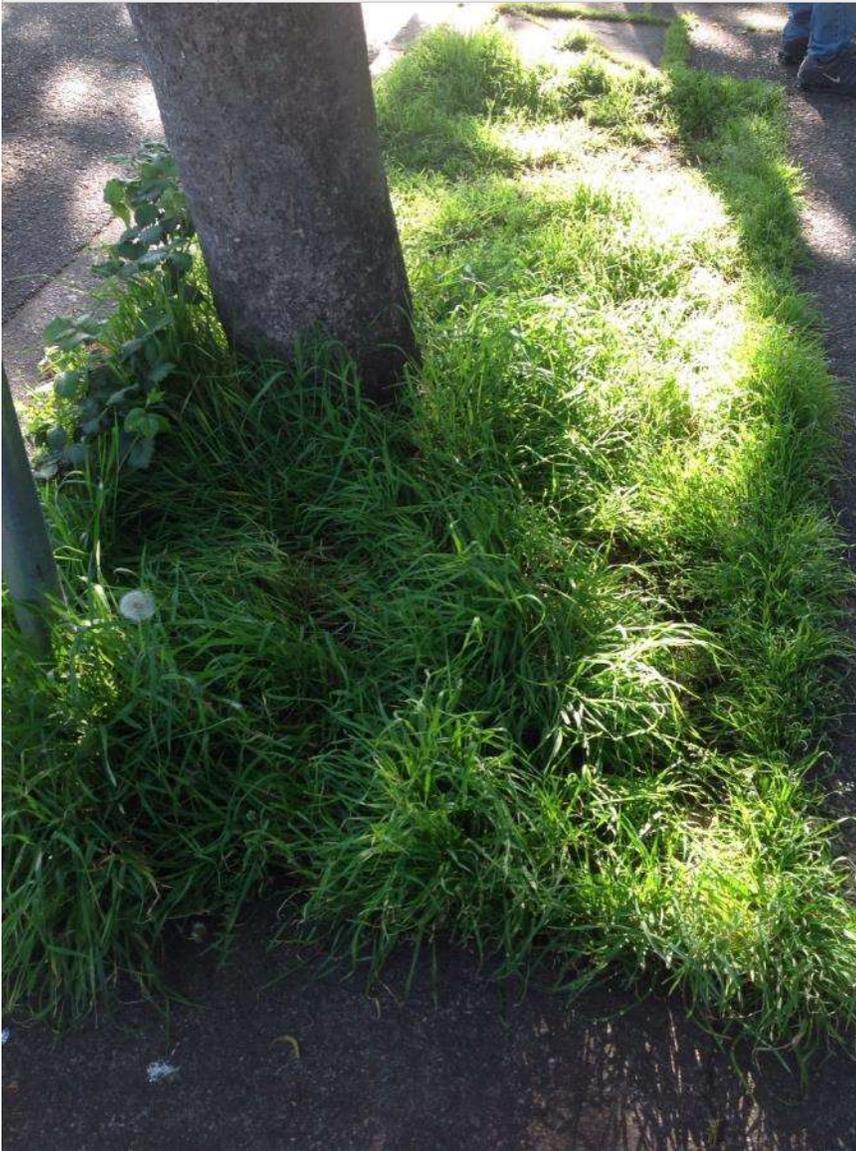
Area:	126	Name:	Sidewalk	Determination of Blight:	Yes
Notes:	Sidewalk is damaged and uneven. Determination of blight based on ORS 457.010 (1)(e).

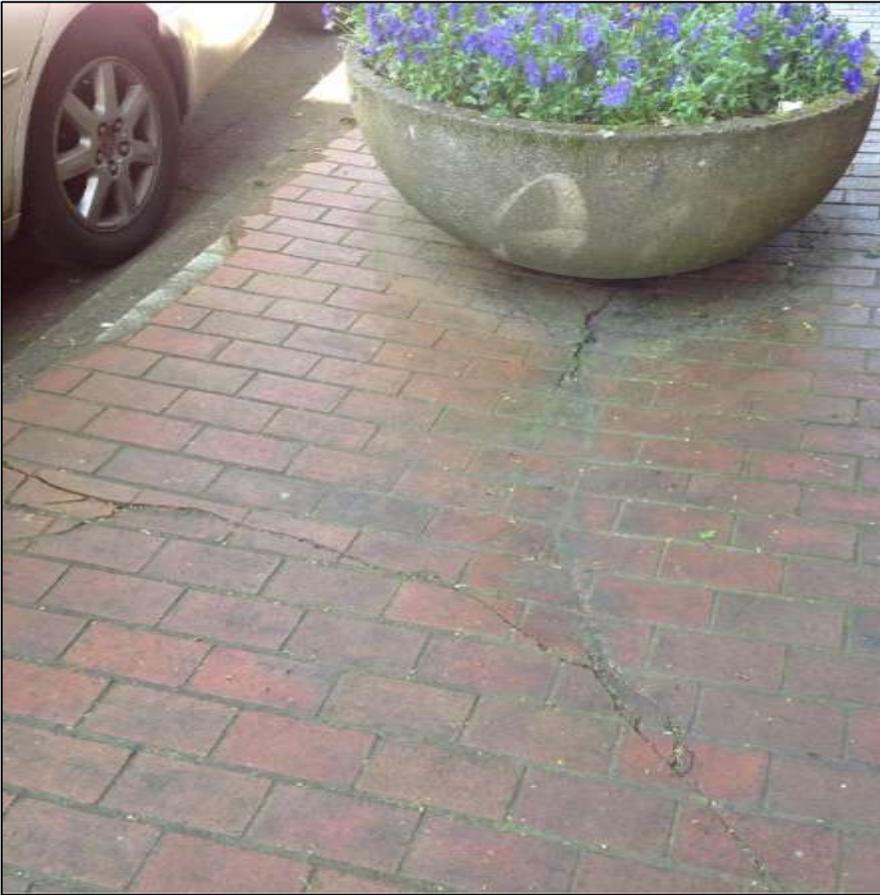
Area:	127	Name:	Sidewalk	Determination of Blight:	Yes
Notes:	Sidewalk has large holes, it is uneven, broken, and accessibility is questioned. Determination of blight based on ORS 457.010 (1)(e).
